Takoma Park Study Area 1

Site Visit Notes

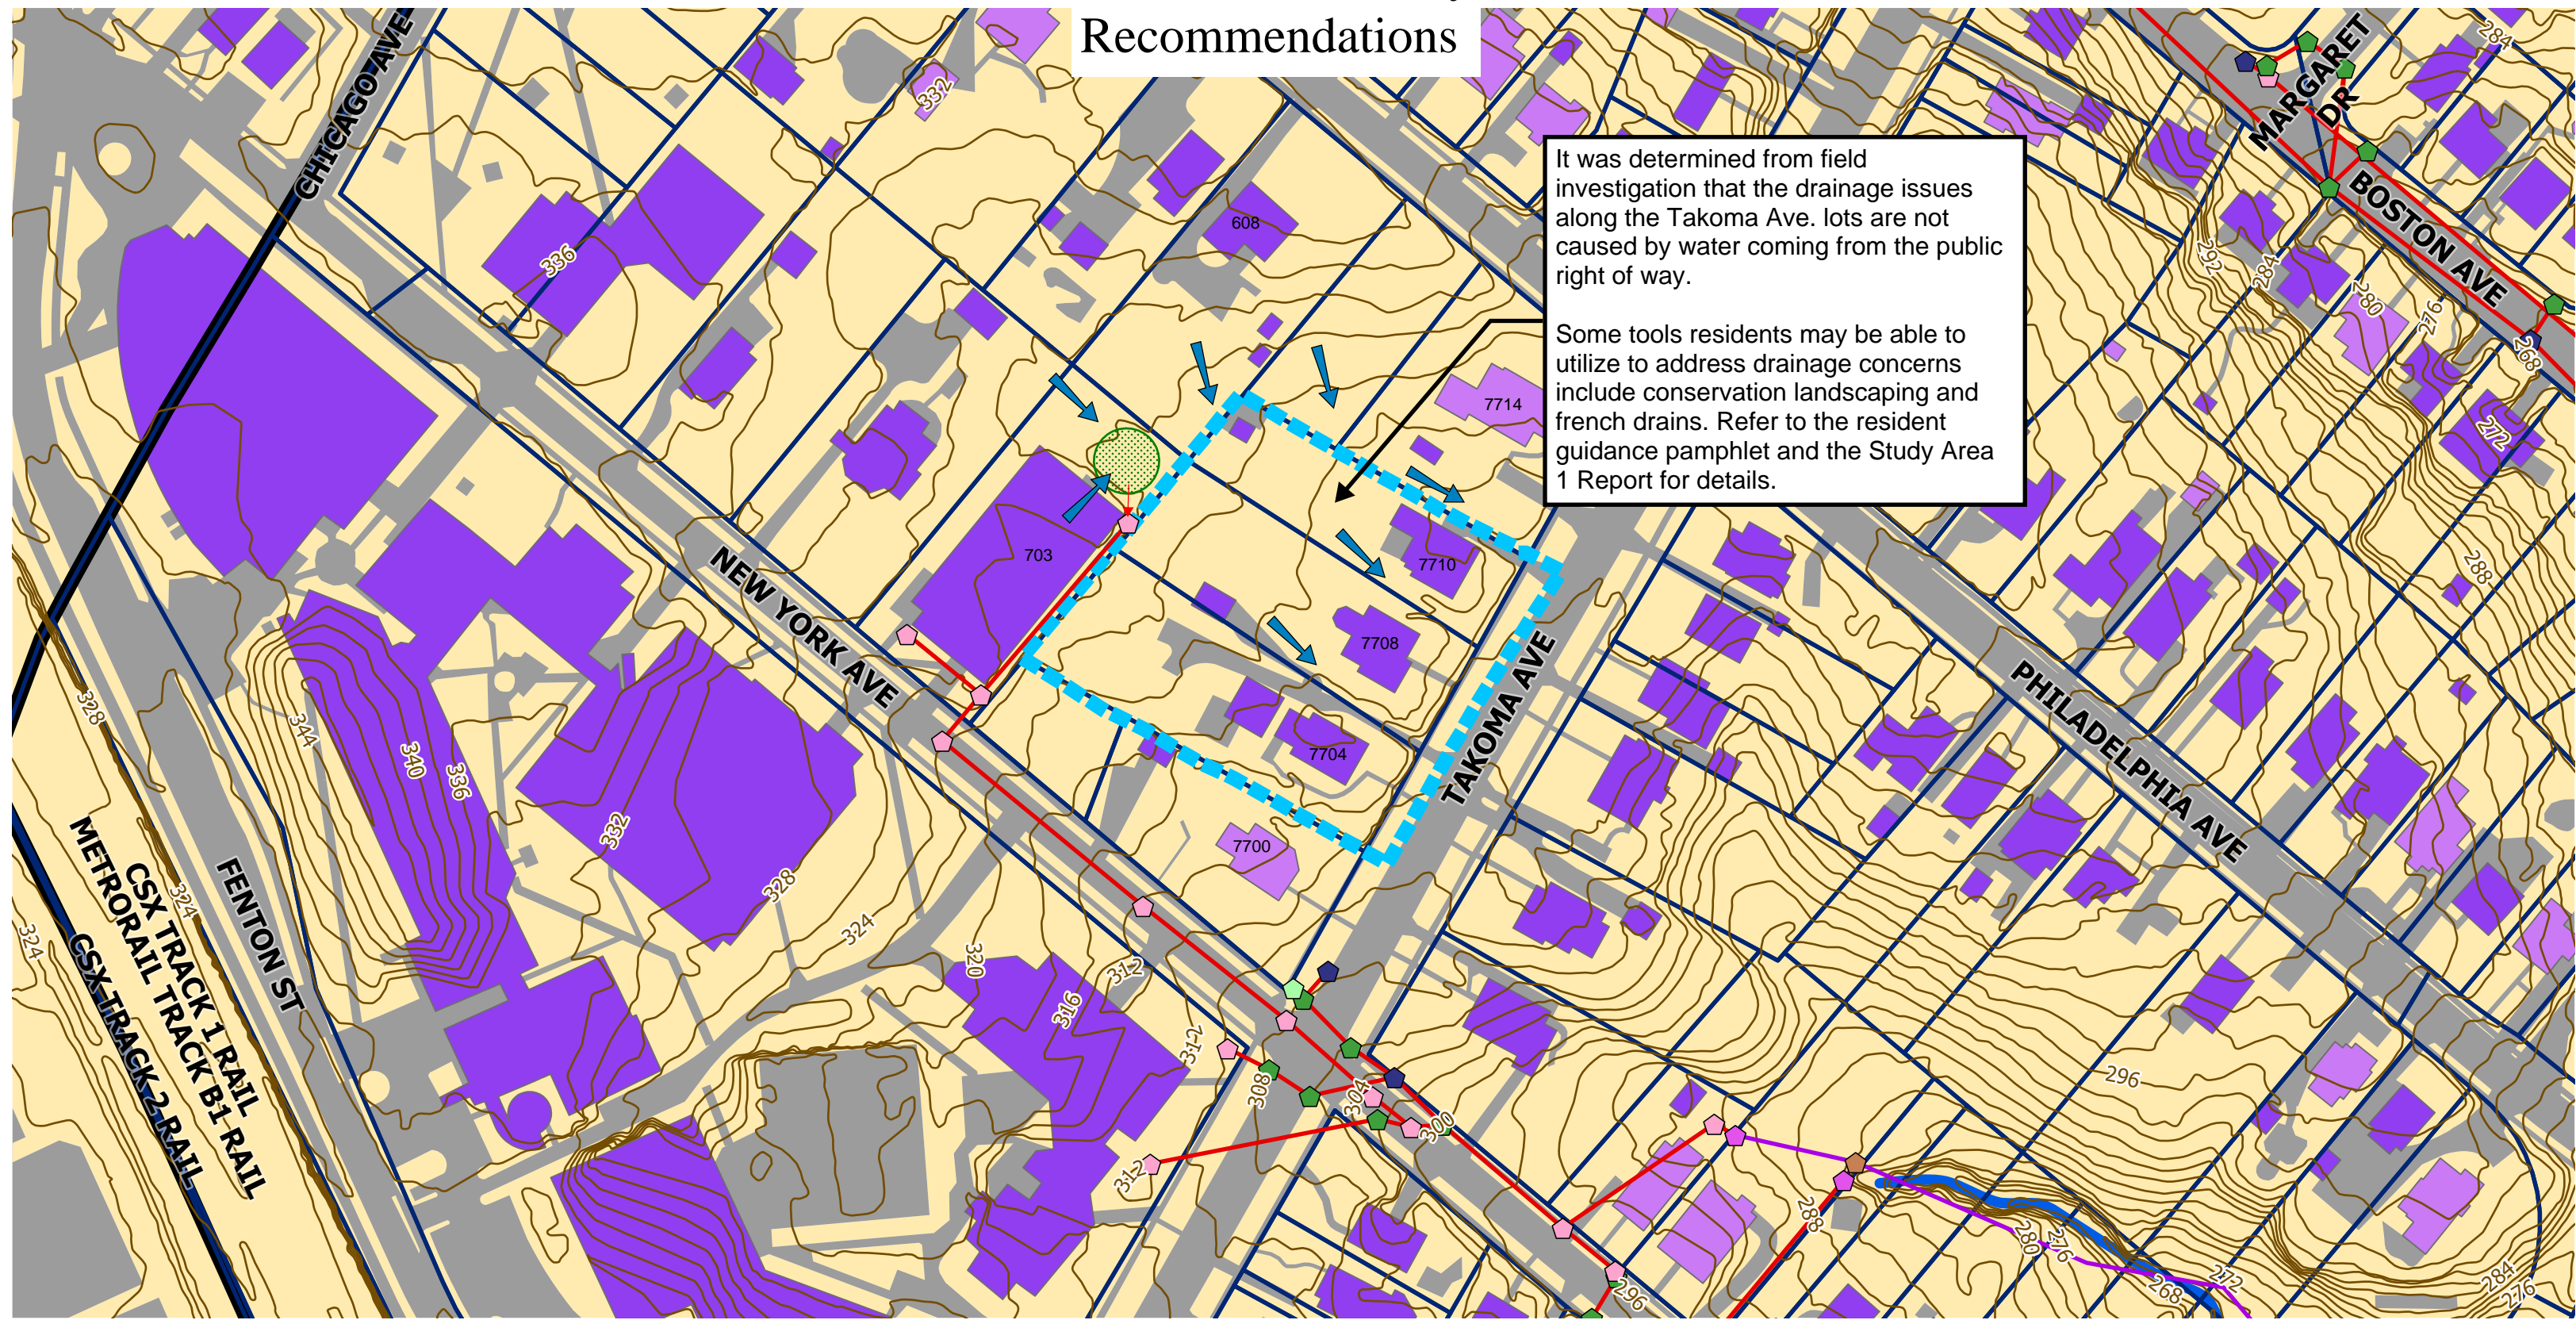
Takoma Park Study Area 1

Bioretention BMP behind Montgomery College Building. According to residents, the Bioretention has alleviated surface runoff from the lot. The bioretention has an underdrain and connects to the 15" pipe that goes out to New York Ave. The bioretention also has a filter fabric liner to prevent groundwater seepage out of the media.

Runoff from 608 Philadelphia Ave lot flows to Takoma Ave. properties.

These three properties have consistently wet backyards. There is minimal infiltration during rain events, which creates ponding and increased runoff flows between the houses. This seems to be due to a high groundwater table in the area.

There is ponding water on the sidewalk in front of 7708 Takoma Ave. According to residents, this usually happens after any rain storm and last a few days.

It was determined from field investigation that the drainage issues along the Takoma Ave. lots are not caused by water coming from the public right of way.

Some tools residents may be able to utilize to address drainage concerns include conservation landscaping and french drains. Refer to the resident guidance pamphlet and the Study Area 1 Report for details.

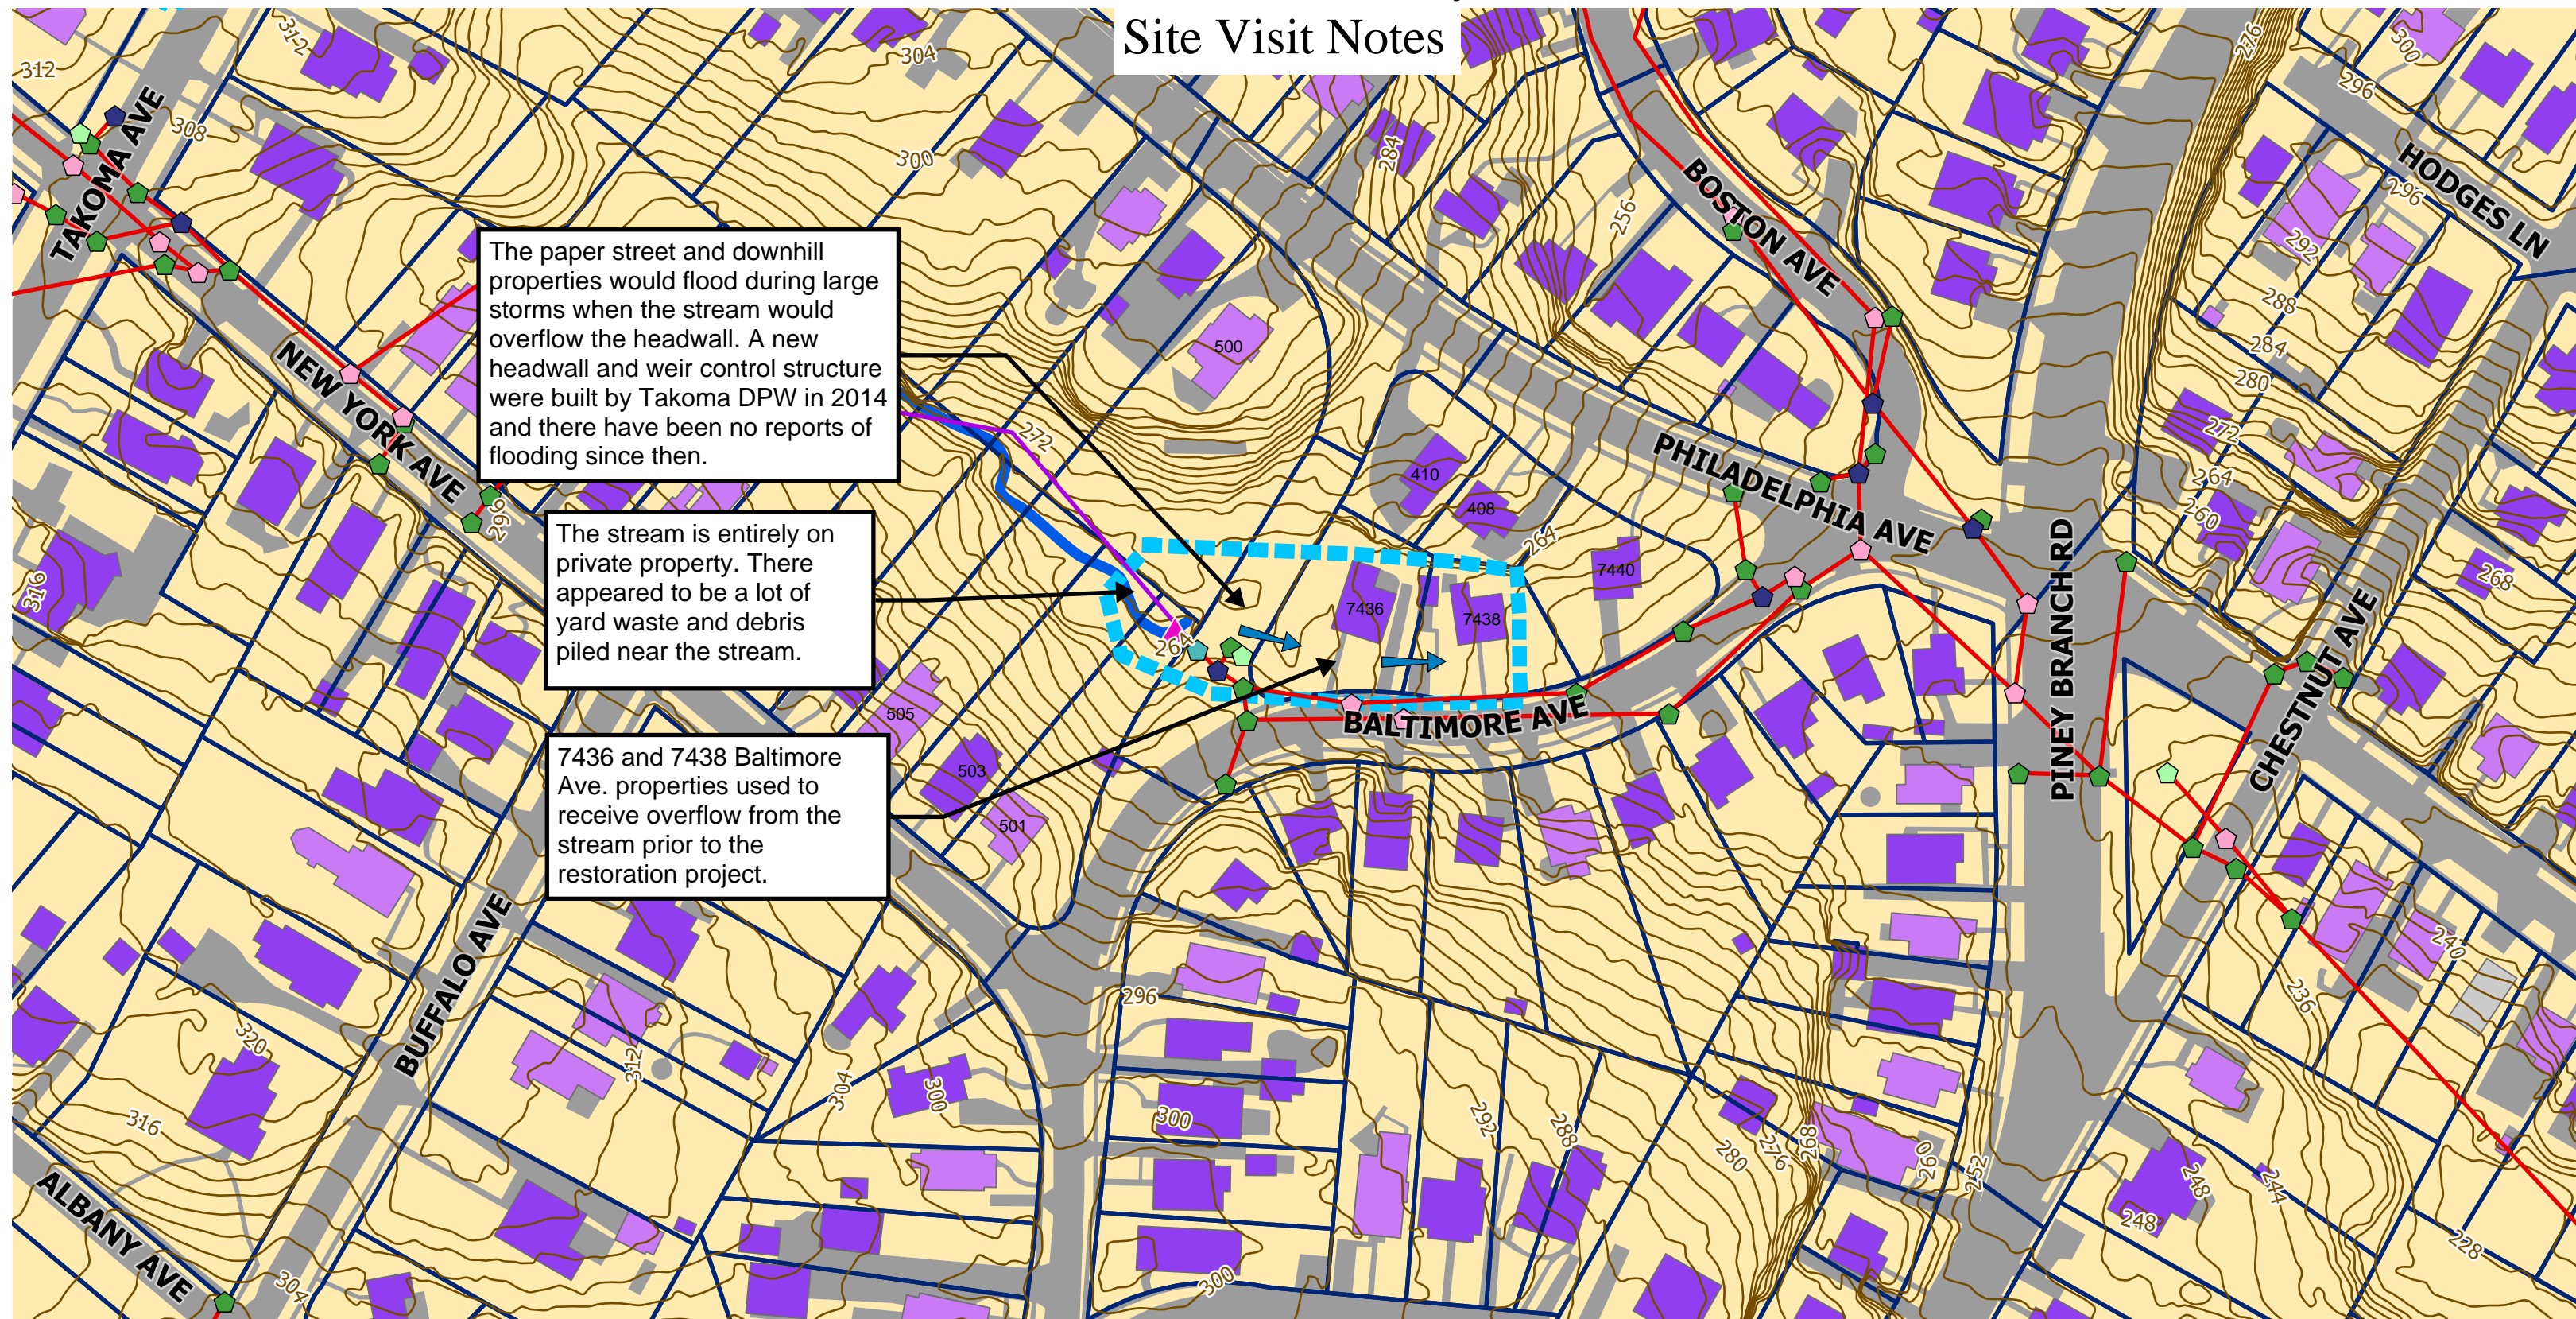
Takoma Park Study Area 2

The paper street and downhill properties would flood during large storms when the stream would overflow the headwall. A new headwall and weir control structure were built by Takoma DPW in 2014 and there have been no reports of flooding since then.

The stream is entirely on private property. There appeared to be a lot of yard waste and debris piled near the stream.

7436 and 7438 Baltimore Ave. properties used to receive overflow from the stream prior to the restoration project.

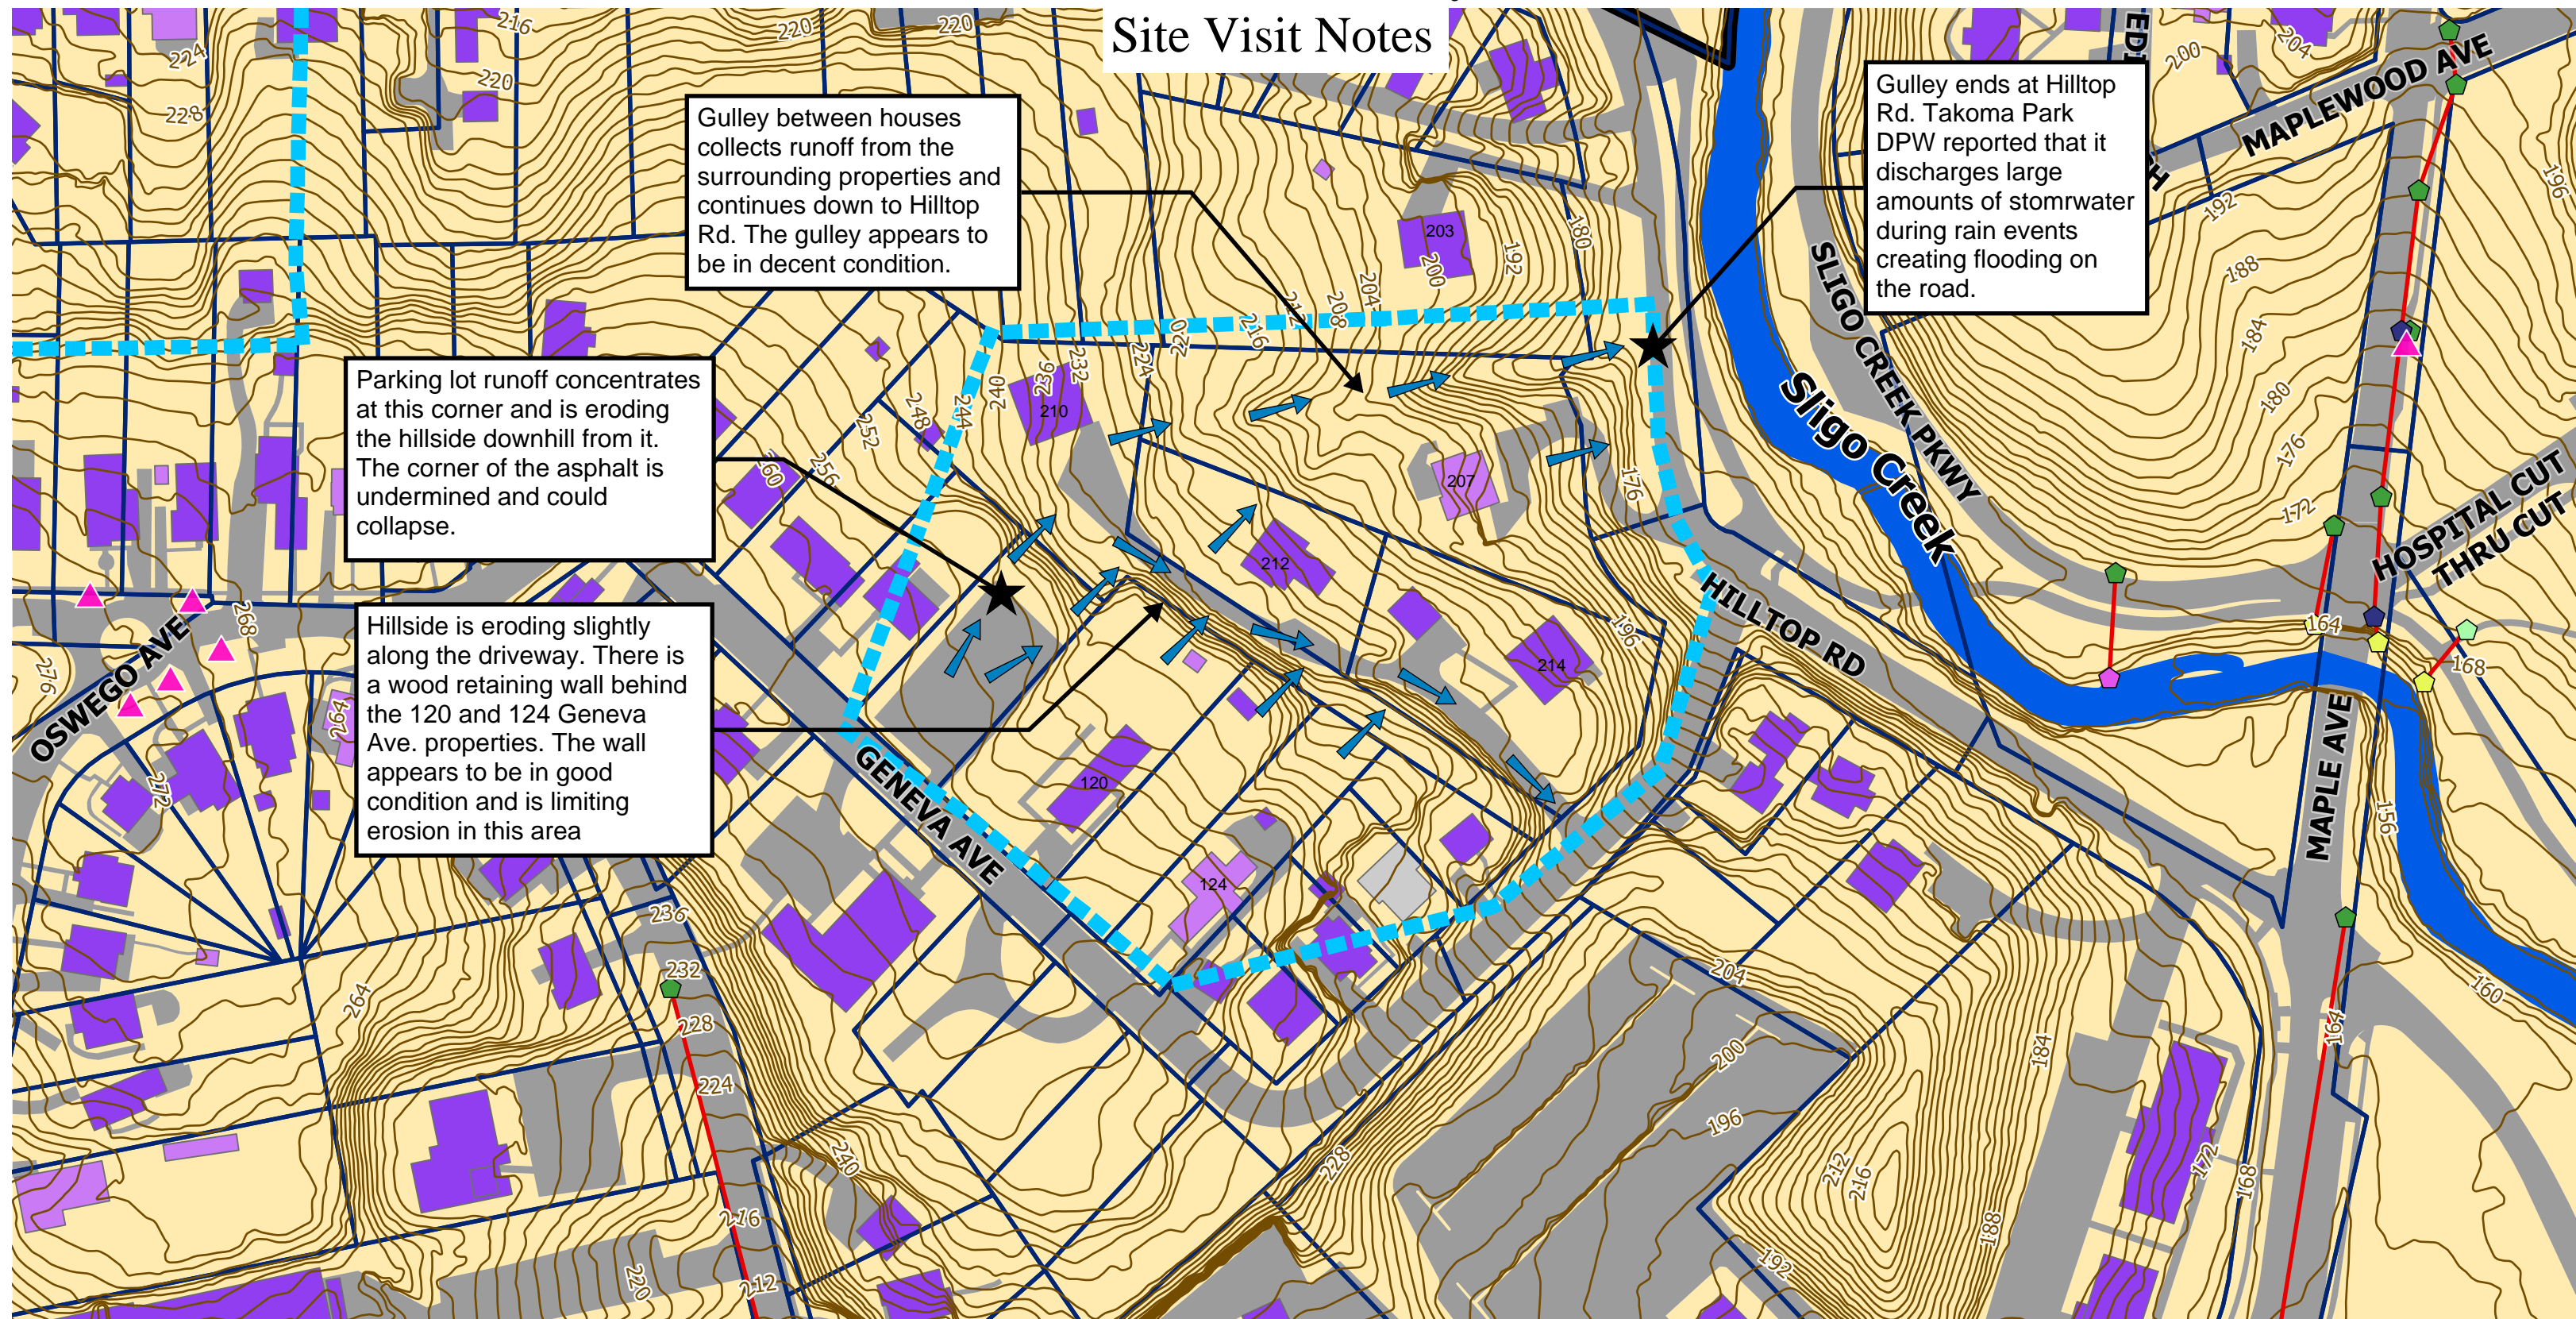
Takoma Park Study Area 5

Gully between houses collects runoff from the surrounding properties and continues down to Hilltop Rd. The gully appears to be in decent condition.

Parking lot runoff concentrates at this corner and is eroding the hillside downhill from it. The corner of the asphalt is undermined and could collapse.

Hillside is eroding slightly along the driveway. There is a wood retaining wall behind the 120 and 124 Geneva Ave. properties. The wall appears to be in good condition and is limiting erosion in this area

Gully ends at Hilltop Rd. Takoma Park DPW reported that it discharges large amounts of stormwater during rain events creating flooding on the road.

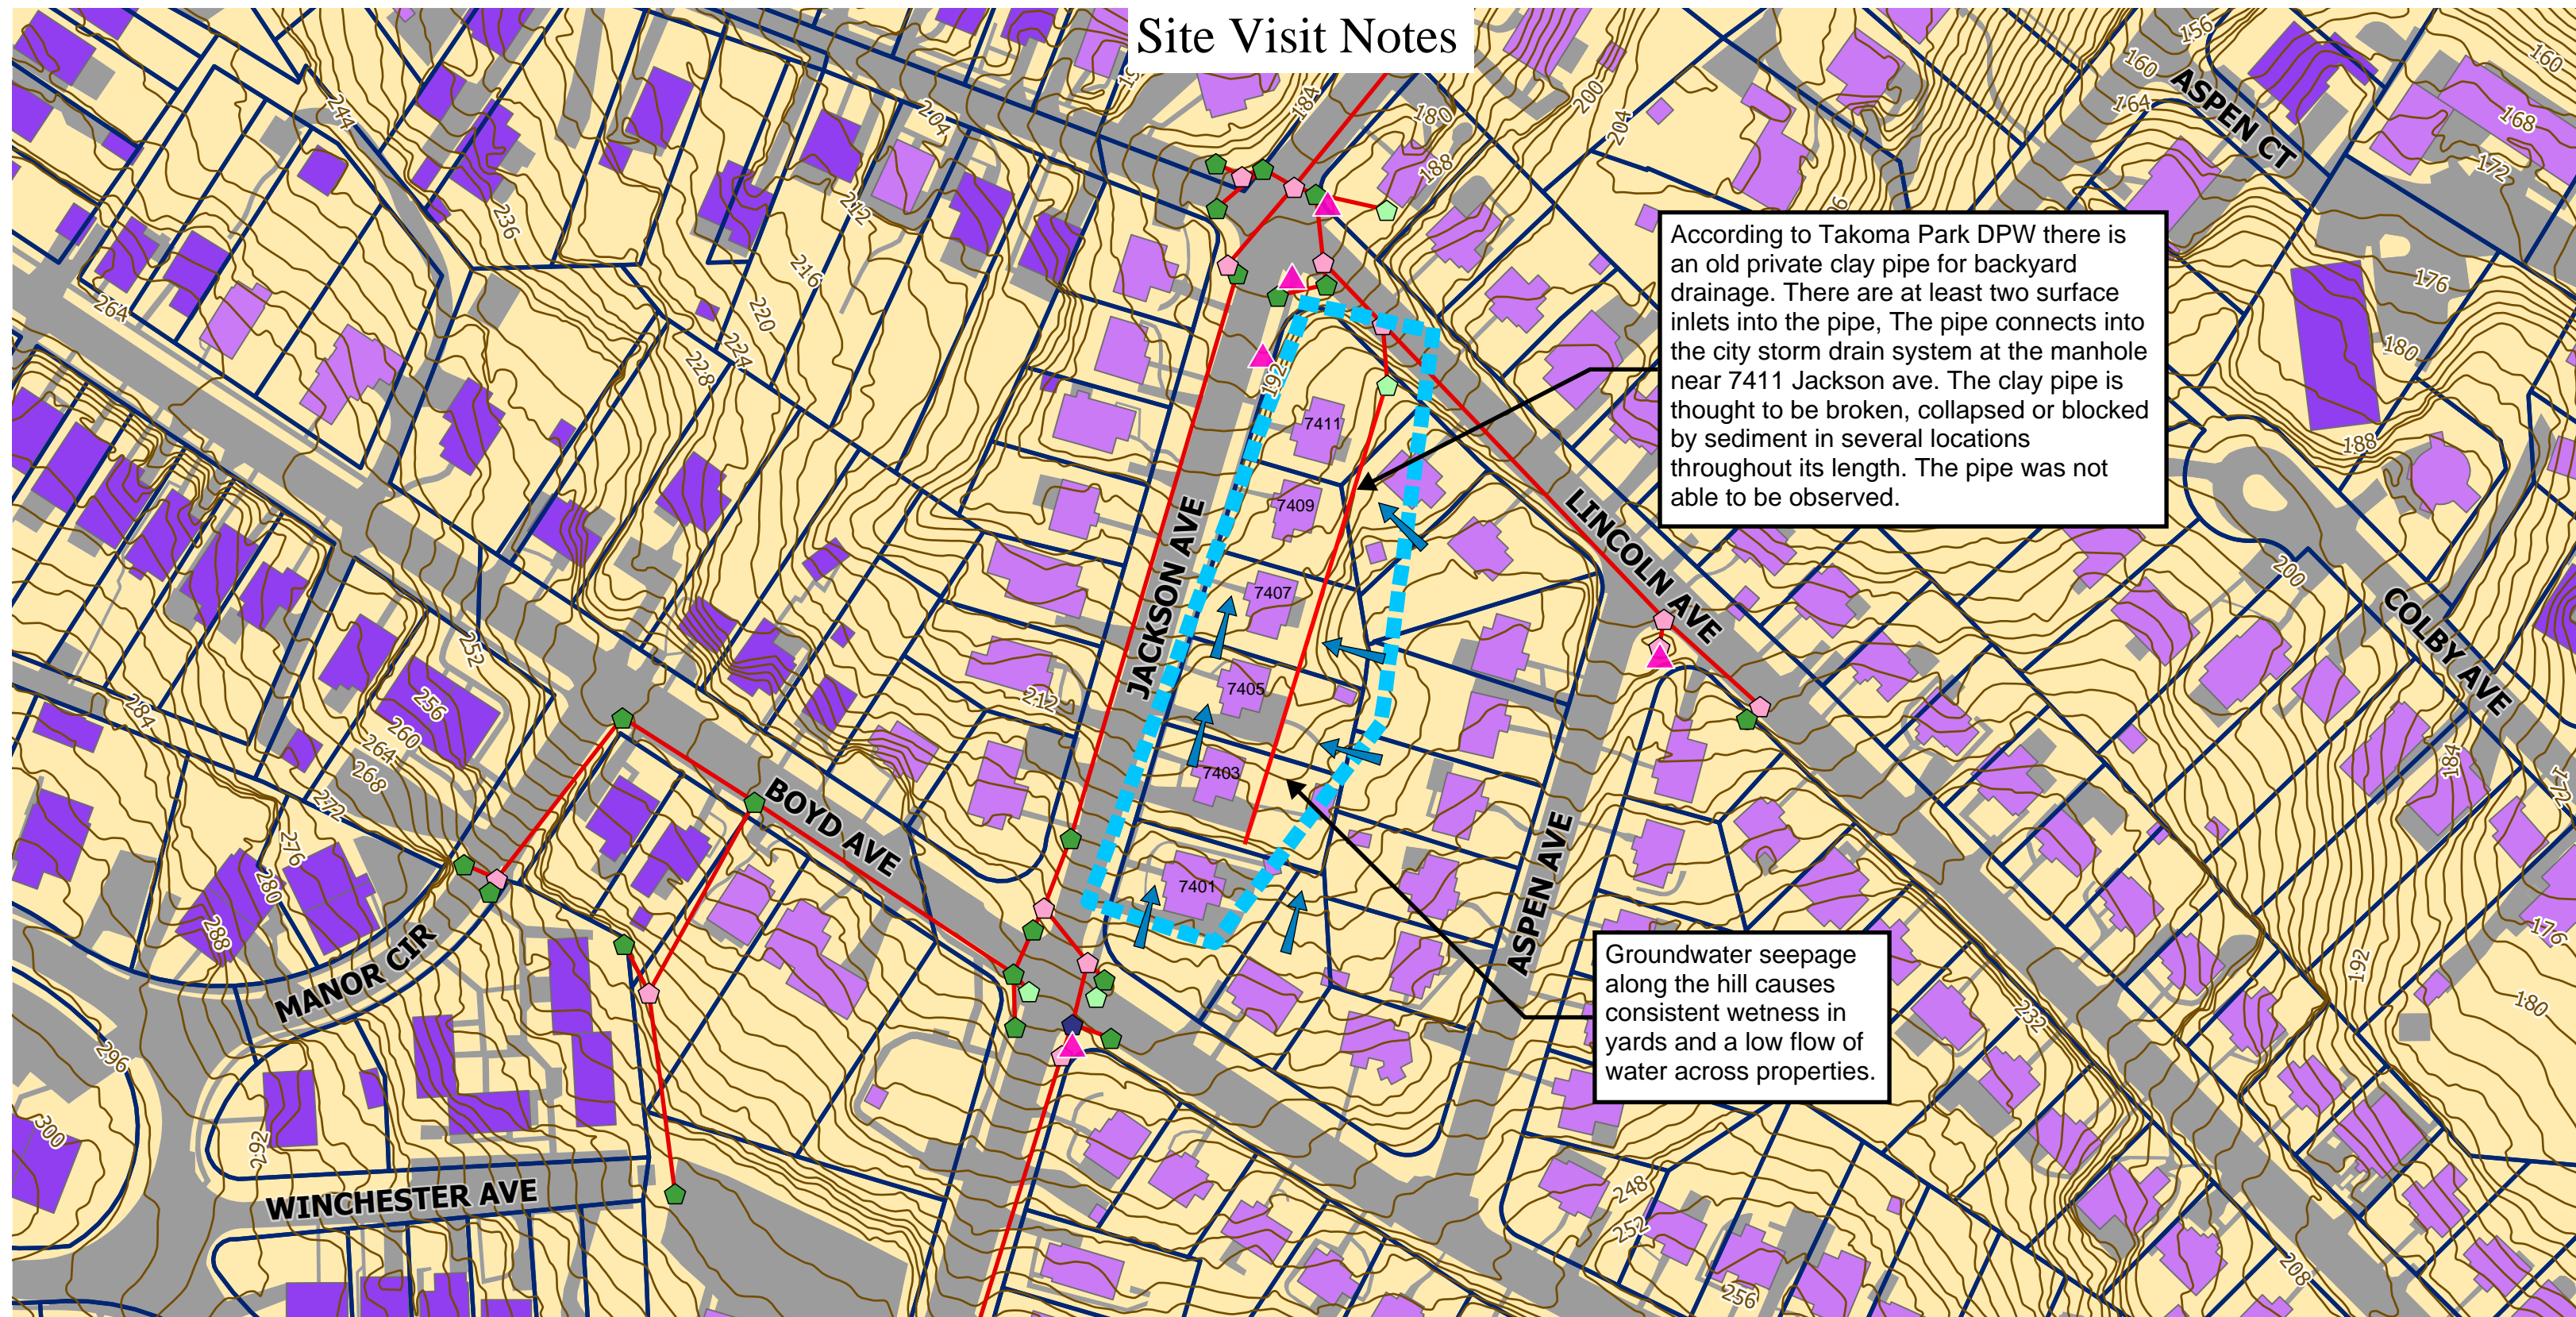
Takoma Park Study Area 8

According to Takoma Park DPW there is an old private clay pipe for backyard drainage. There are at least two surface inlets into the pipe, The pipe connects into the city storm drain system at the manhole near 7411 Jackson ave. The clay pipe is thought to be broken, collapsed or blocked by sediment in several locations throughout its length. The pipe was not able to be observed.

Groundwater seepage along the hill causes consistent wetness in yards and a low flow of water across properties.

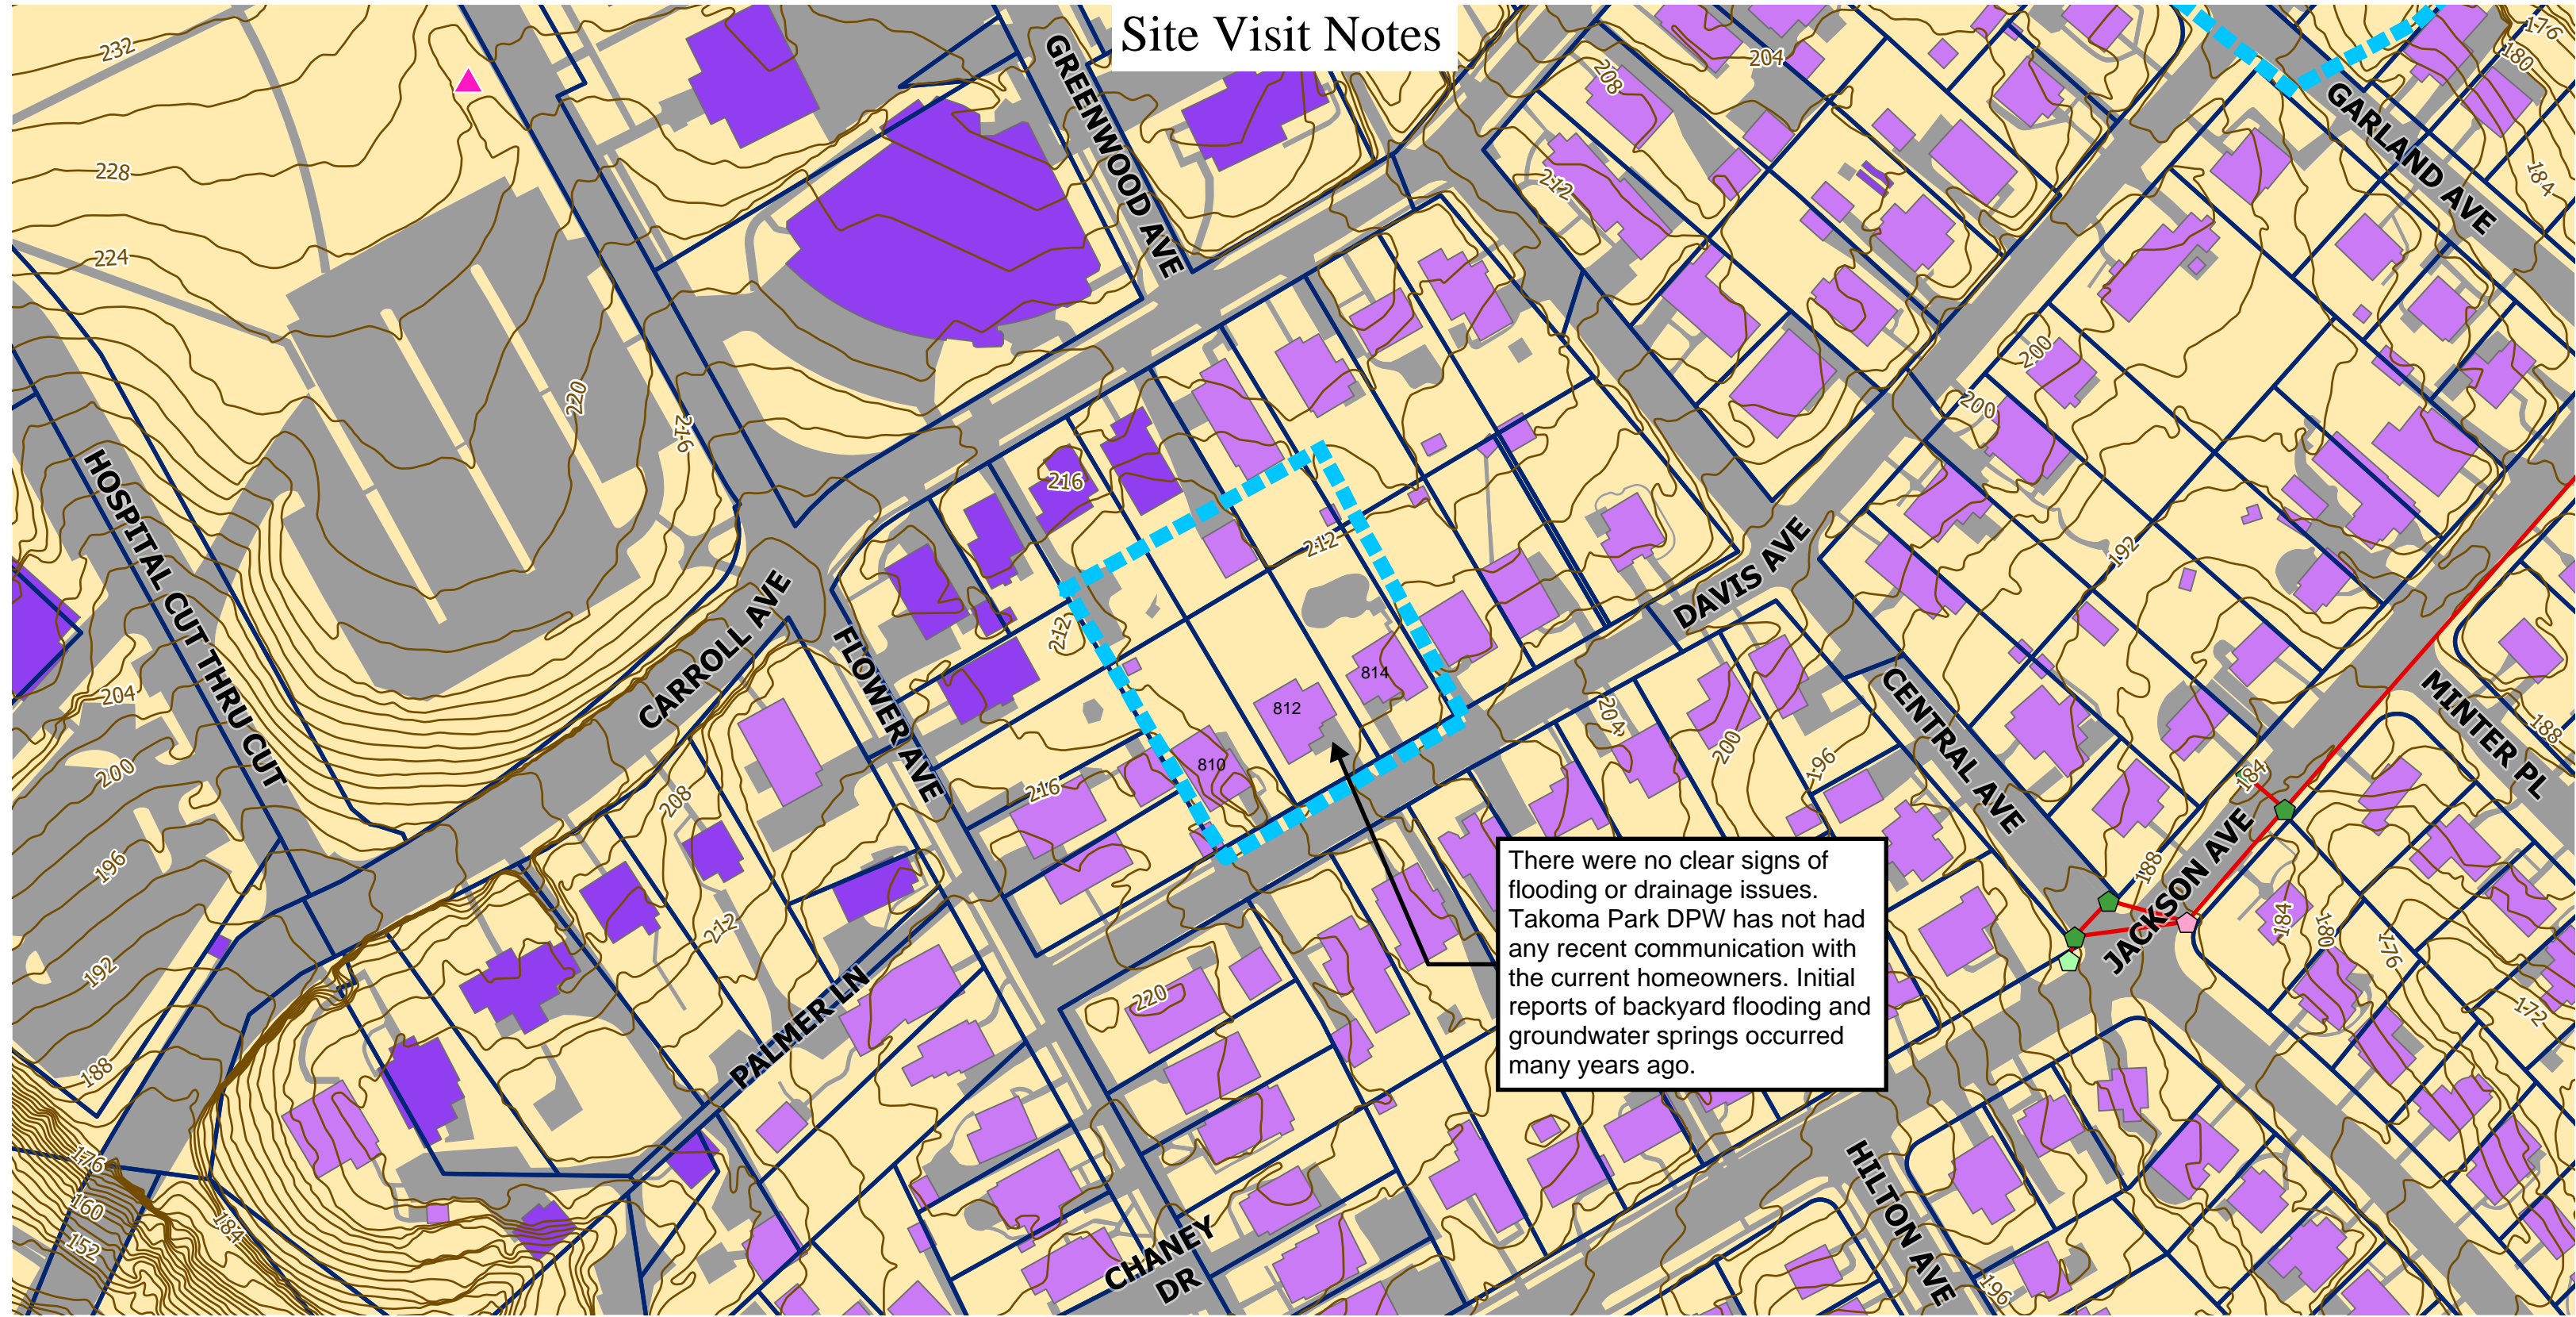
Takoma Park Study Area 9

There were no clear signs of flooding or drainage issues. Takoma Park DPW has not had any recent communication with the current homeowners. Initial reports of backyard flooding and groundwater springs occurred many years ago.

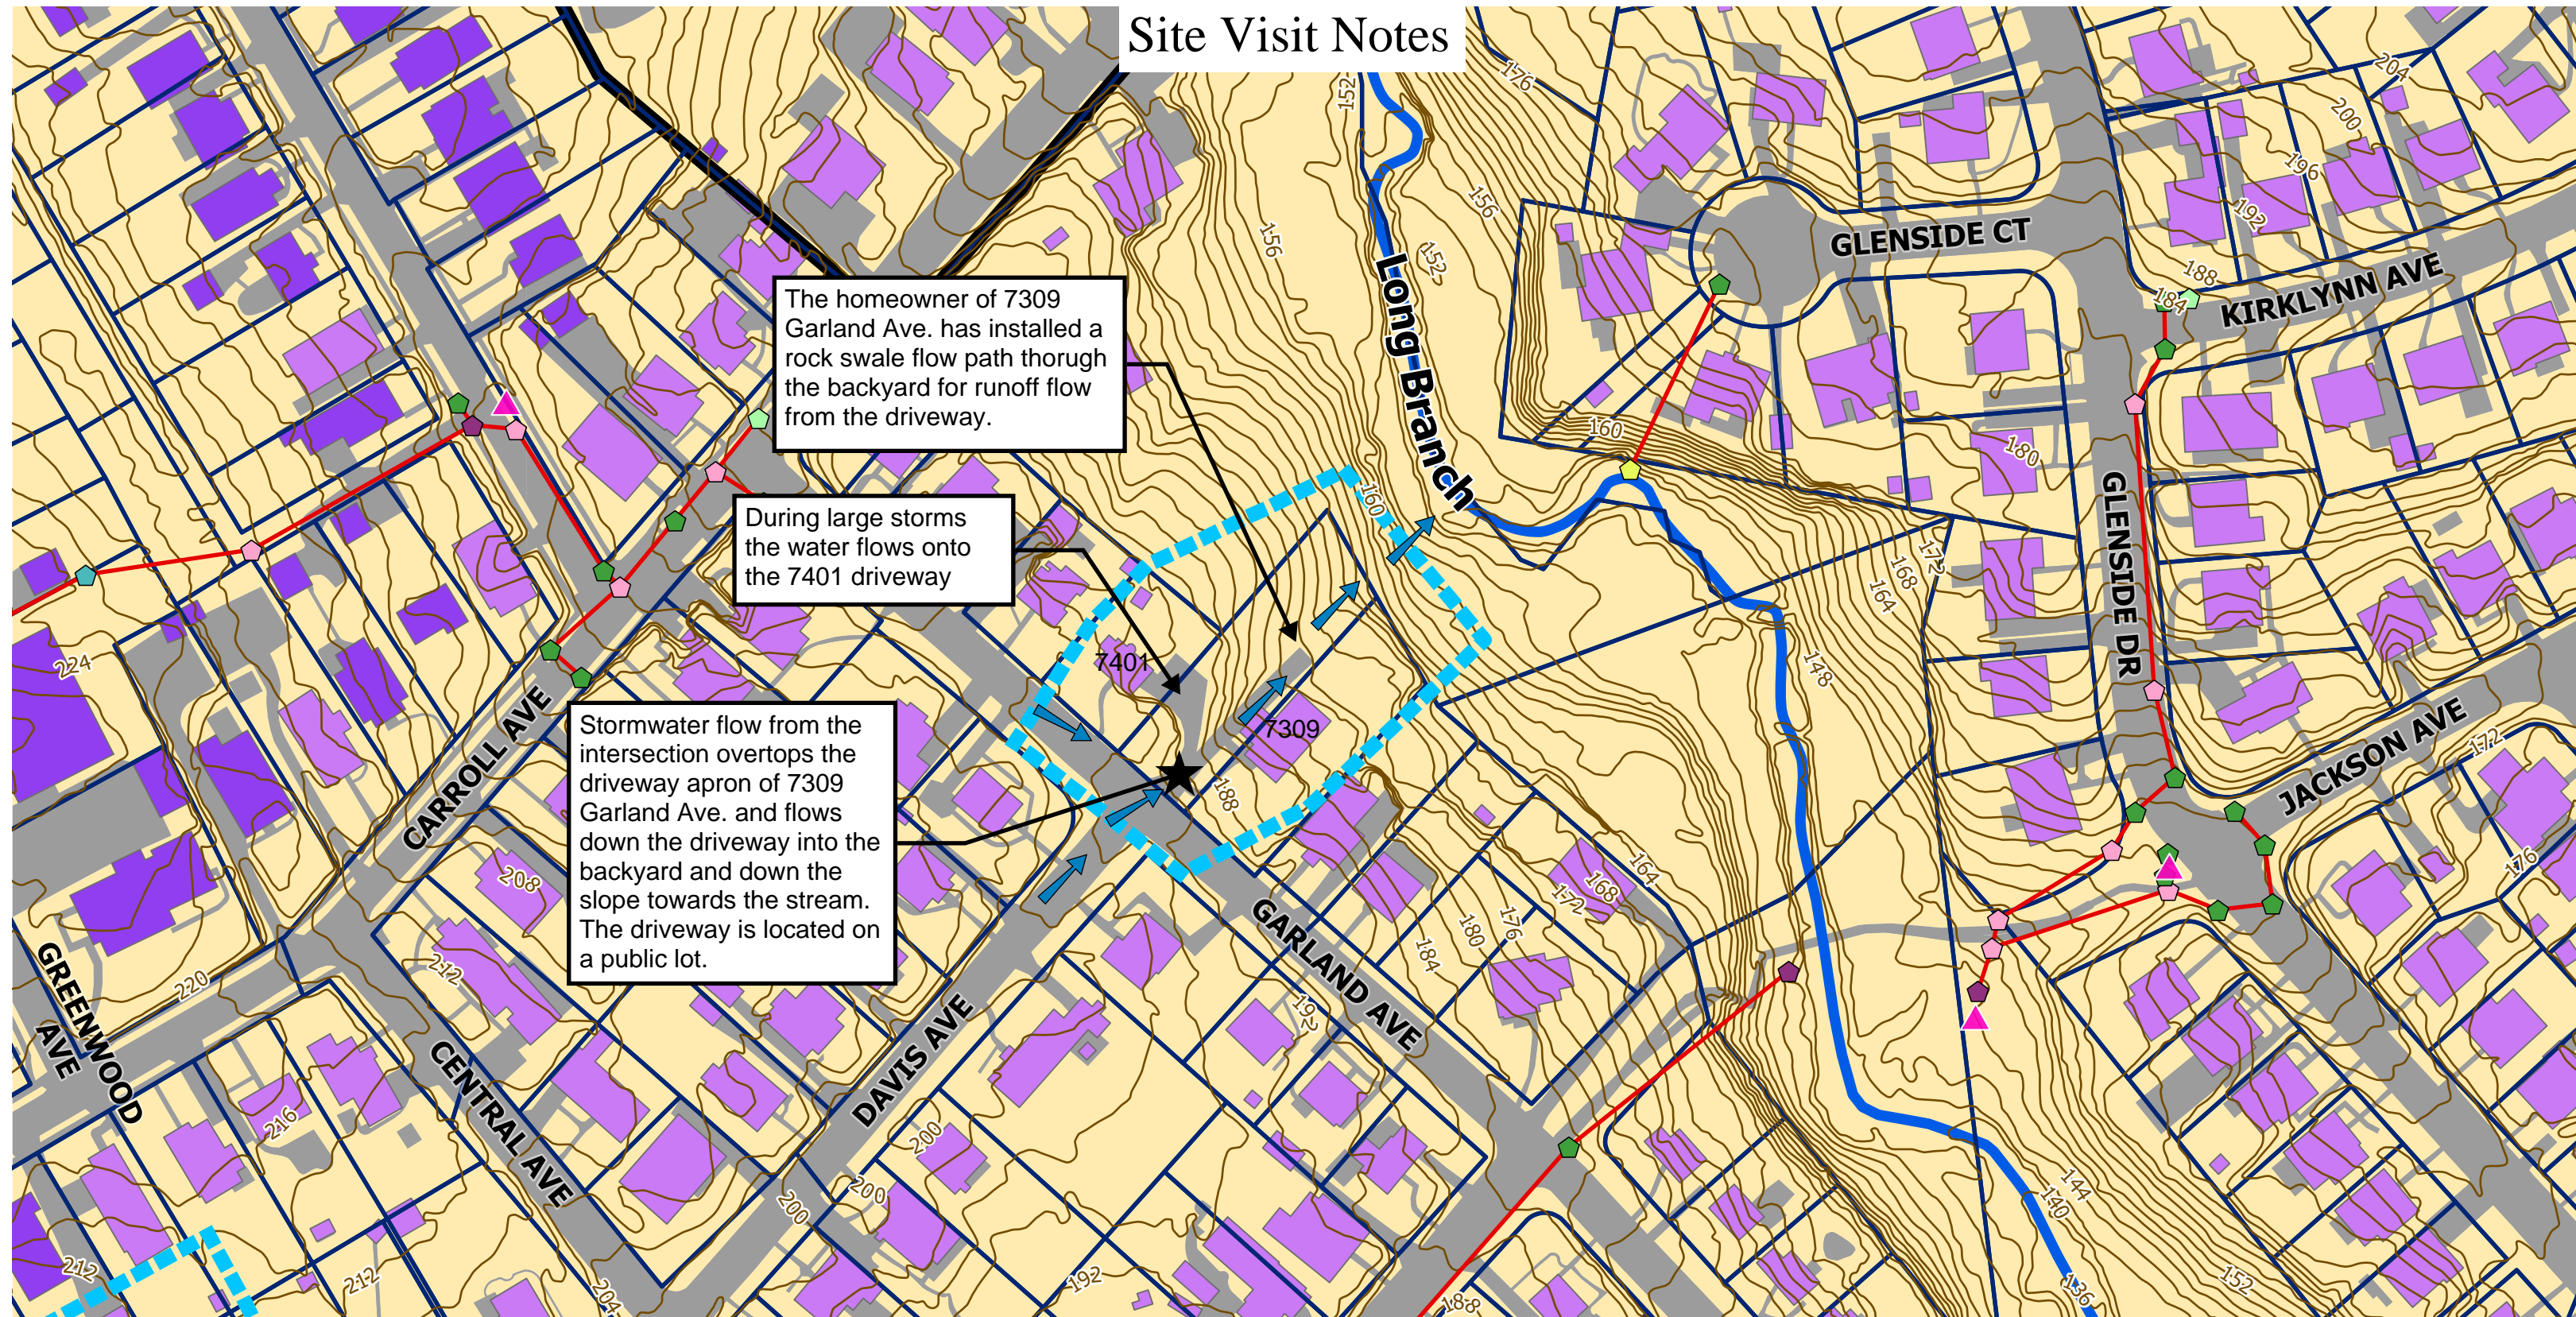
Takoma Park Study Area 10

The homeowner of 7309 Garland Ave. has installed a rock swale flow path through the backyard for runoff flow from the driveway.

During large storms the water flows onto the 7401 driveway

Stormwater flow from the intersection overtops the driveway apron of 7309 Garland Ave. and flows down the driveway into the backyard and down the slope towards the stream. The driveway is located on a public lot.
