Takoma Park Study Area 1

Site Visit Notes

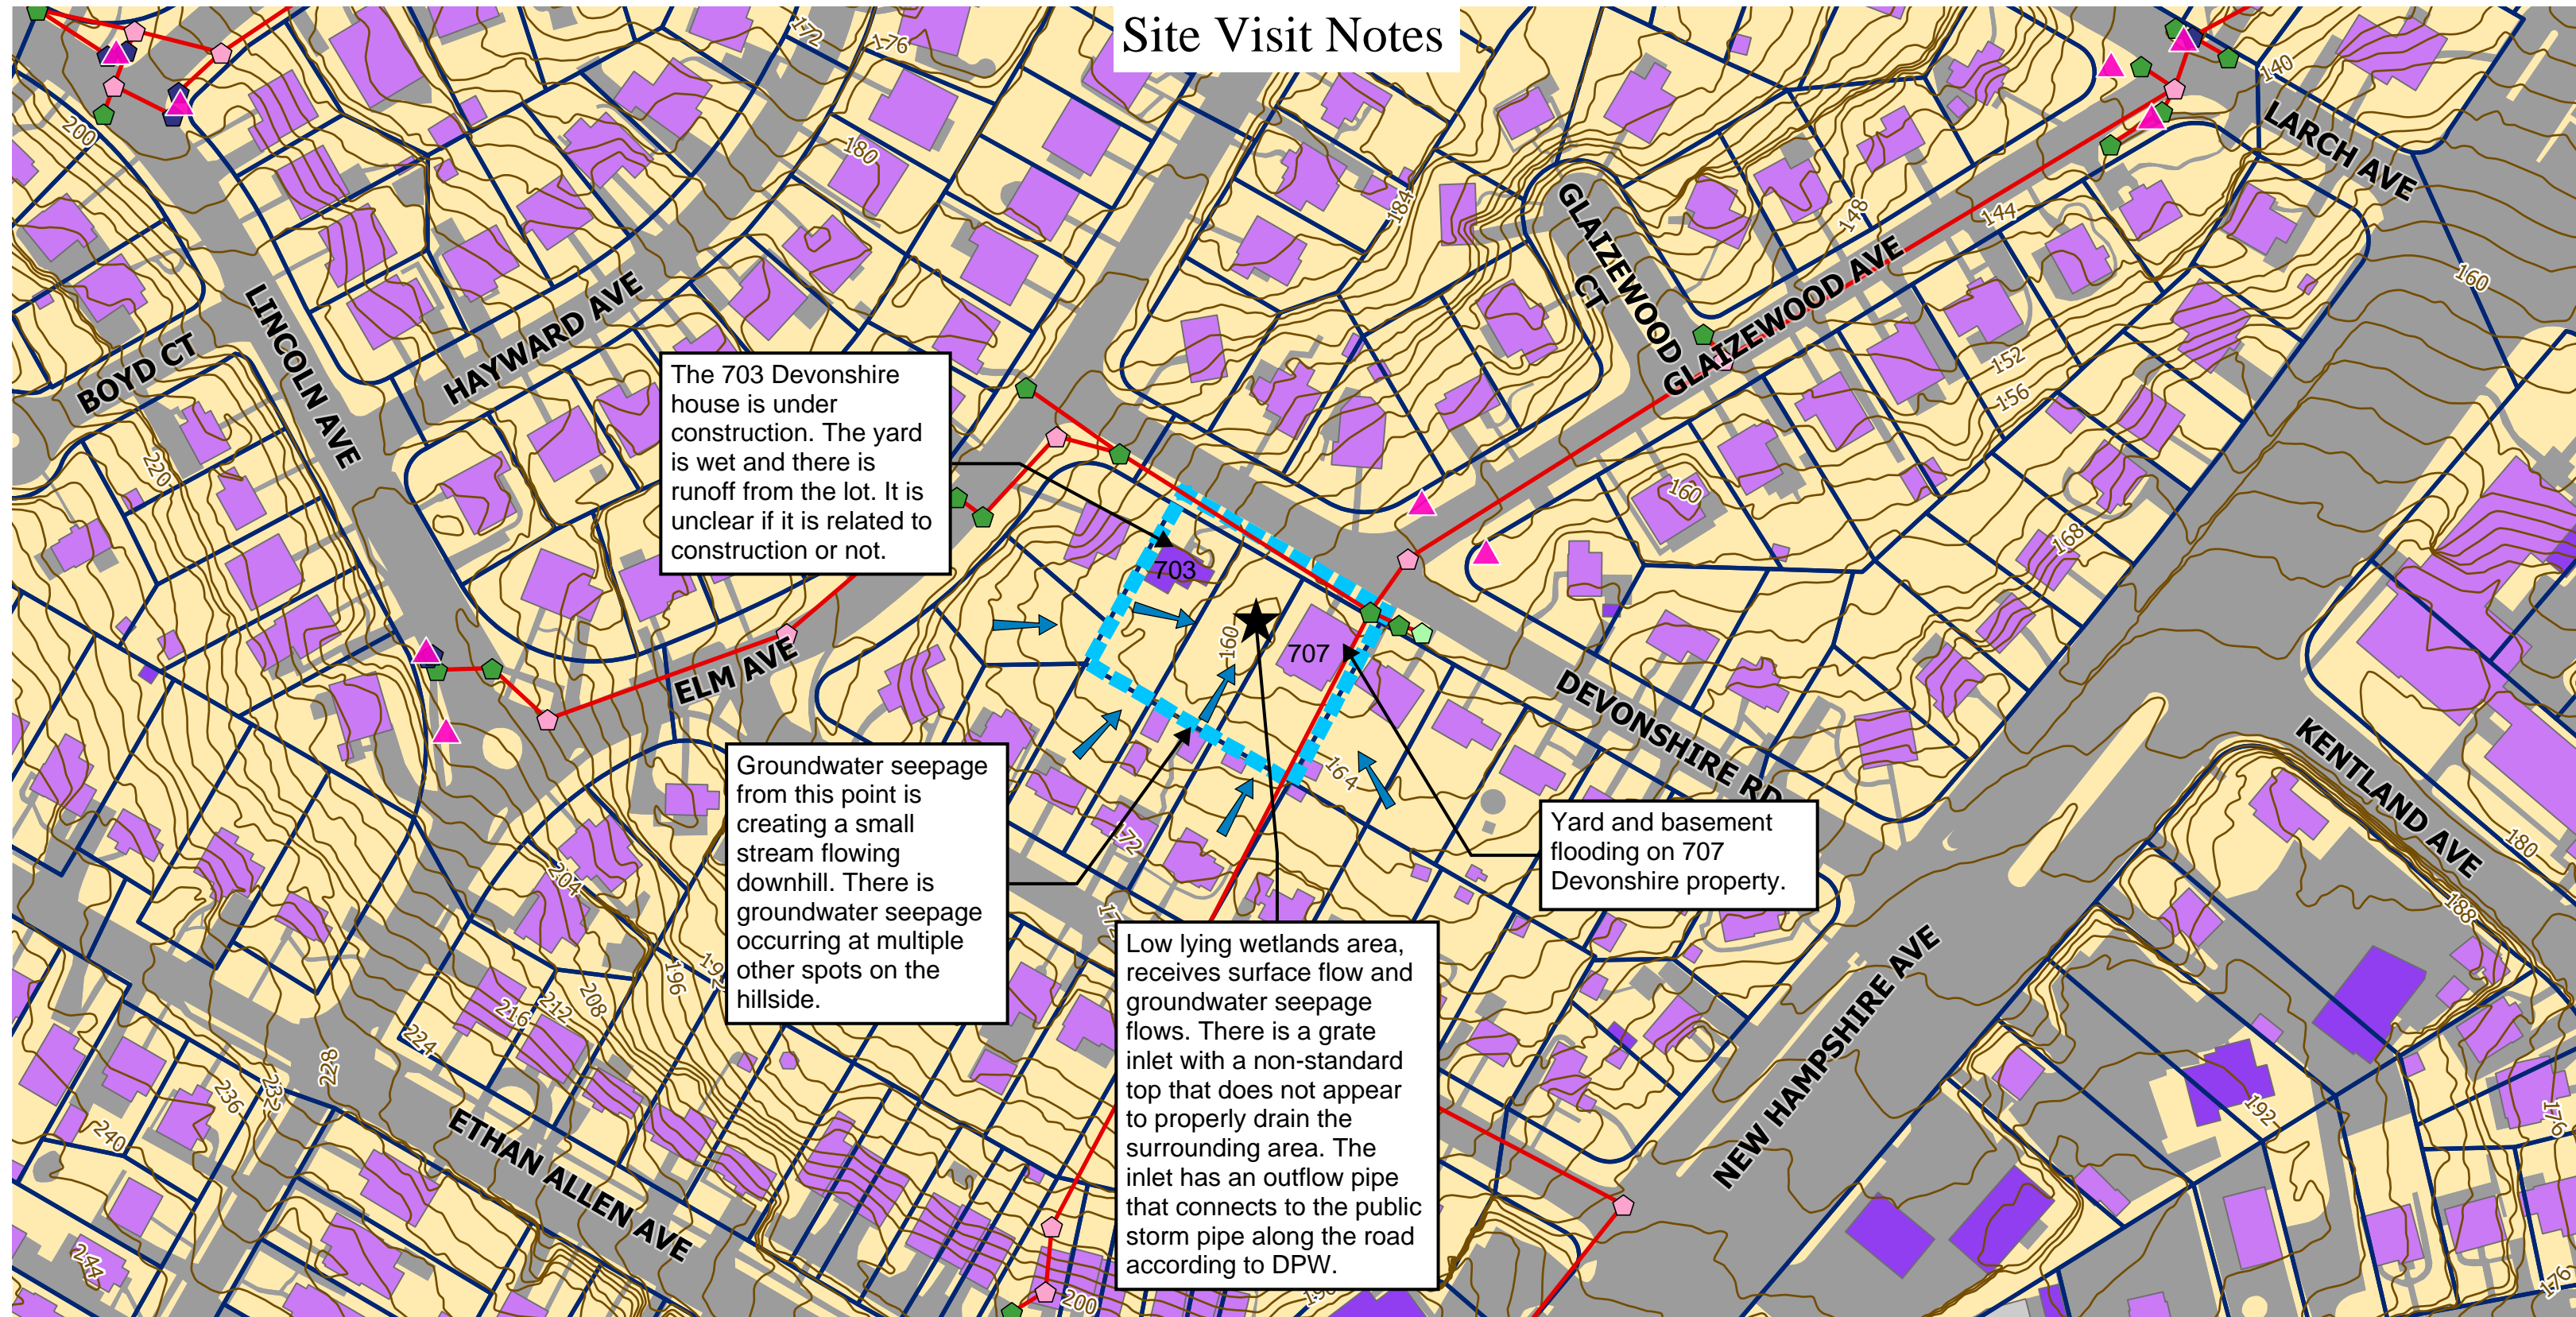
The 703 Devonshire house is under construction. The yard is wet and there is runoff from the lot. It is unclear if it is related to construction or not.

Groundwater seepage from this point is creating a small stream flowing downhill. There is groundwater seepage occurring at multiple other spots on the hillside.

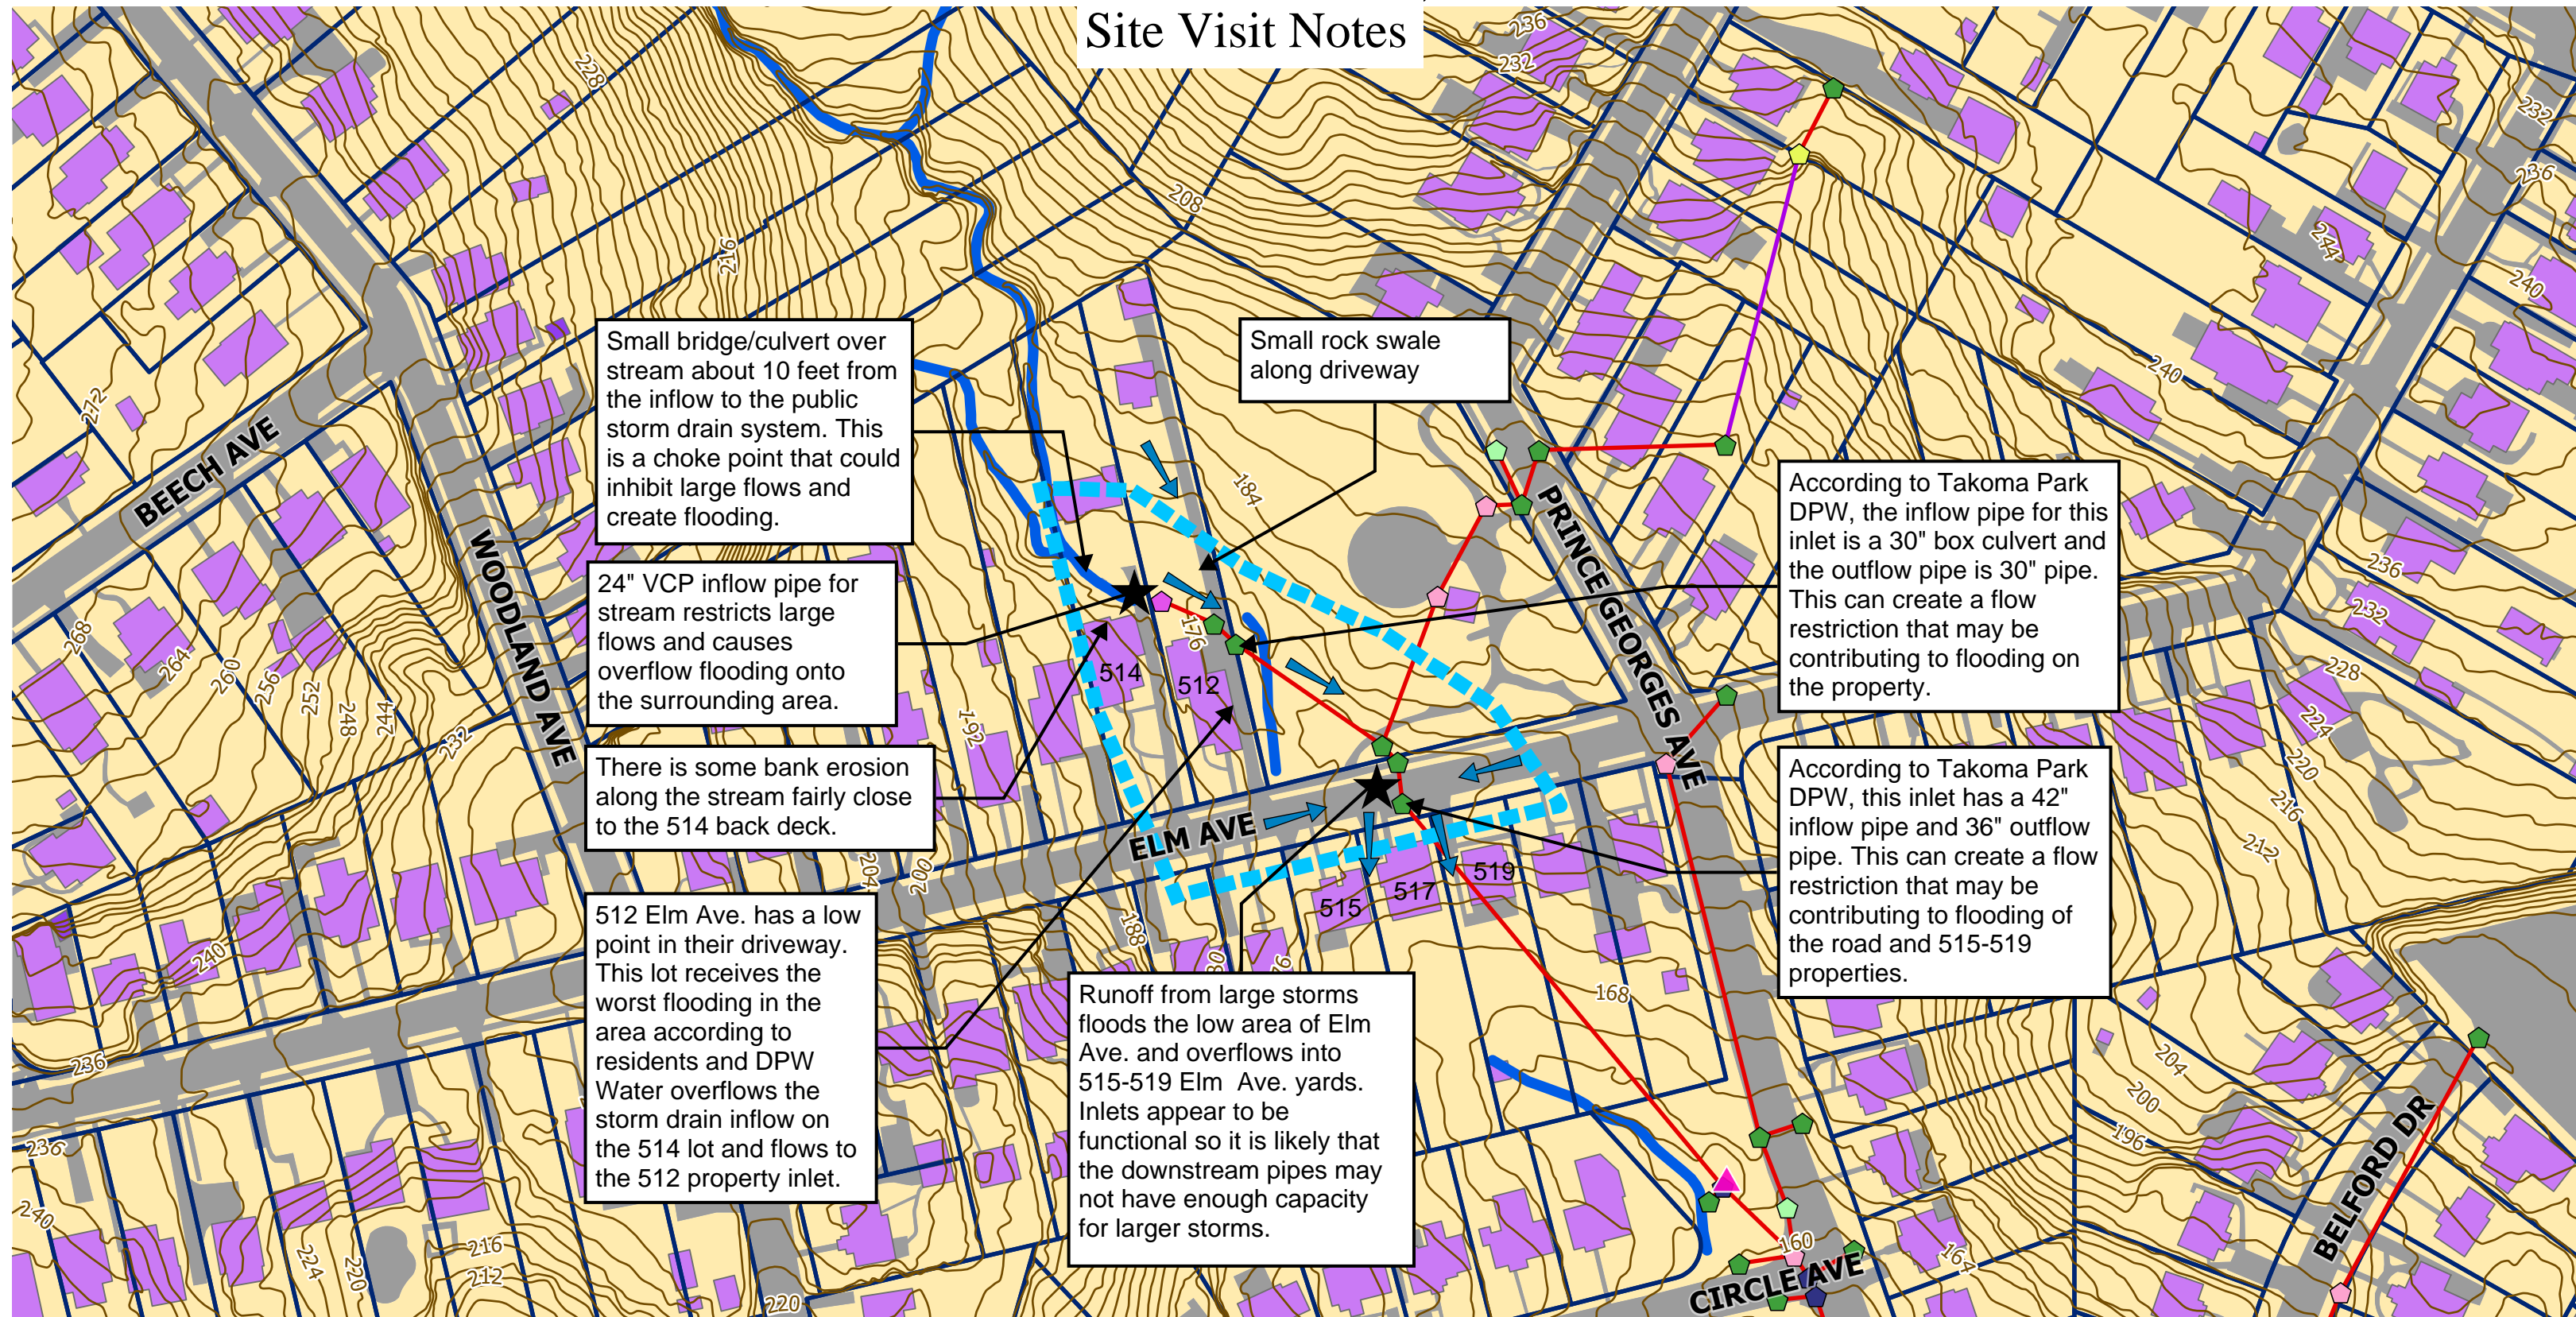
Small bridge/culvert over stream about 10 feet from the inflow to the public storm drain system. This is a choke point that could inhibit large flows and create flooding.

Small rock swale along driveway

24" VCP inflow pipe for stream restricts large flows and causes overflow flooding onto the surrounding area.

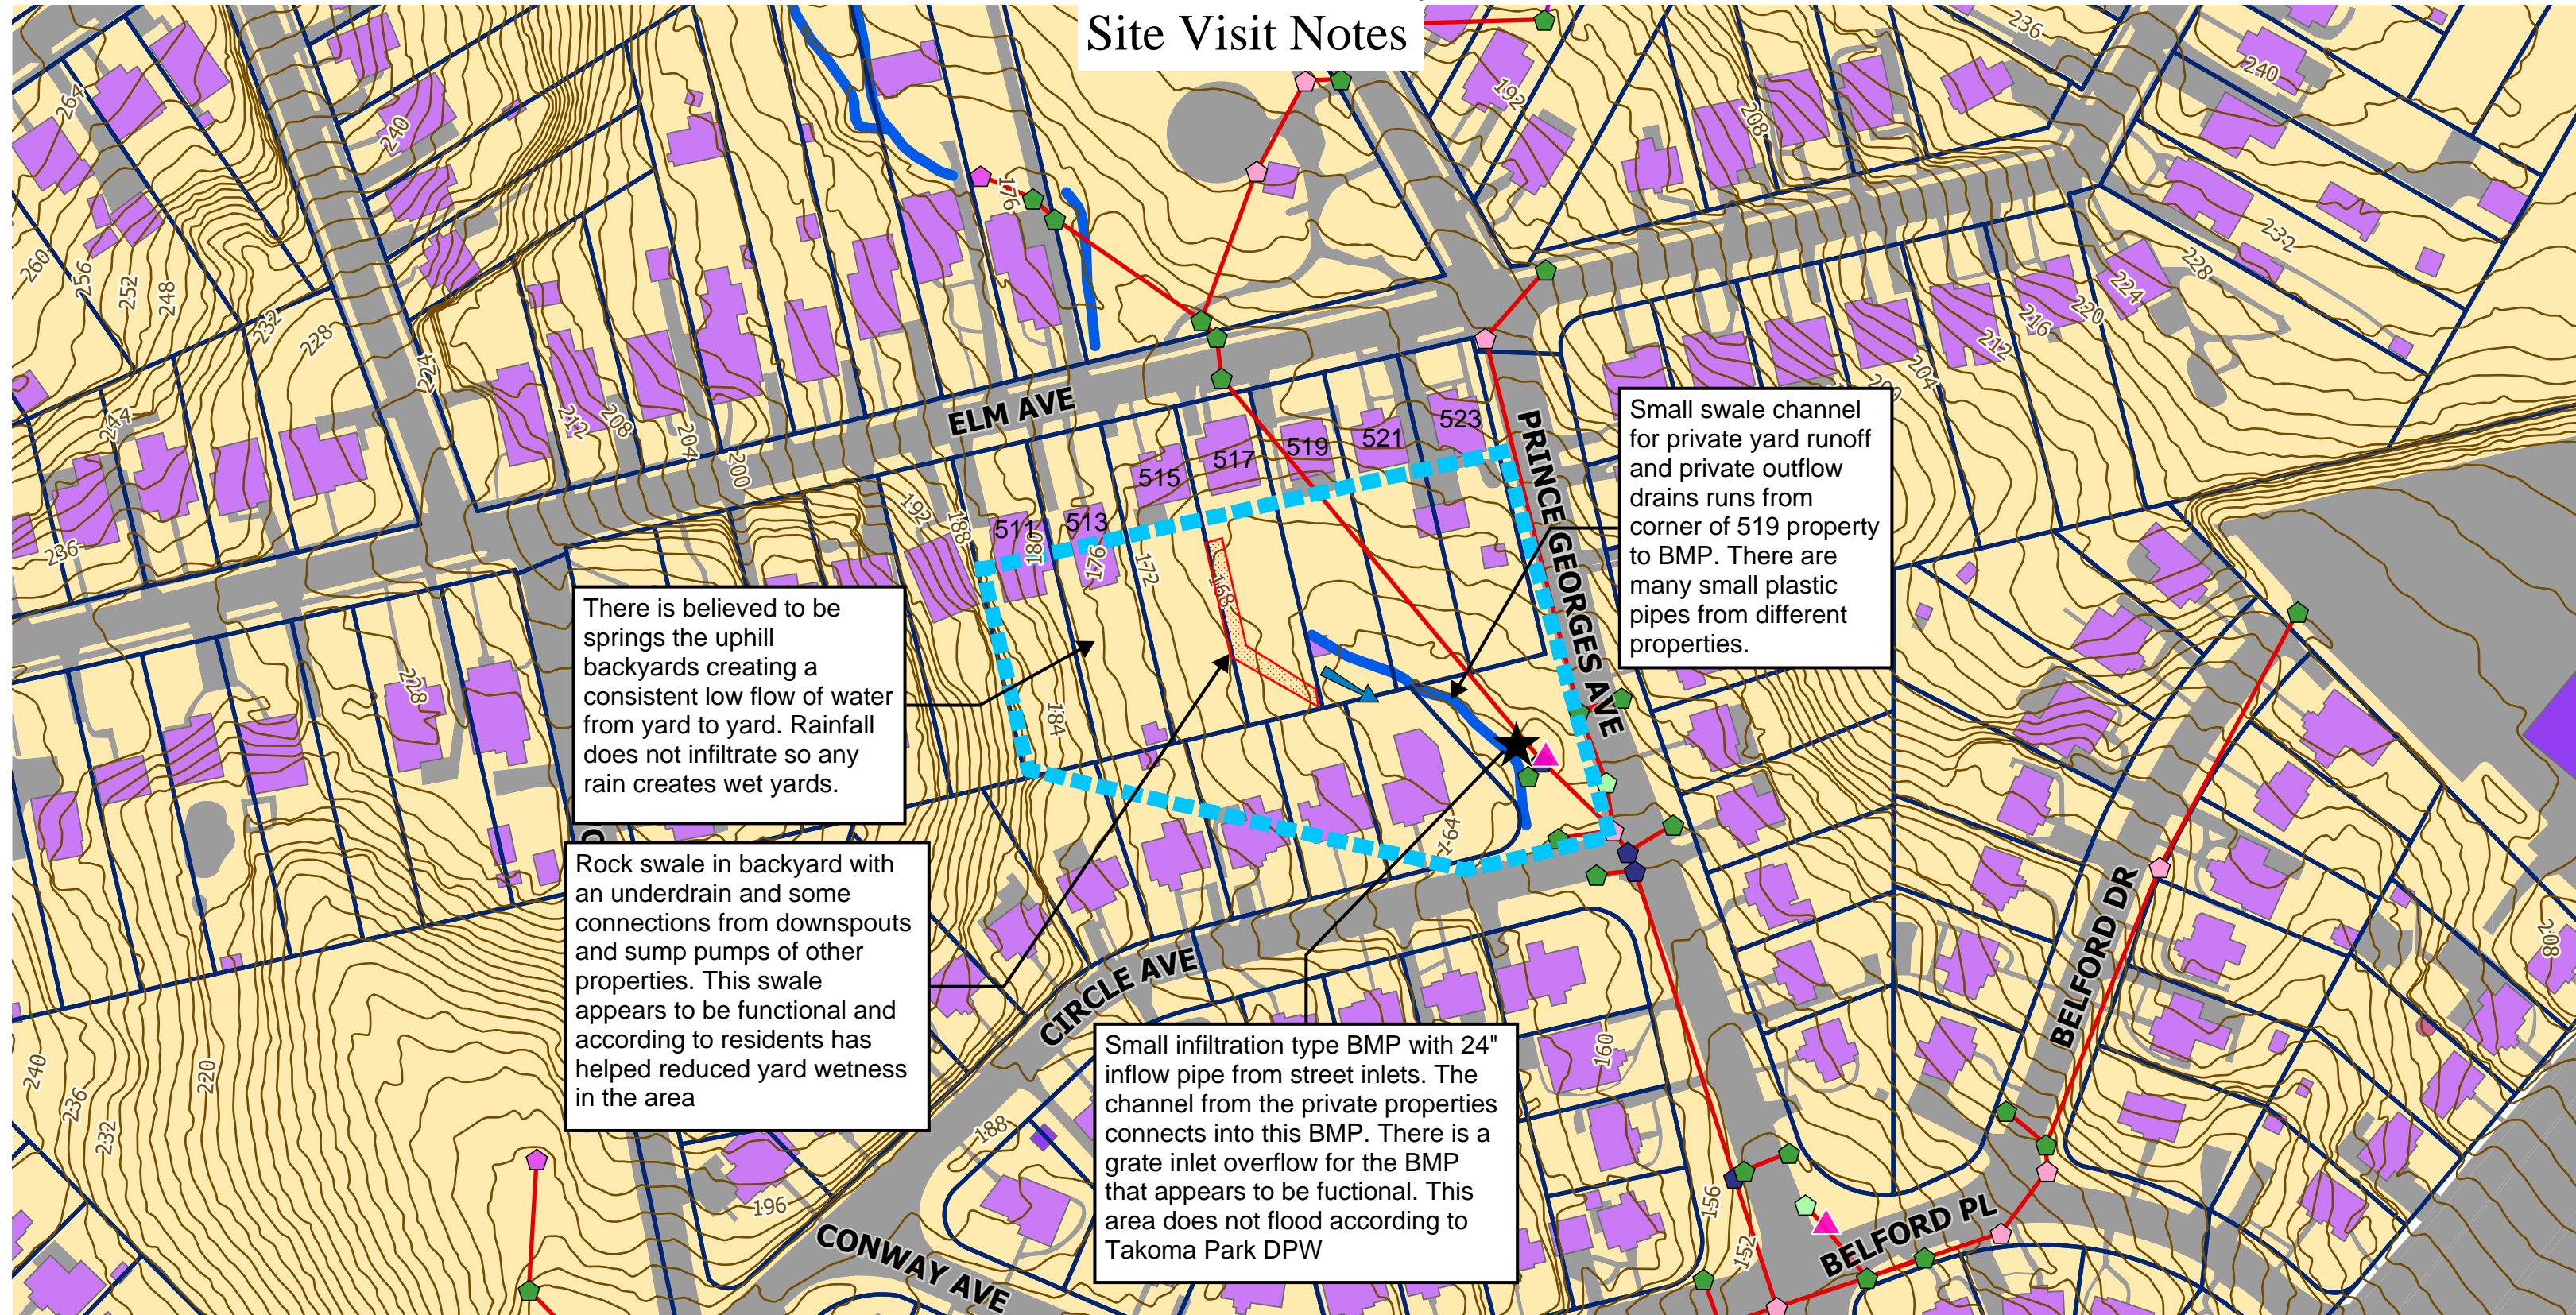
Takoma Park Study Area 15

There is believed to be springs the uphill backyards creating a consistent low flow of water from yard to yard. Rainfall does not infiltrate so any rain creates wet yards.

Rock swale in backyard with an underdrain and some connections from downspouts and sump pumps of other properties. This swale appears to be functional and according to residents has helped reduced yard wetness in the area

Small infiltration type BMP with 24" inflow pipe from street inlets. The channel from the private properties connects into this BMP. There is a grate inlet overflow for the BMP that appears to be fuctional. This area does not flood according to Takoma Park DPW

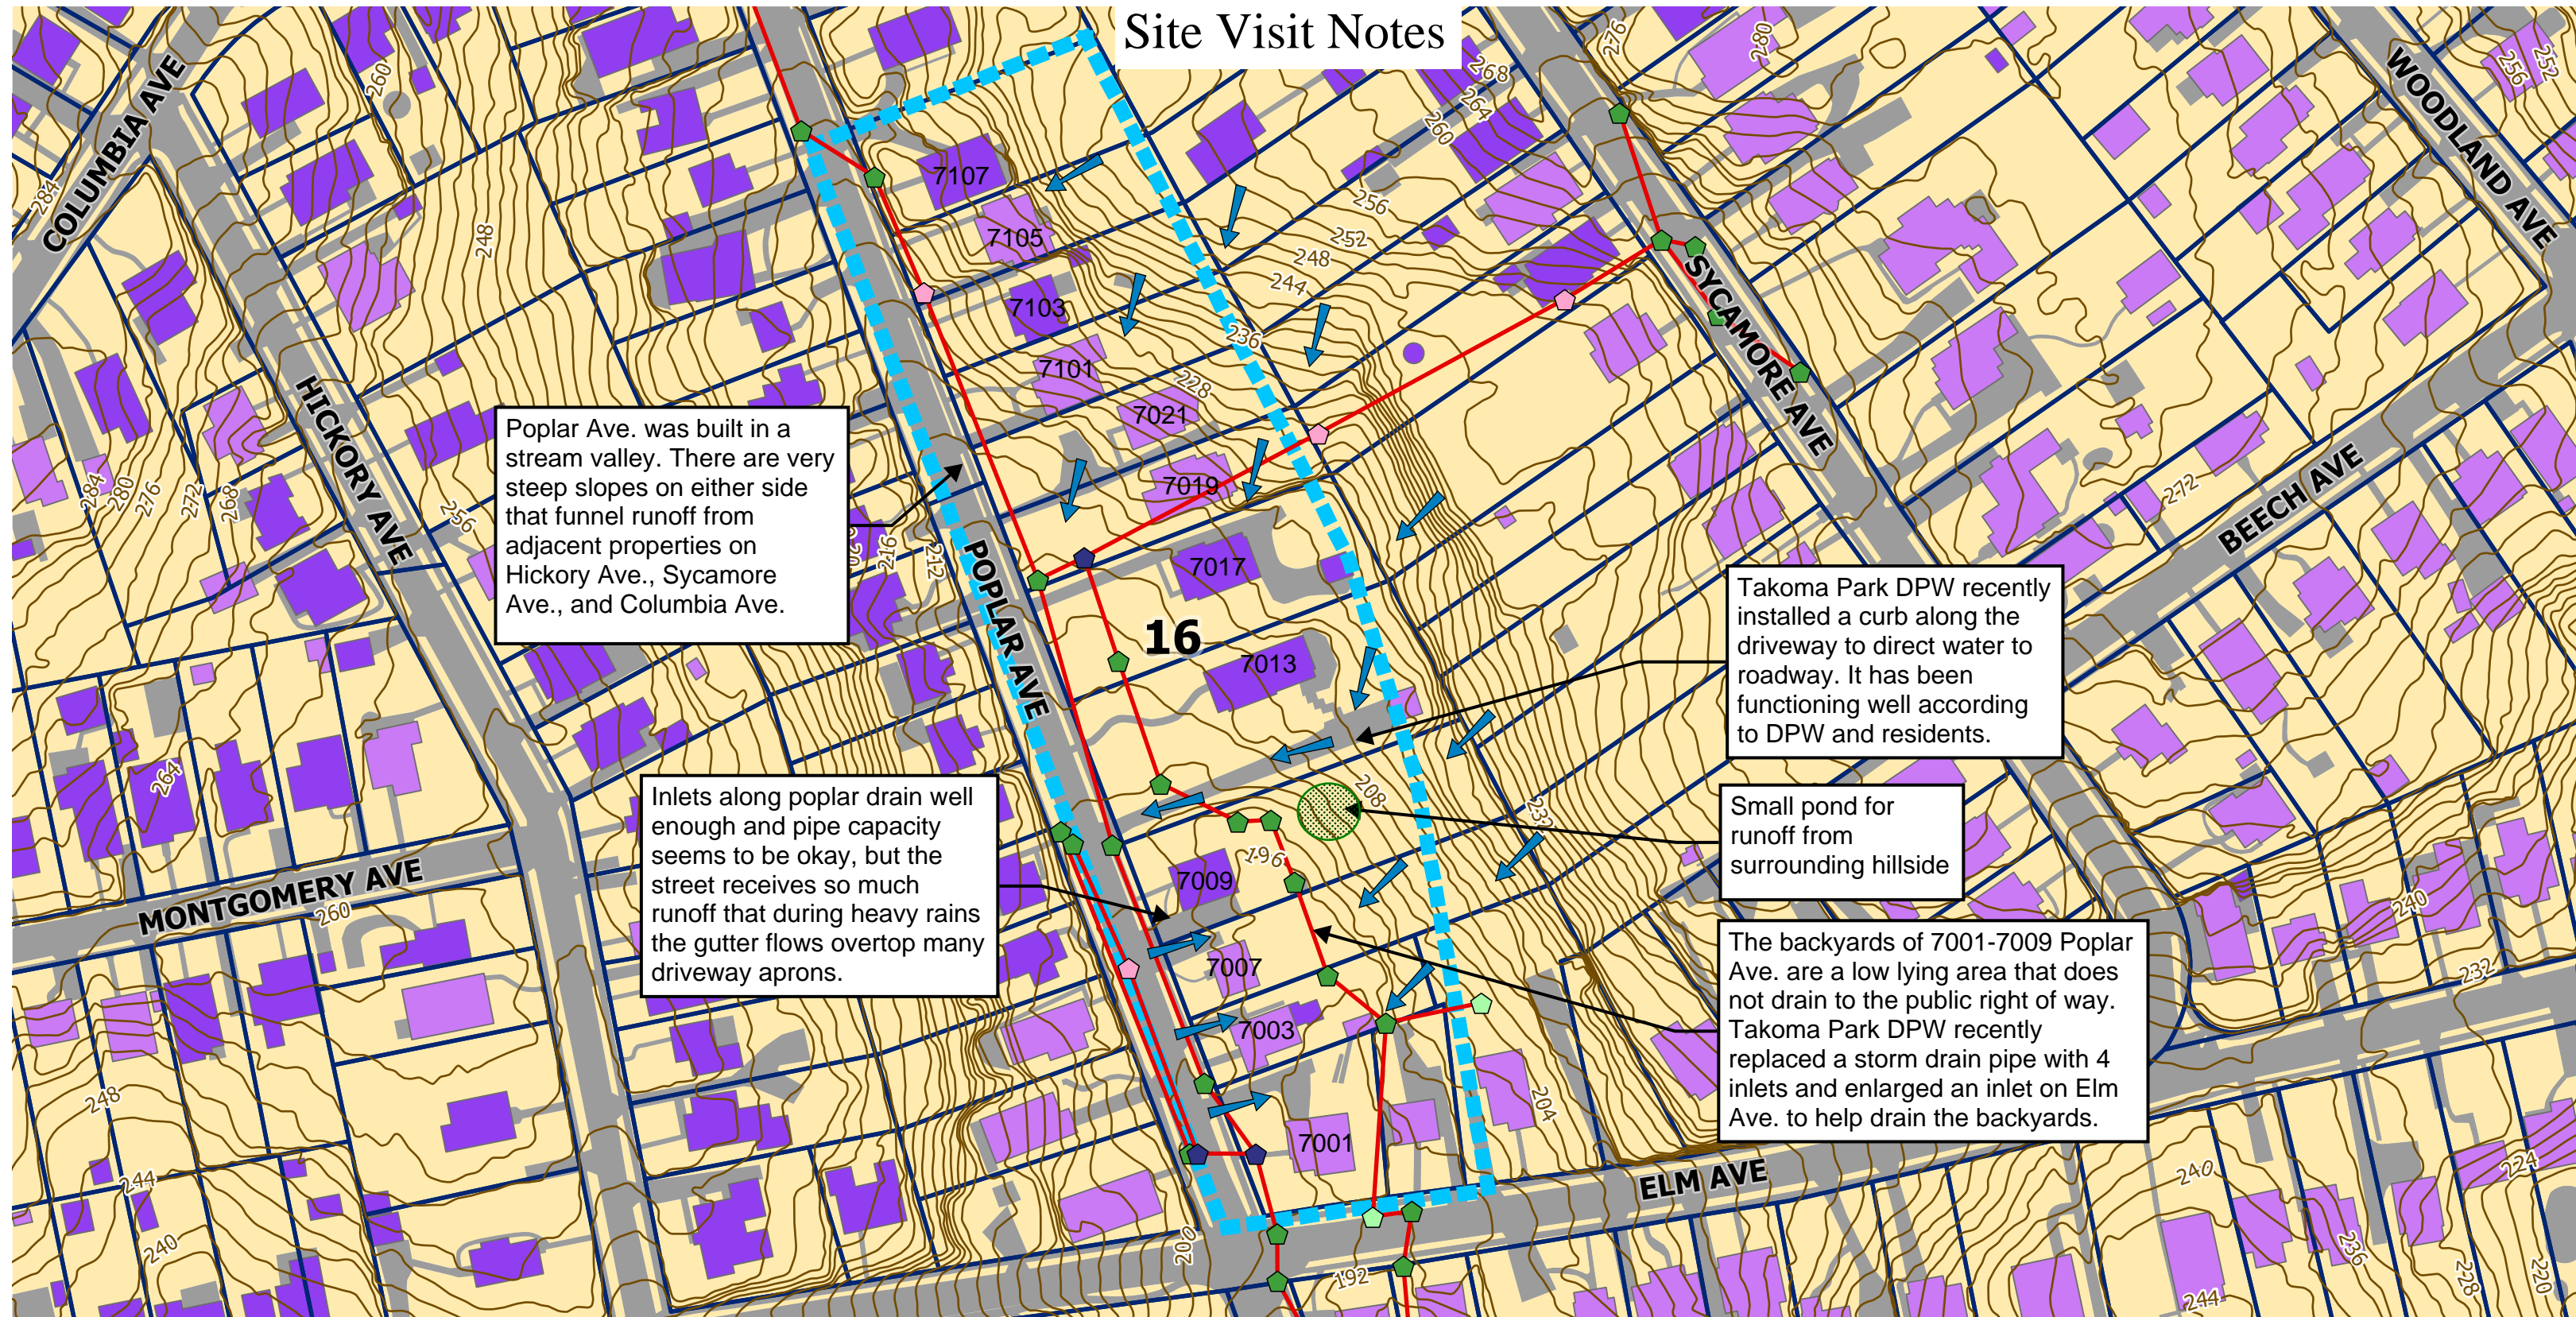
Takoma Park Study Area 16

Poplar Ave. was built in a stream valley. There are very steep slopes on either side that funnel runoff from adjacent properties on Hickory Ave., Sycamore Ave., and Columbia Ave.

Inlets along poplar drain well enough and pipe capacity seems to be okay, but the street receives so much runoff that during heavy rains the gutter flows overtop many driveway aprons.

The backyards of 7001-7009 Poplar Ave. are a low lying area that does not drain to the public right of way. Takoma Park DPW recently replaced a storm drain pipe with 4 inlets and enlarged an inlet on Elm Ave. to help drain the backyards.

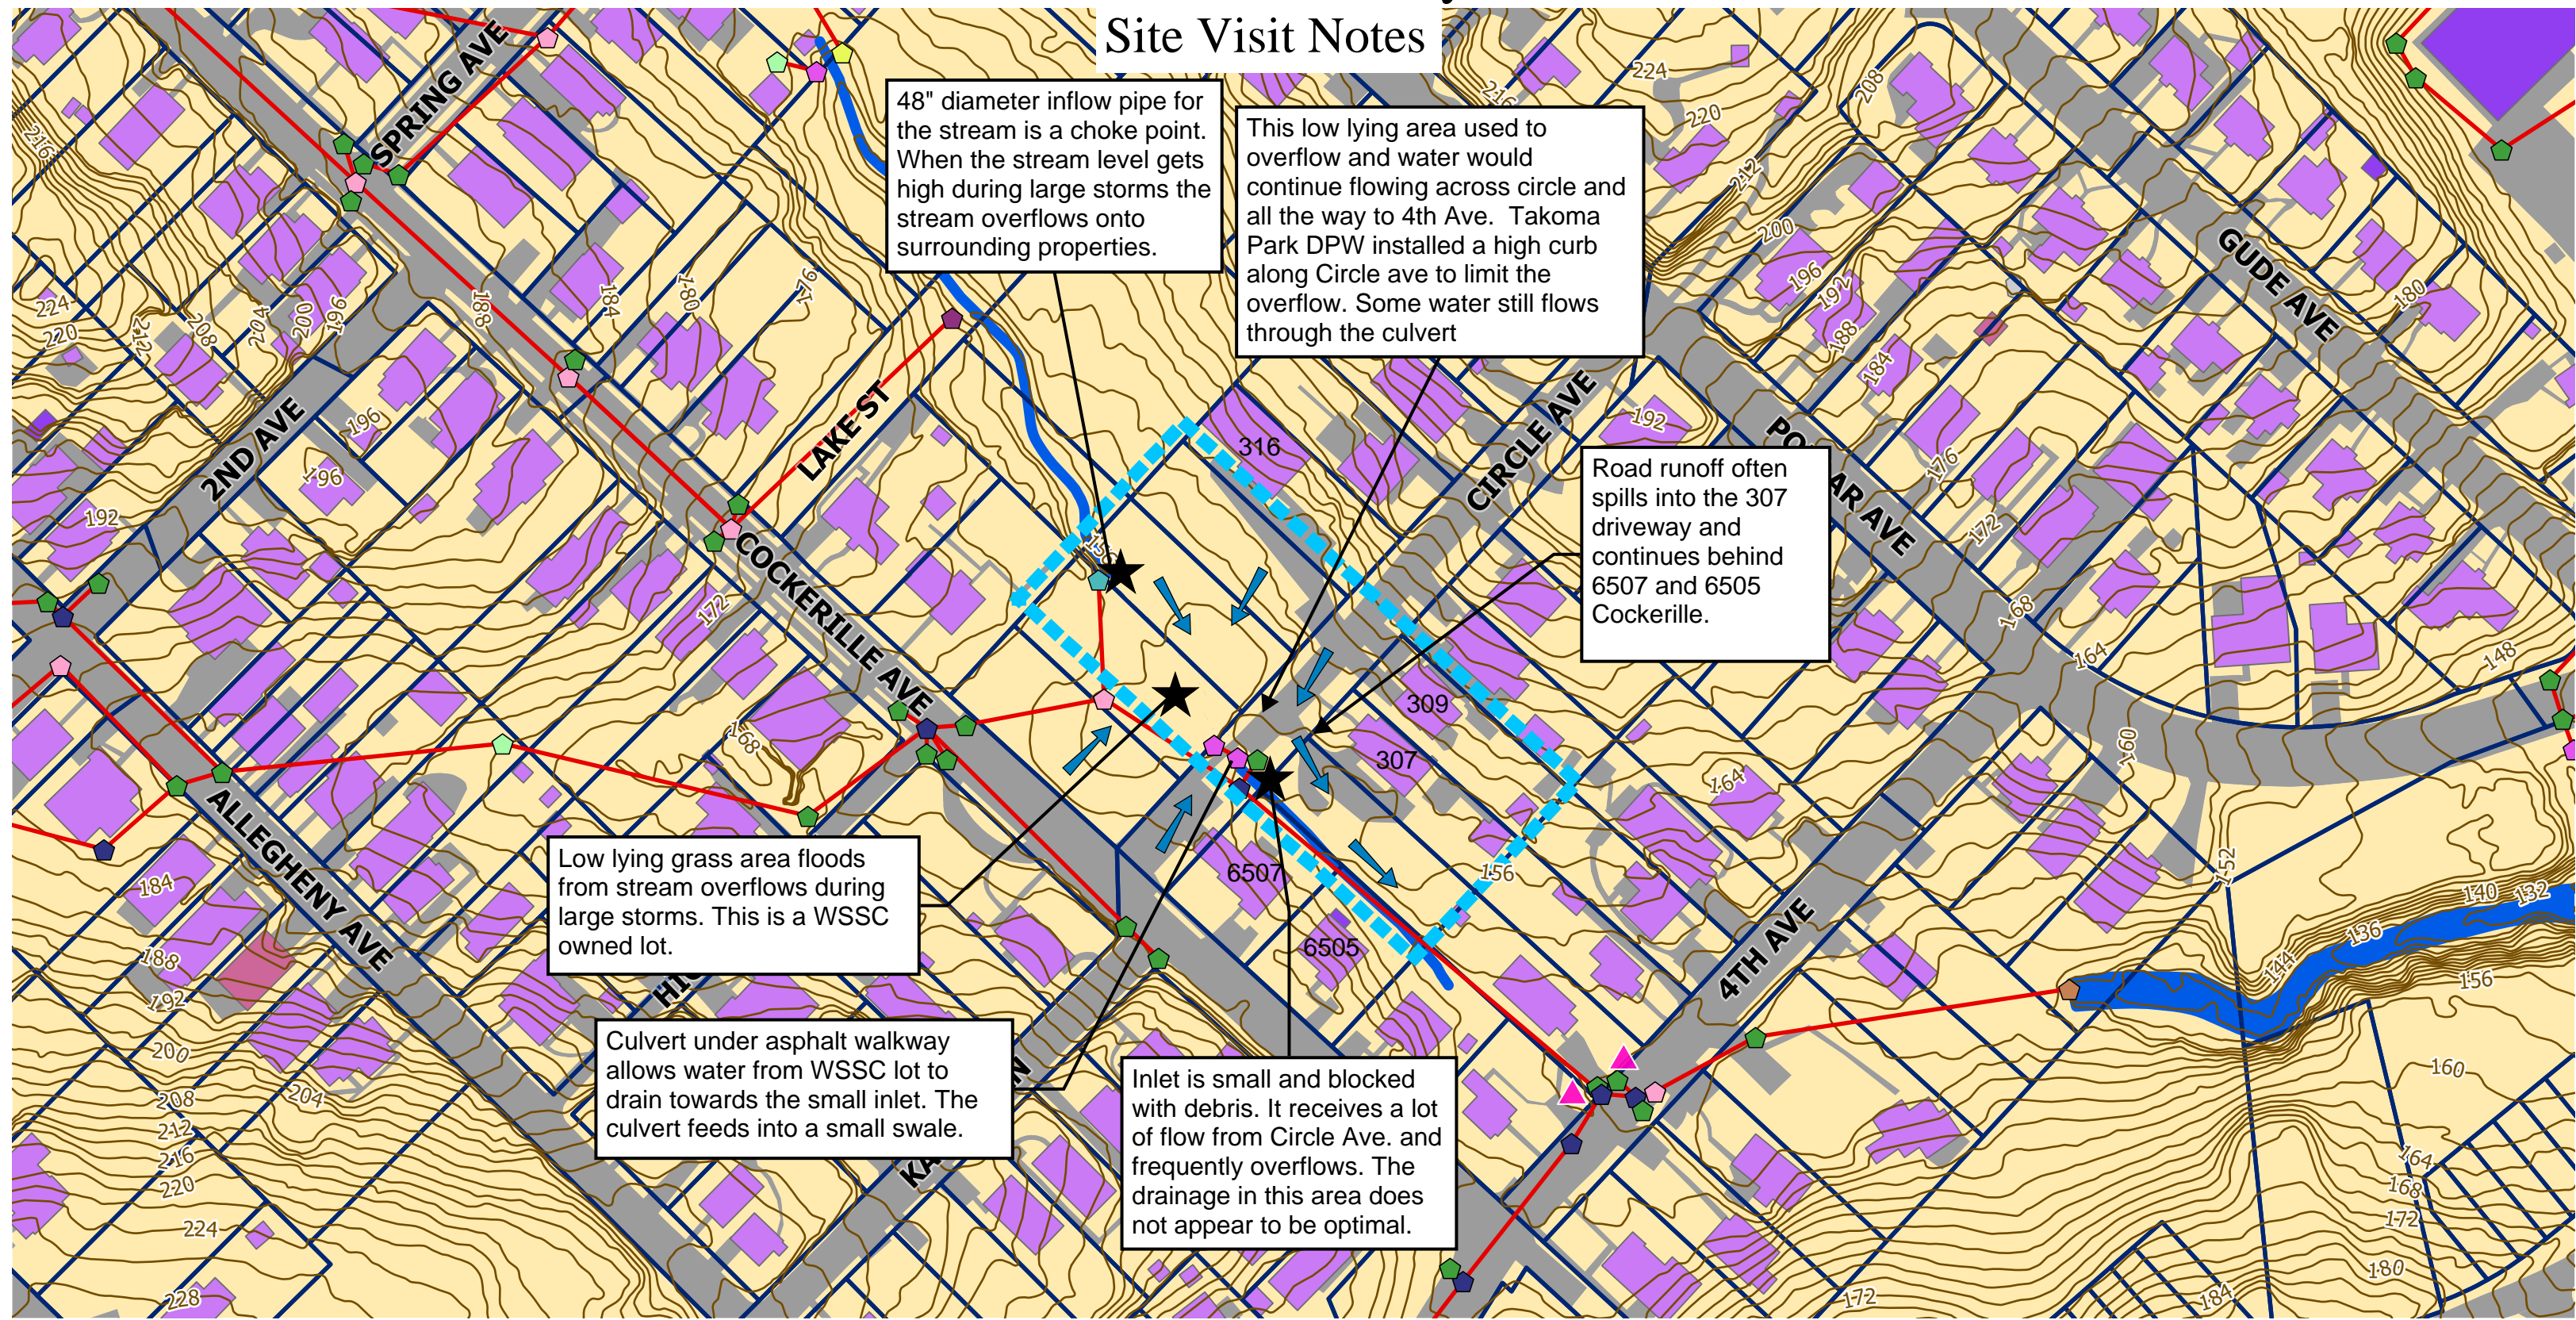
Takoma Park Study Area 18

Inlet is small and blocked with debris. It receives a lot of flow from Circle Ave. and frequently overflows. The drainage in this area does not appear to be optimal.

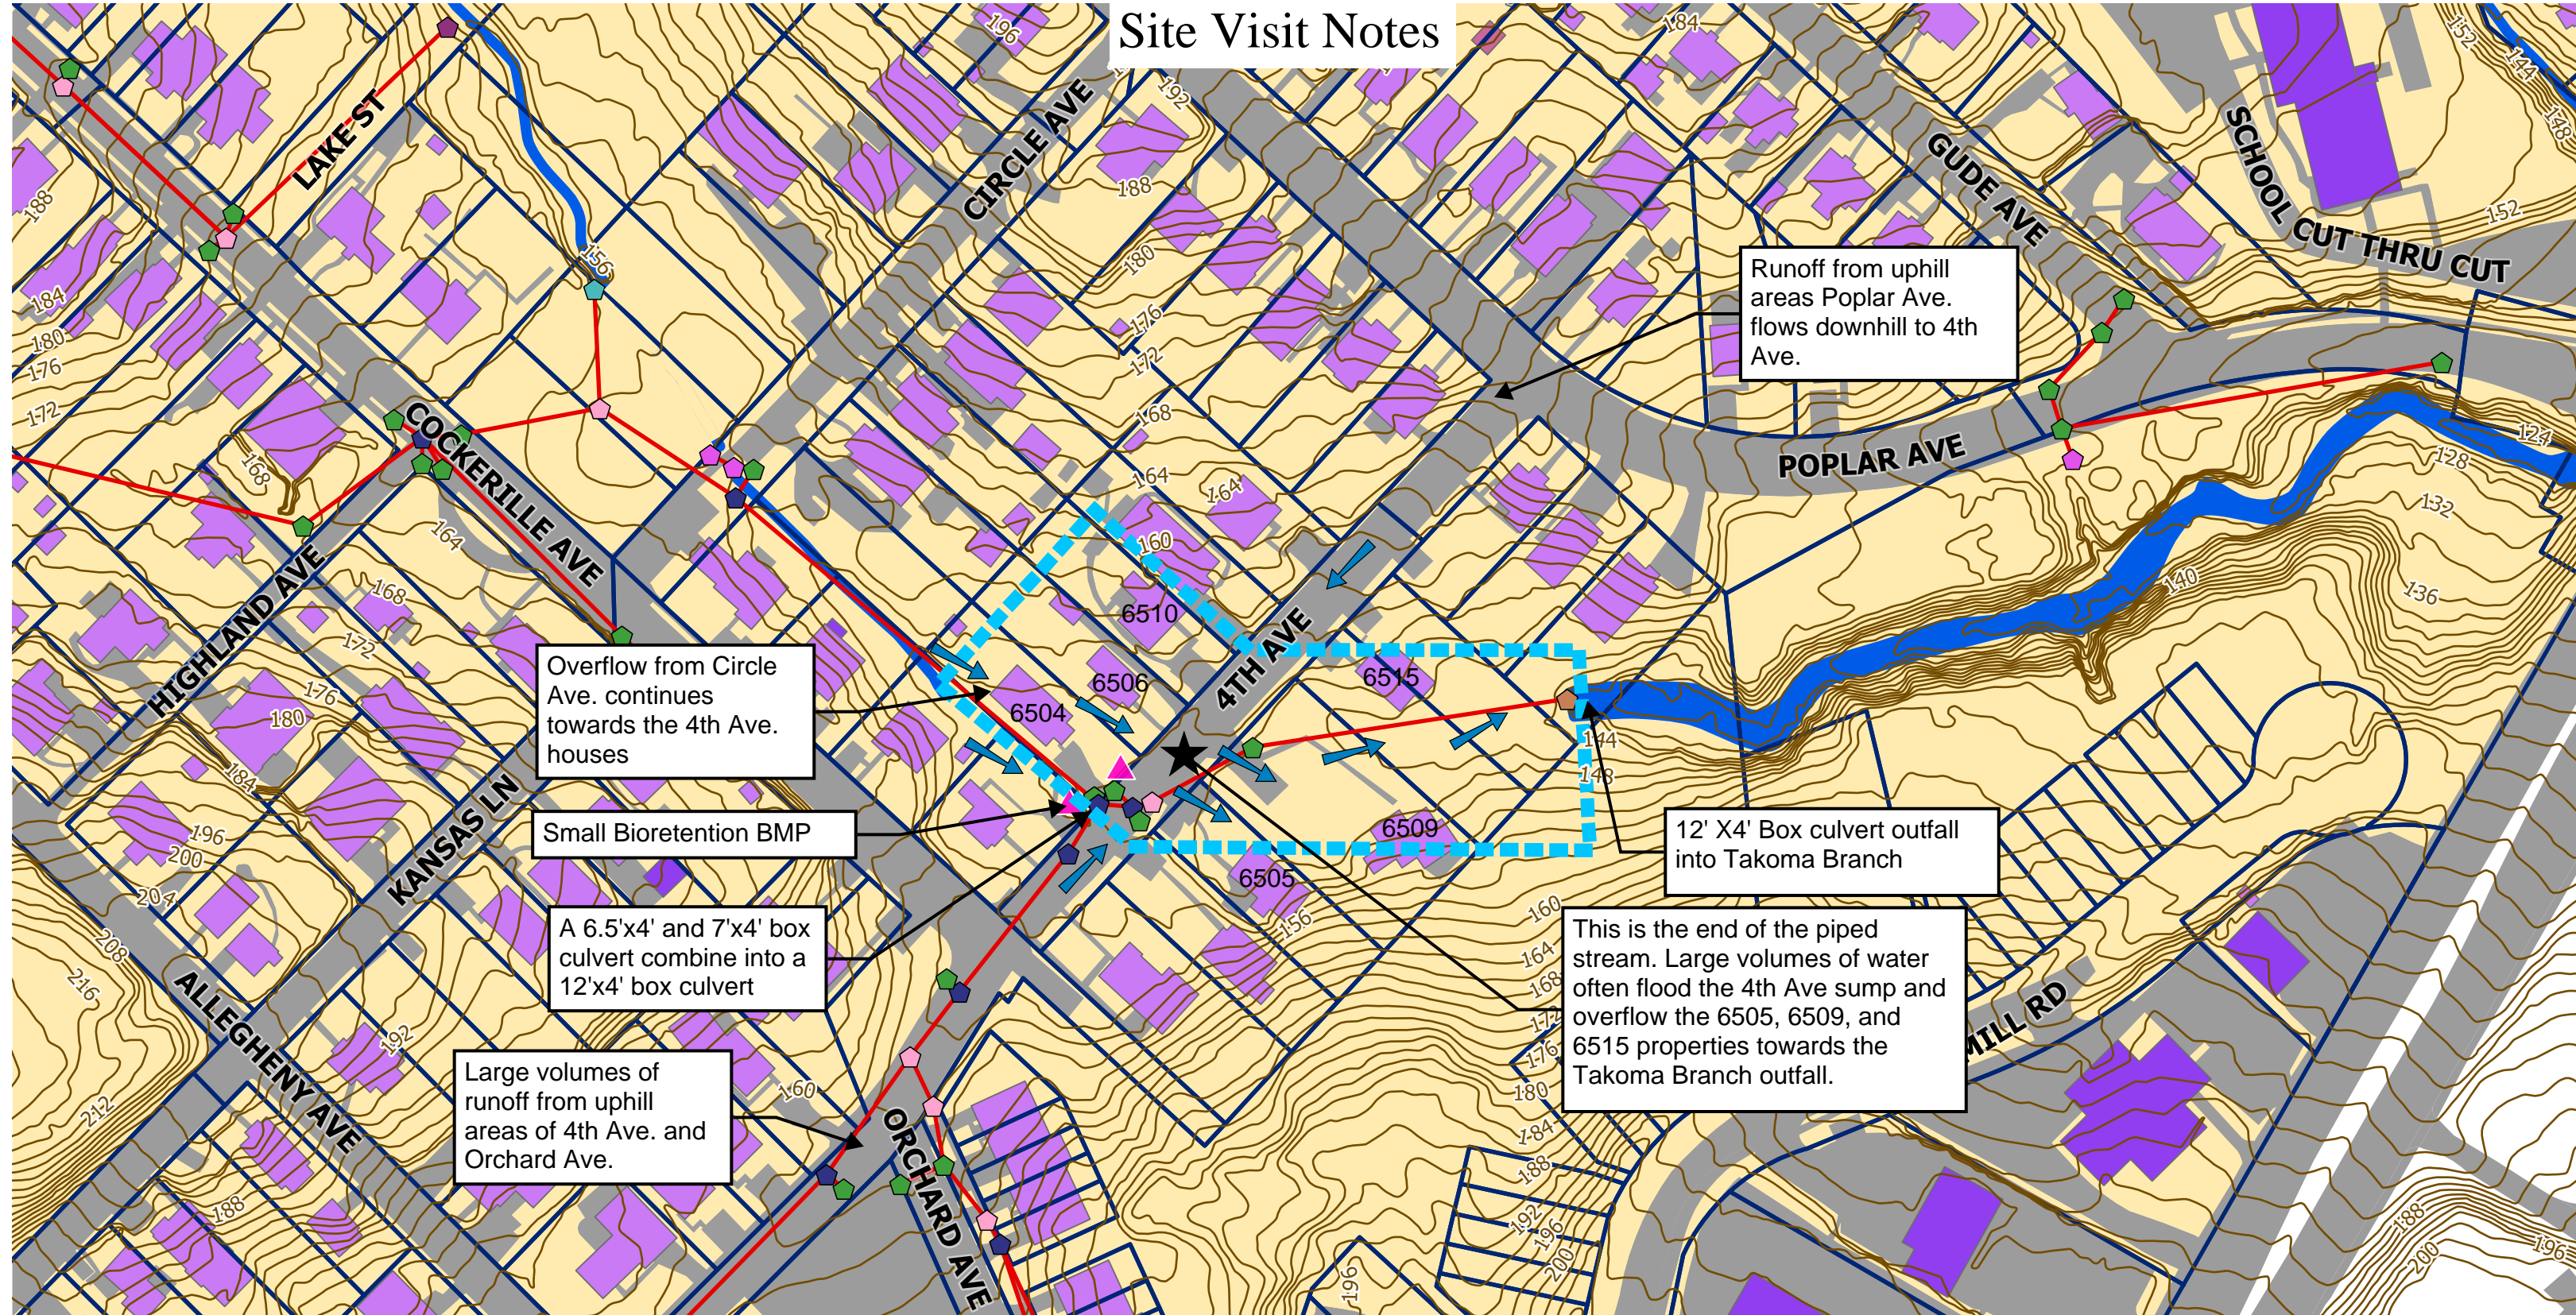
Takoma Park Study Area 19

Runoff from uphill areas Poplar Ave. flows downhill to 4th Ave.
