Takoma Park Study Area 1

Site Visit Notes

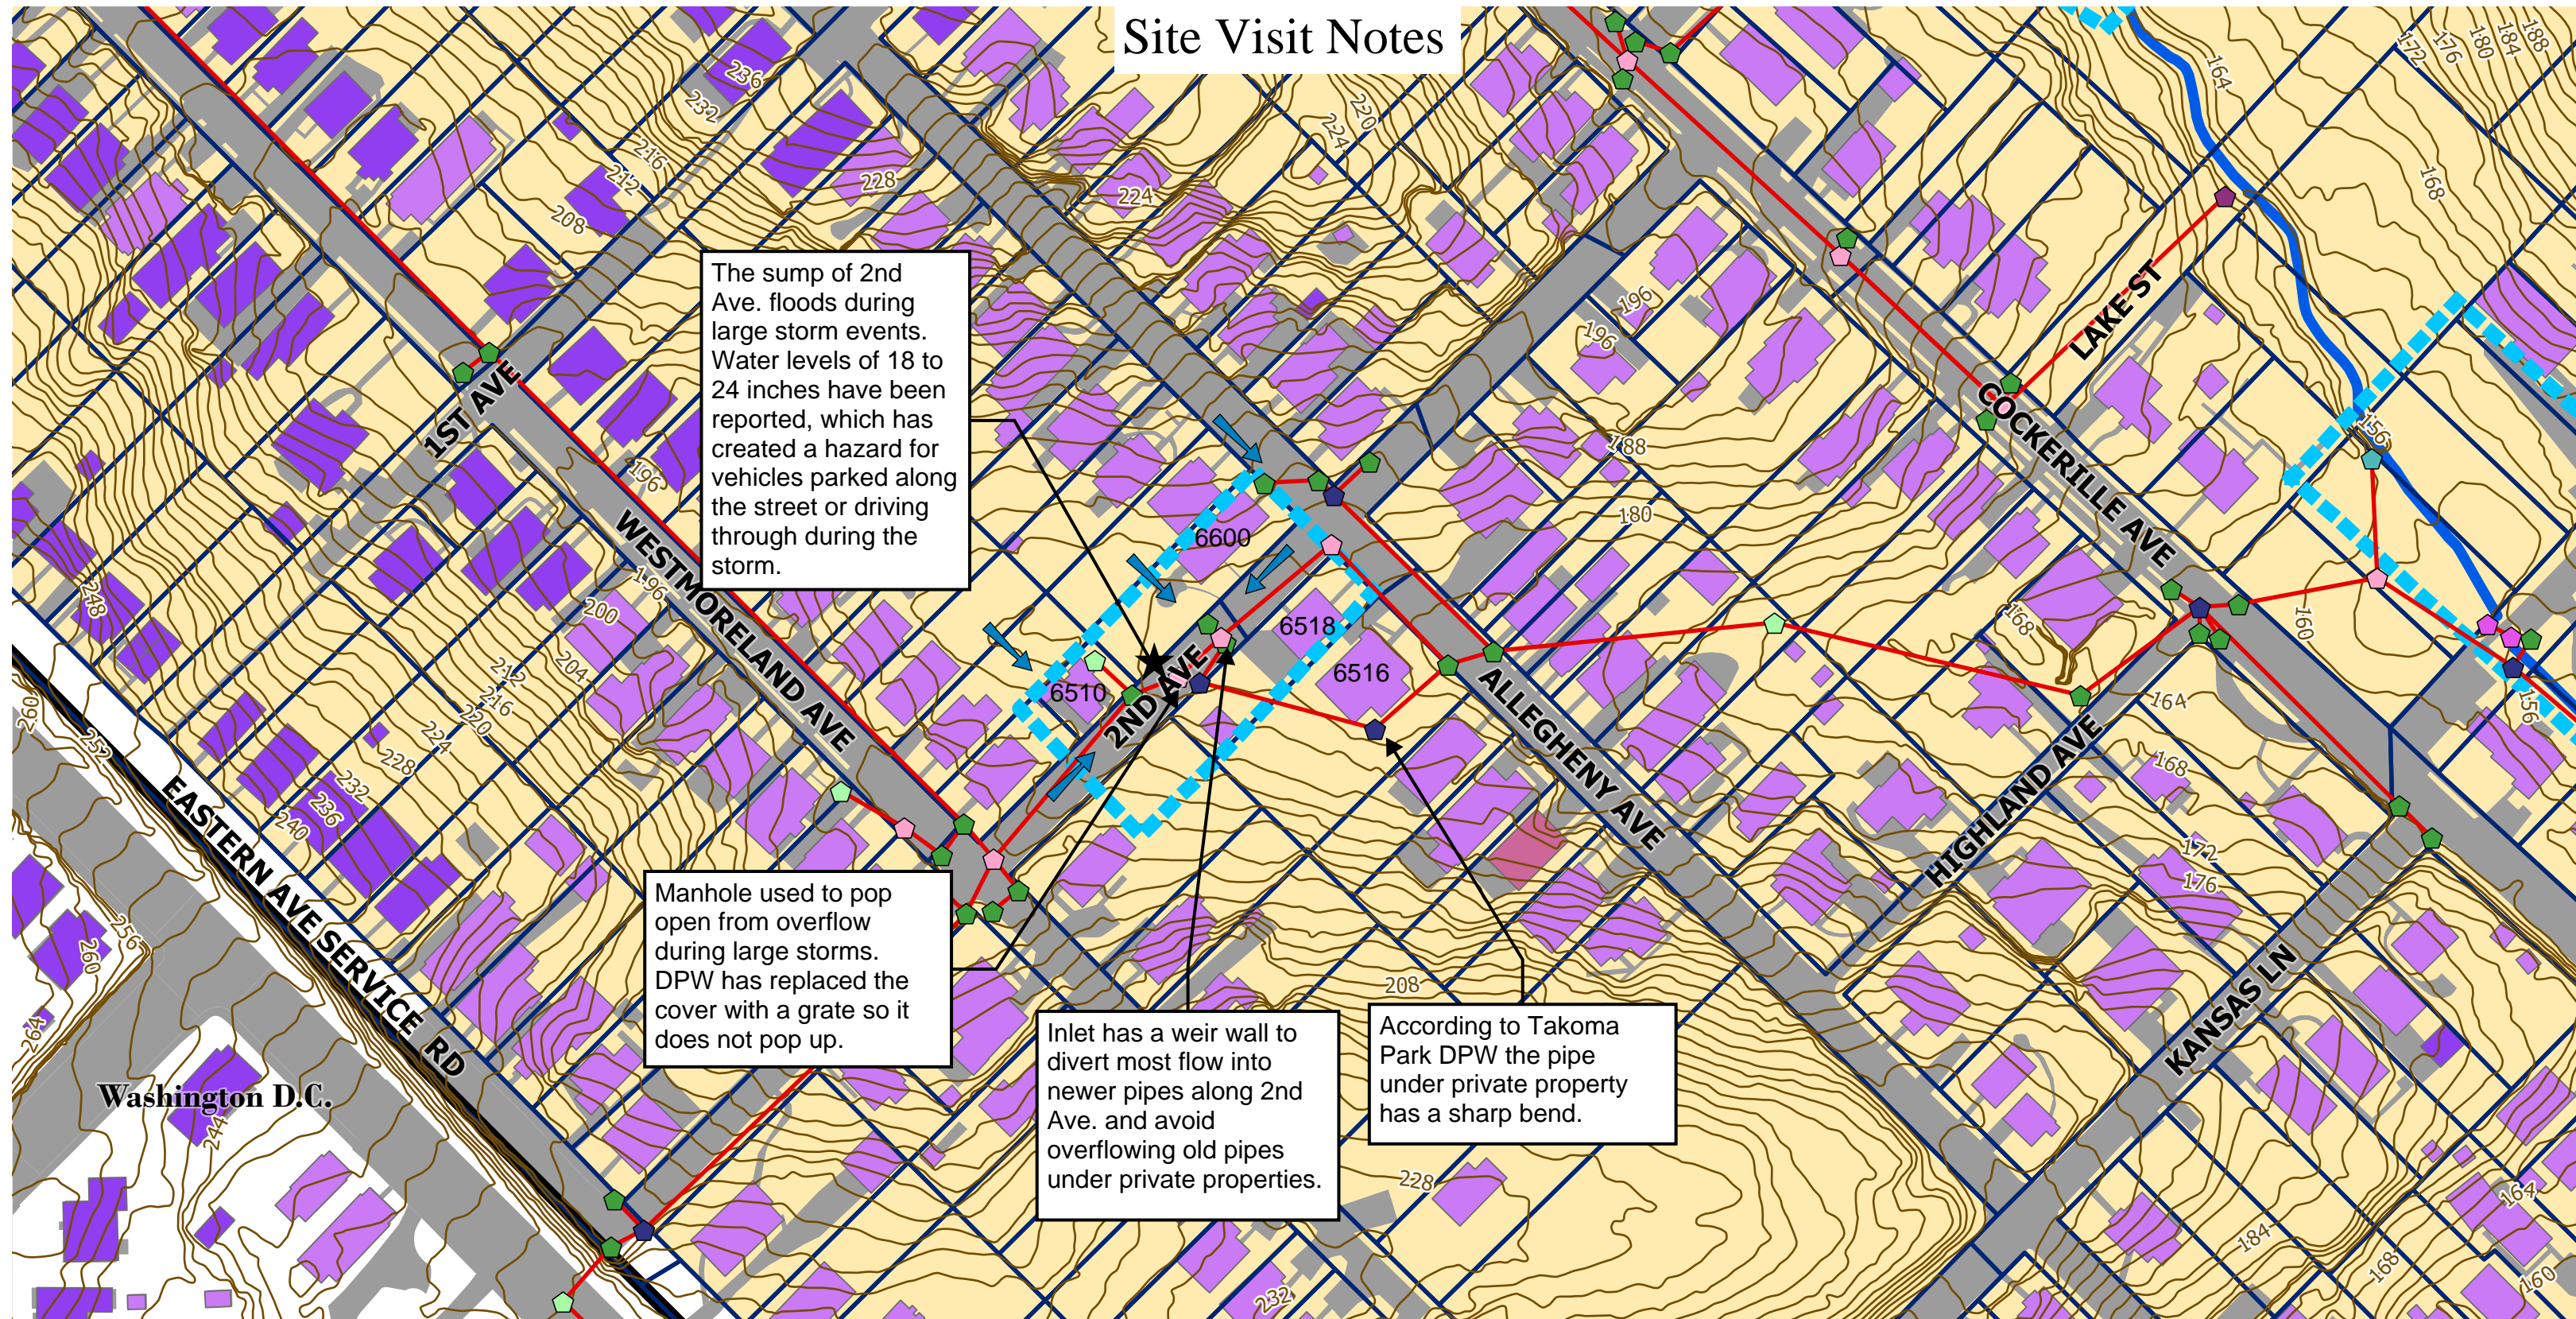
The sump of 2nd Ave. floods during large storm events. Water levels of 18 to 24 inches have been reported, which has created a hazard for vehicles parked along the street or driving through during the storm.

Manhole used to pop open from overflow during large storms. DPW has replaced the cover with a grate so it does not pop up.
