Stormwater Climate Adaptation Plan Report for the City of Takoma Park, Maryland

Prepared by:
The Low Impact Development Center for The City of Takoma Park

June 2024

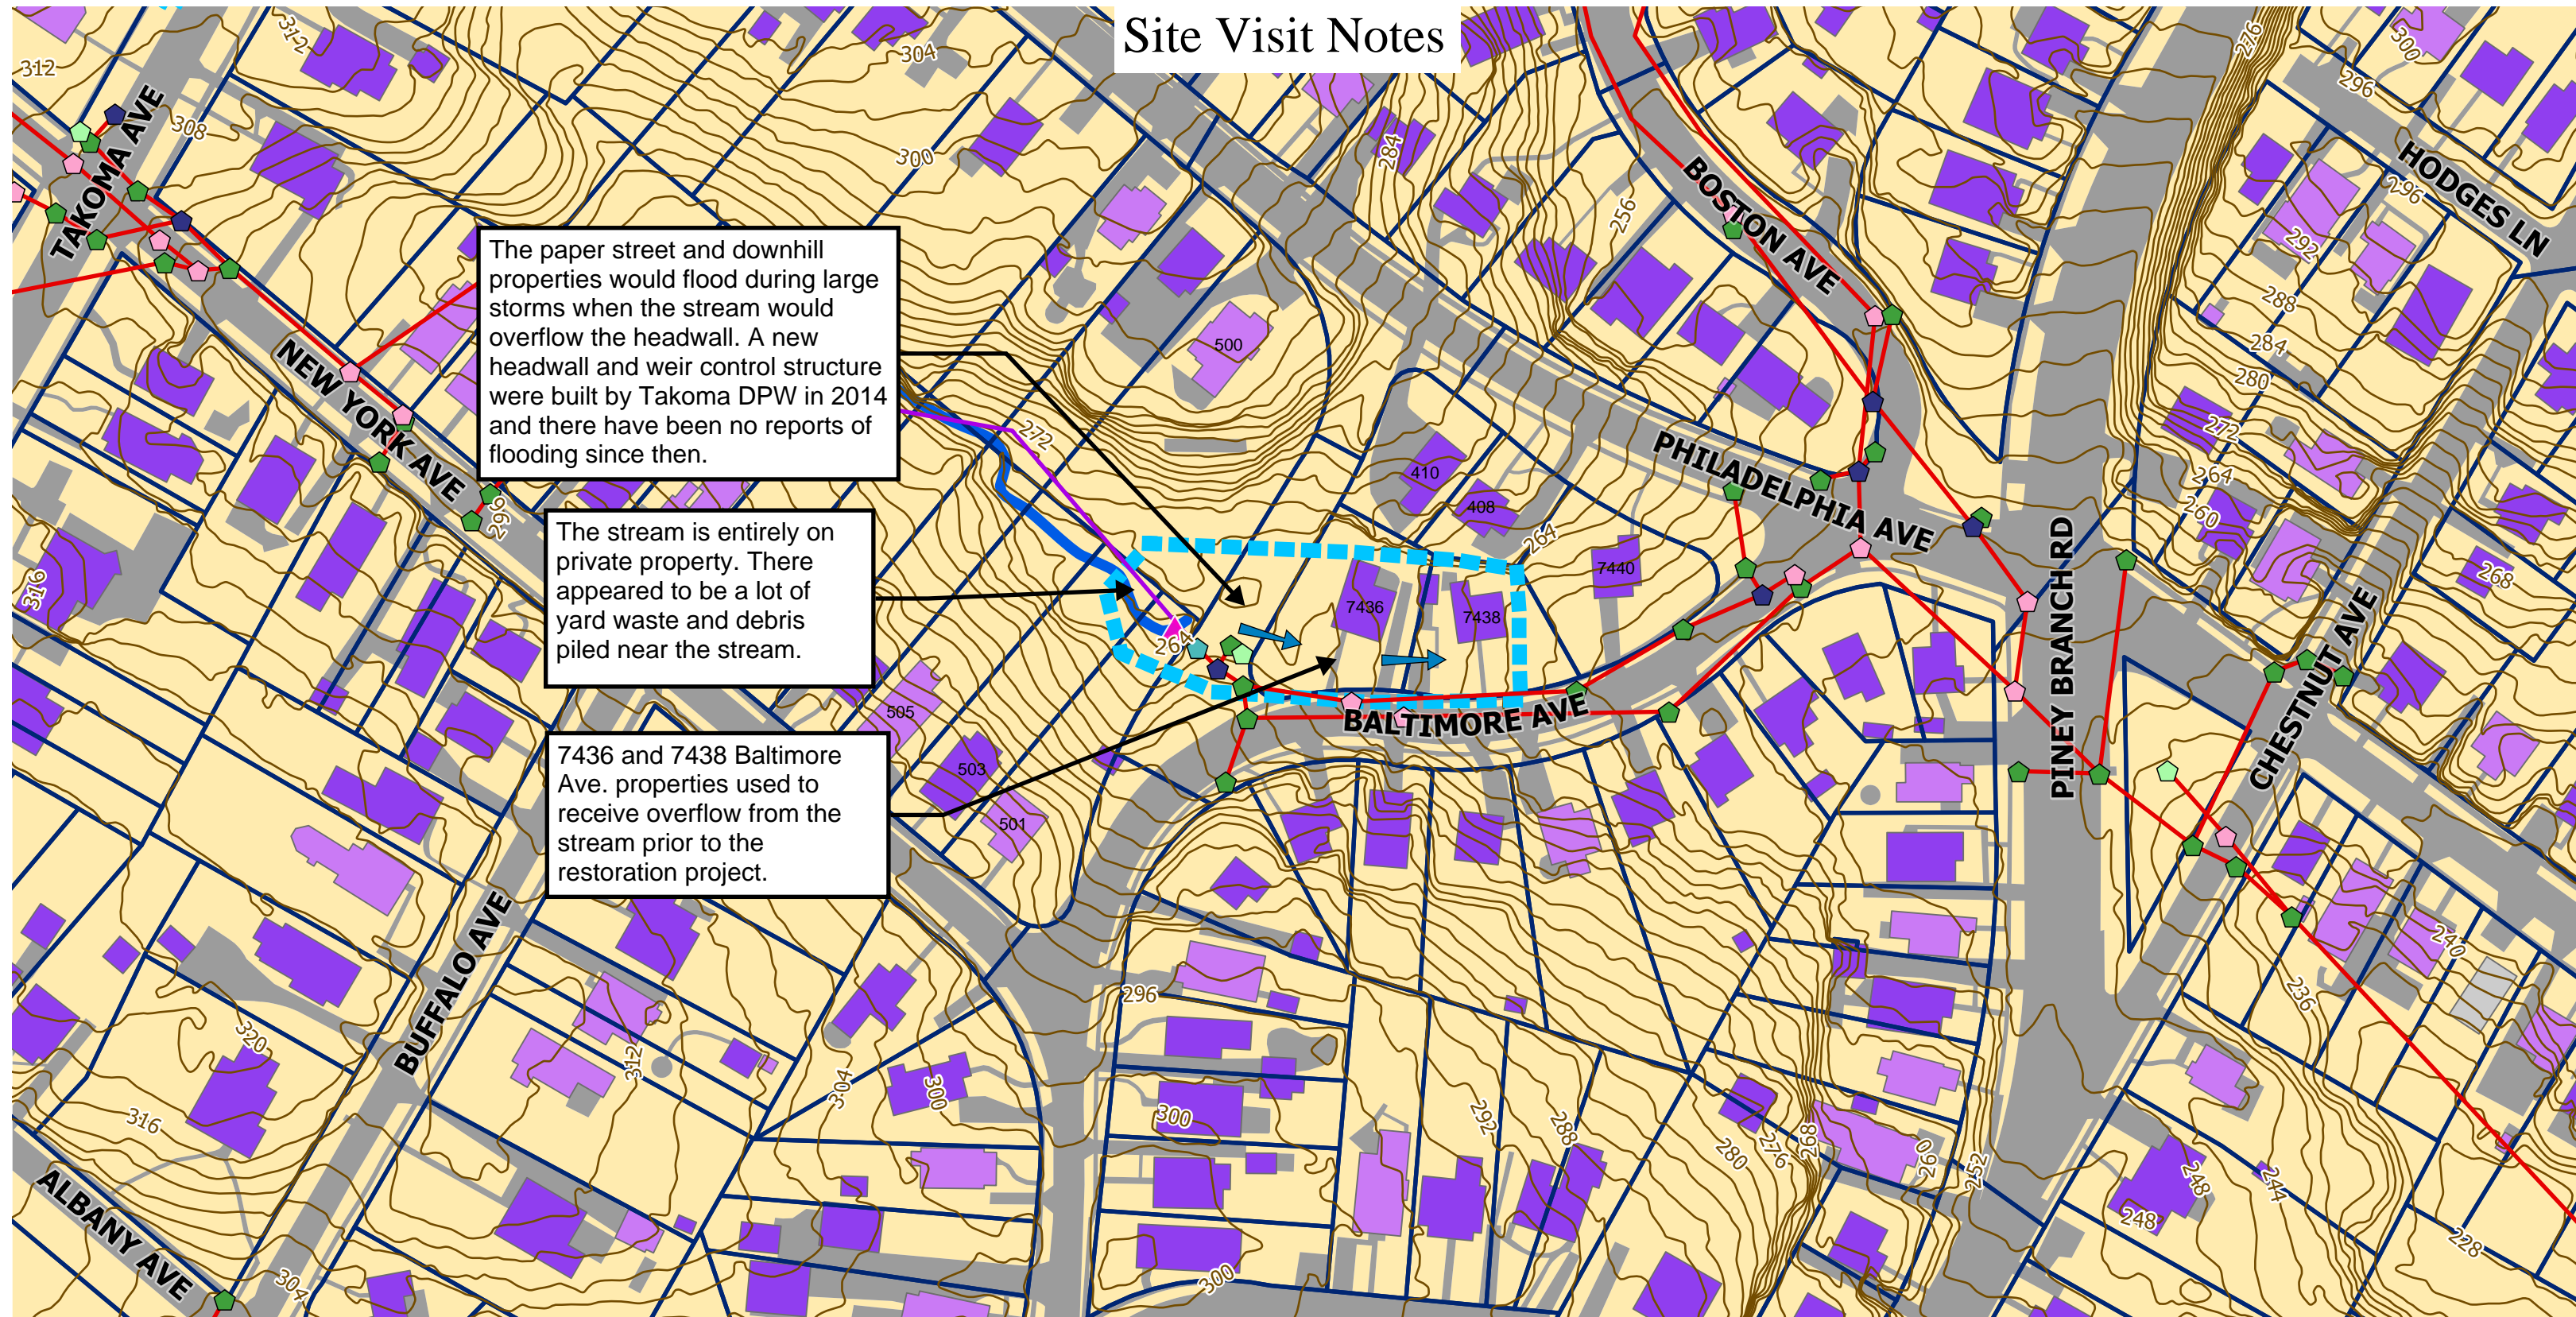
The paper street and downhill properties would flood during large storms when the stream would overflow the headwall. A new headwall and weir control structure were built by Takoma DPW in 2014 and there have been no reports of flooding since then.

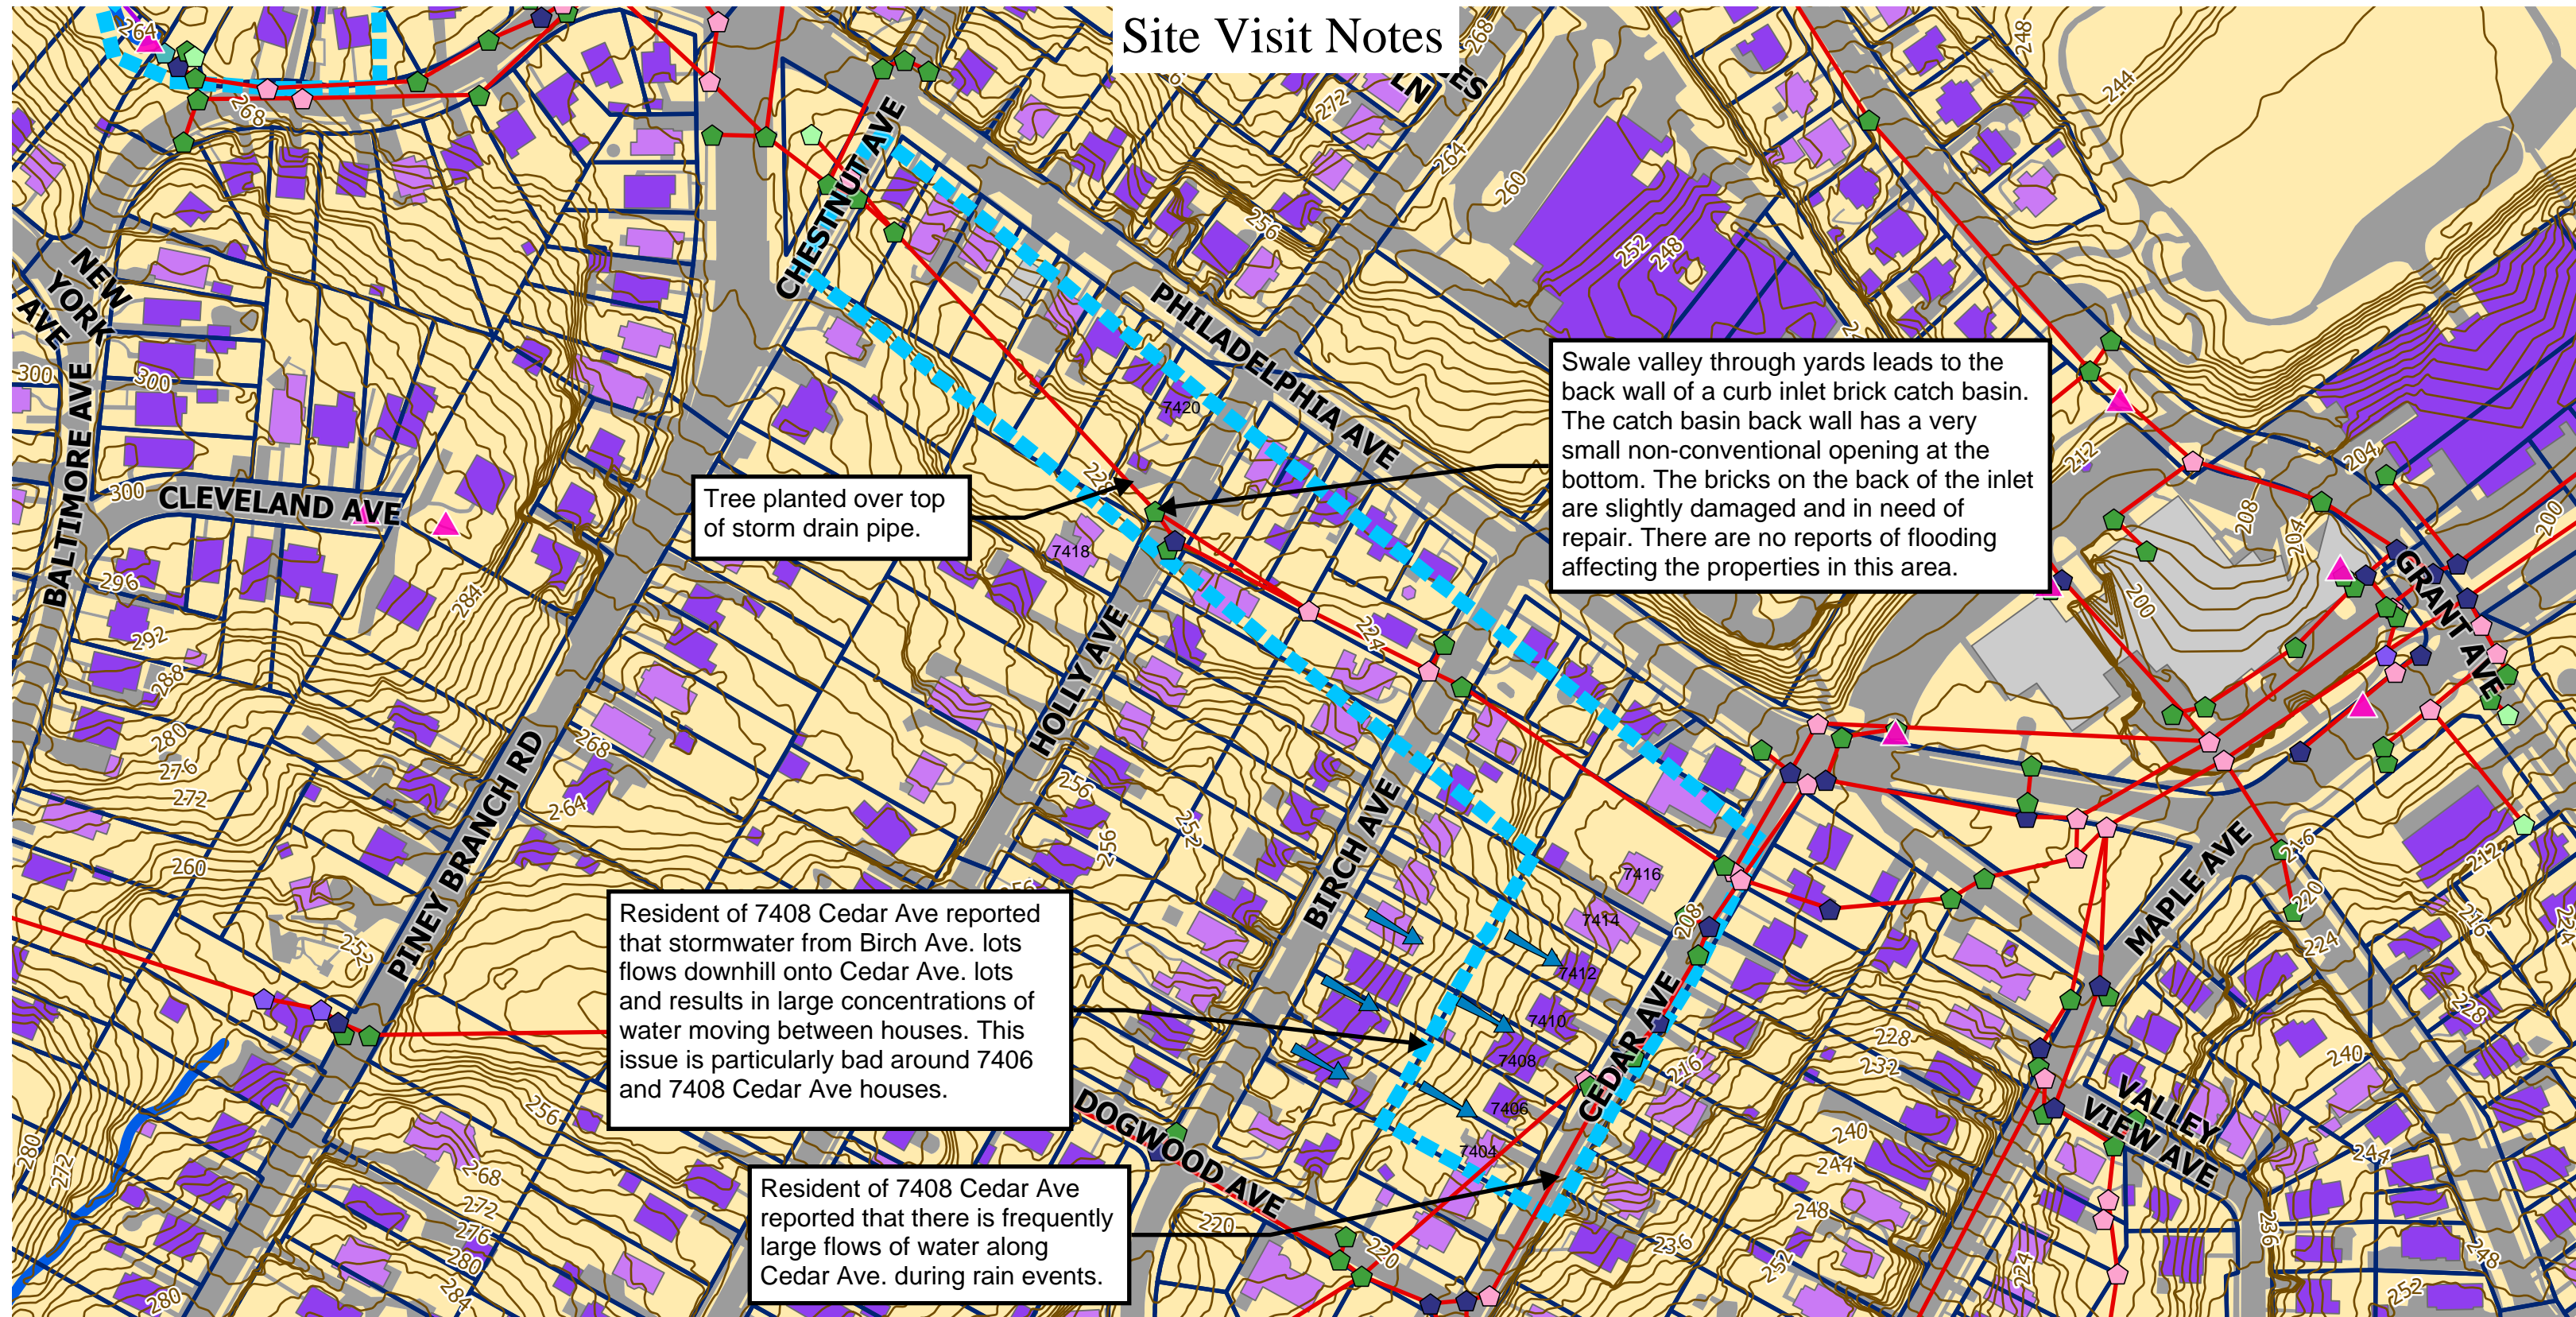
Tree planted over top of storm drain pipe.

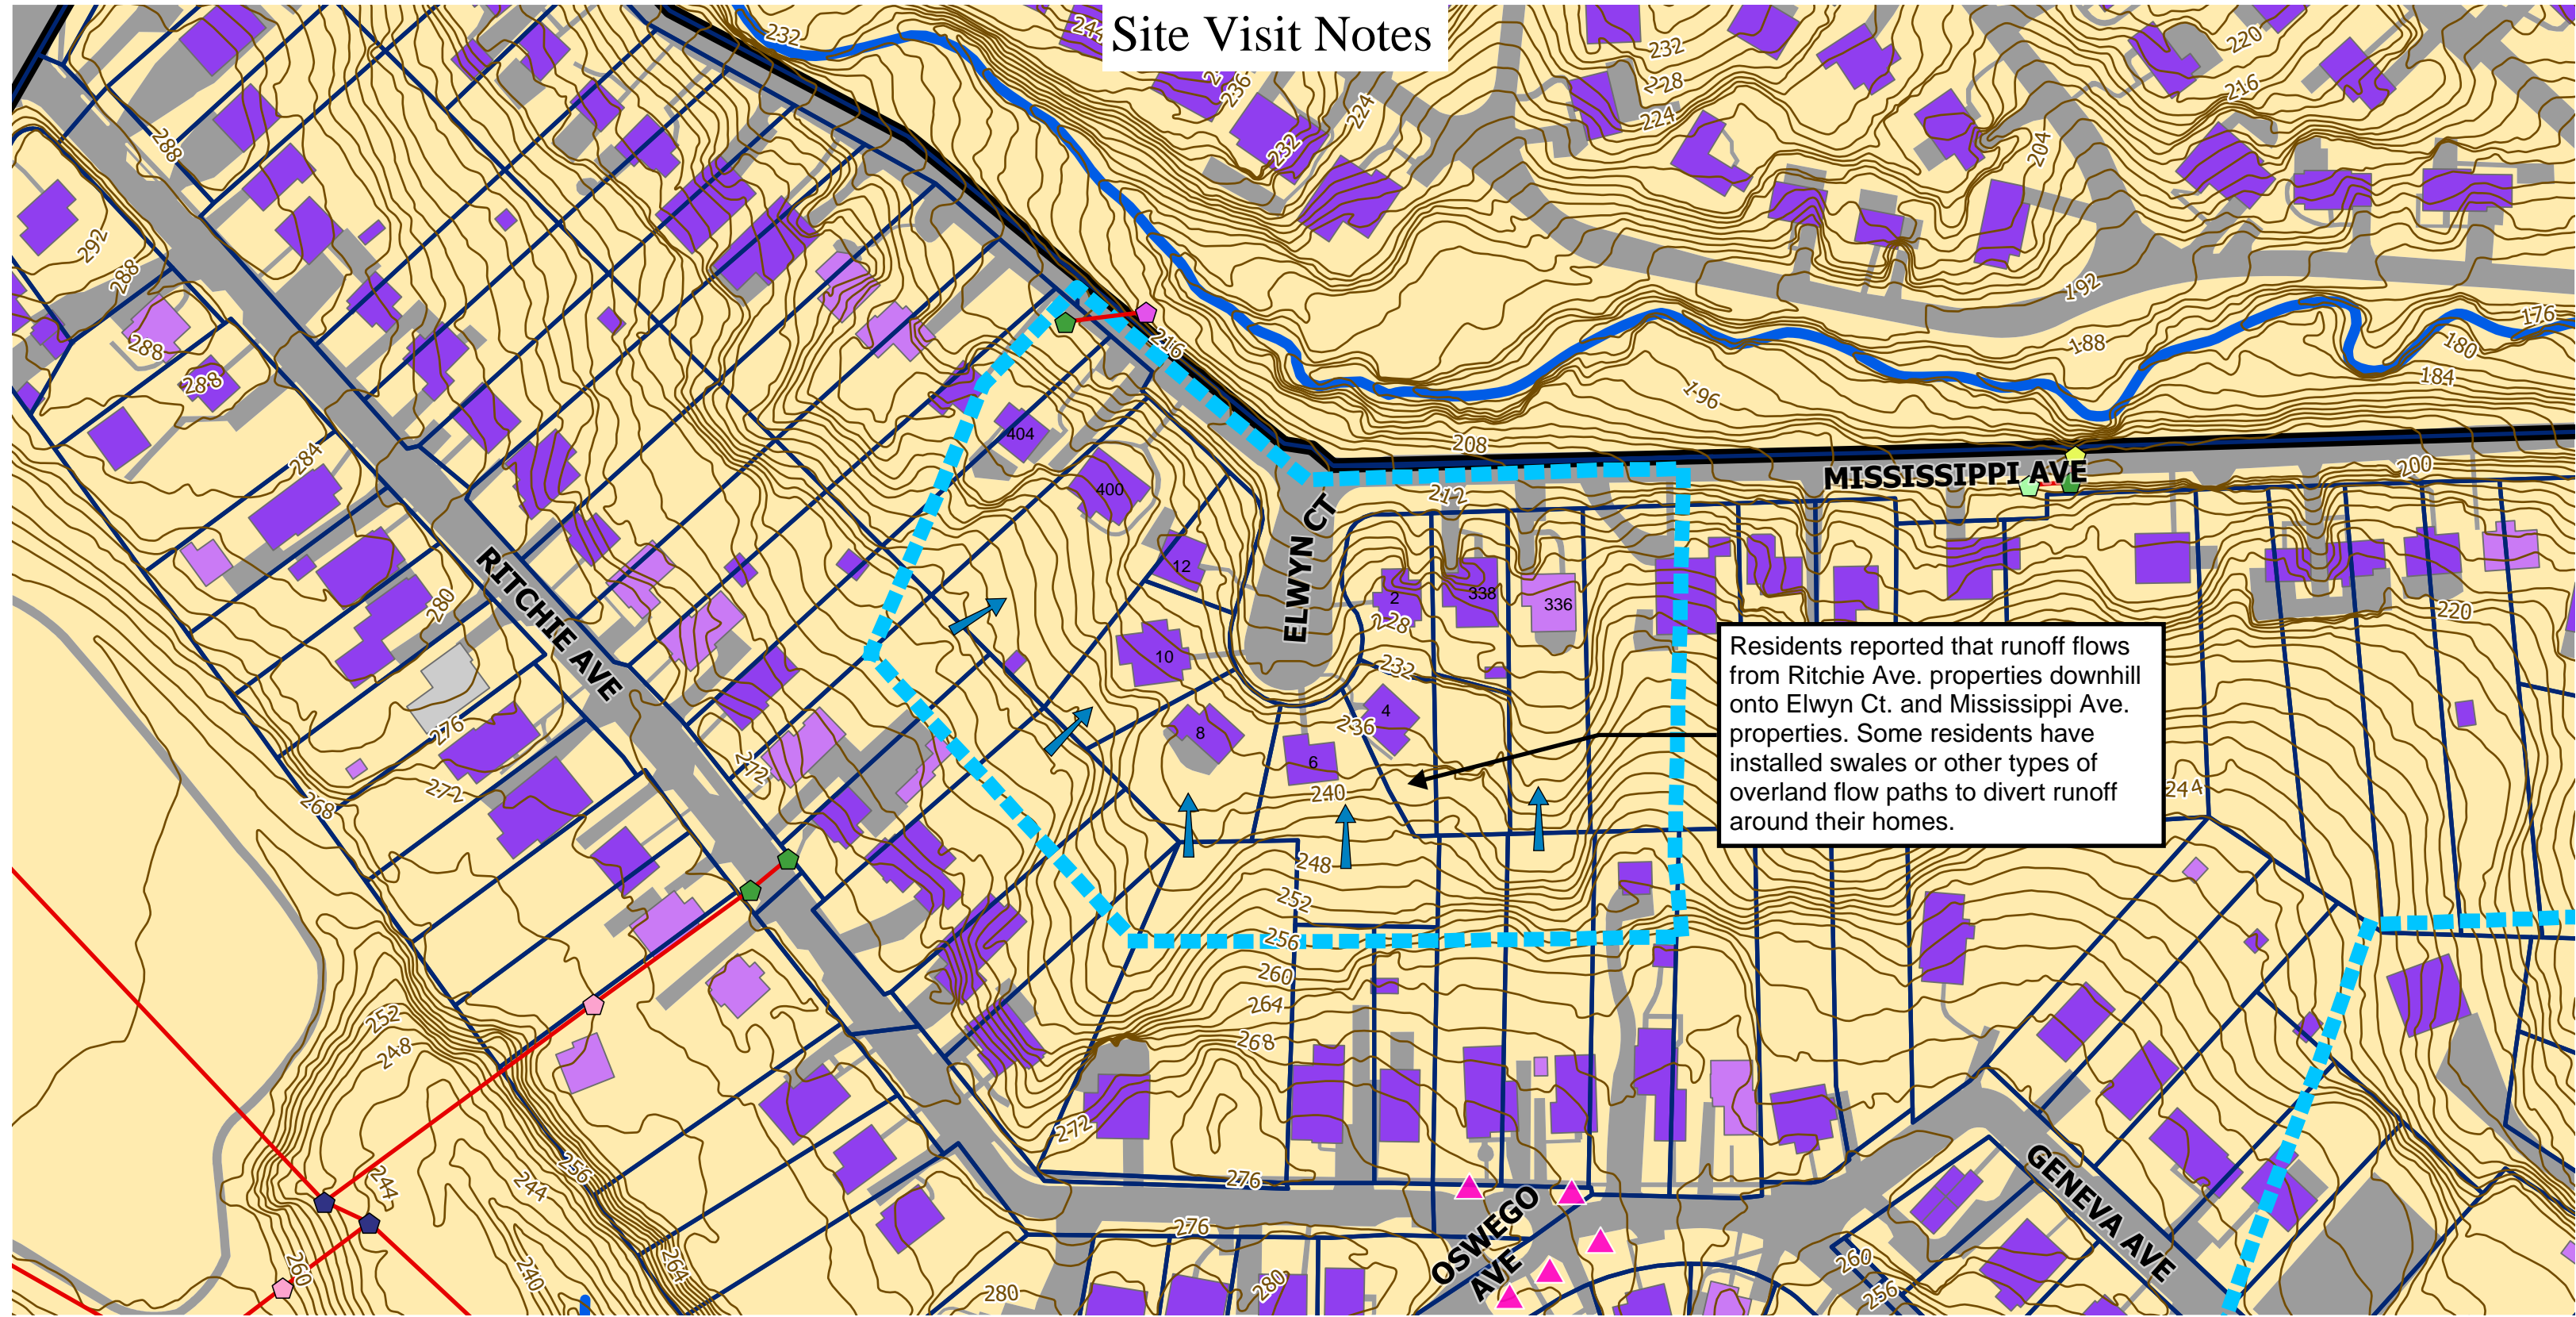
Residents reported that runoff flows from Ritchie Ave. properties downhill onto Elwyn Ct. and Mississippi Ave. properties. Some residents have installed swales or other types of overland flow paths to divert runoff around their homes.

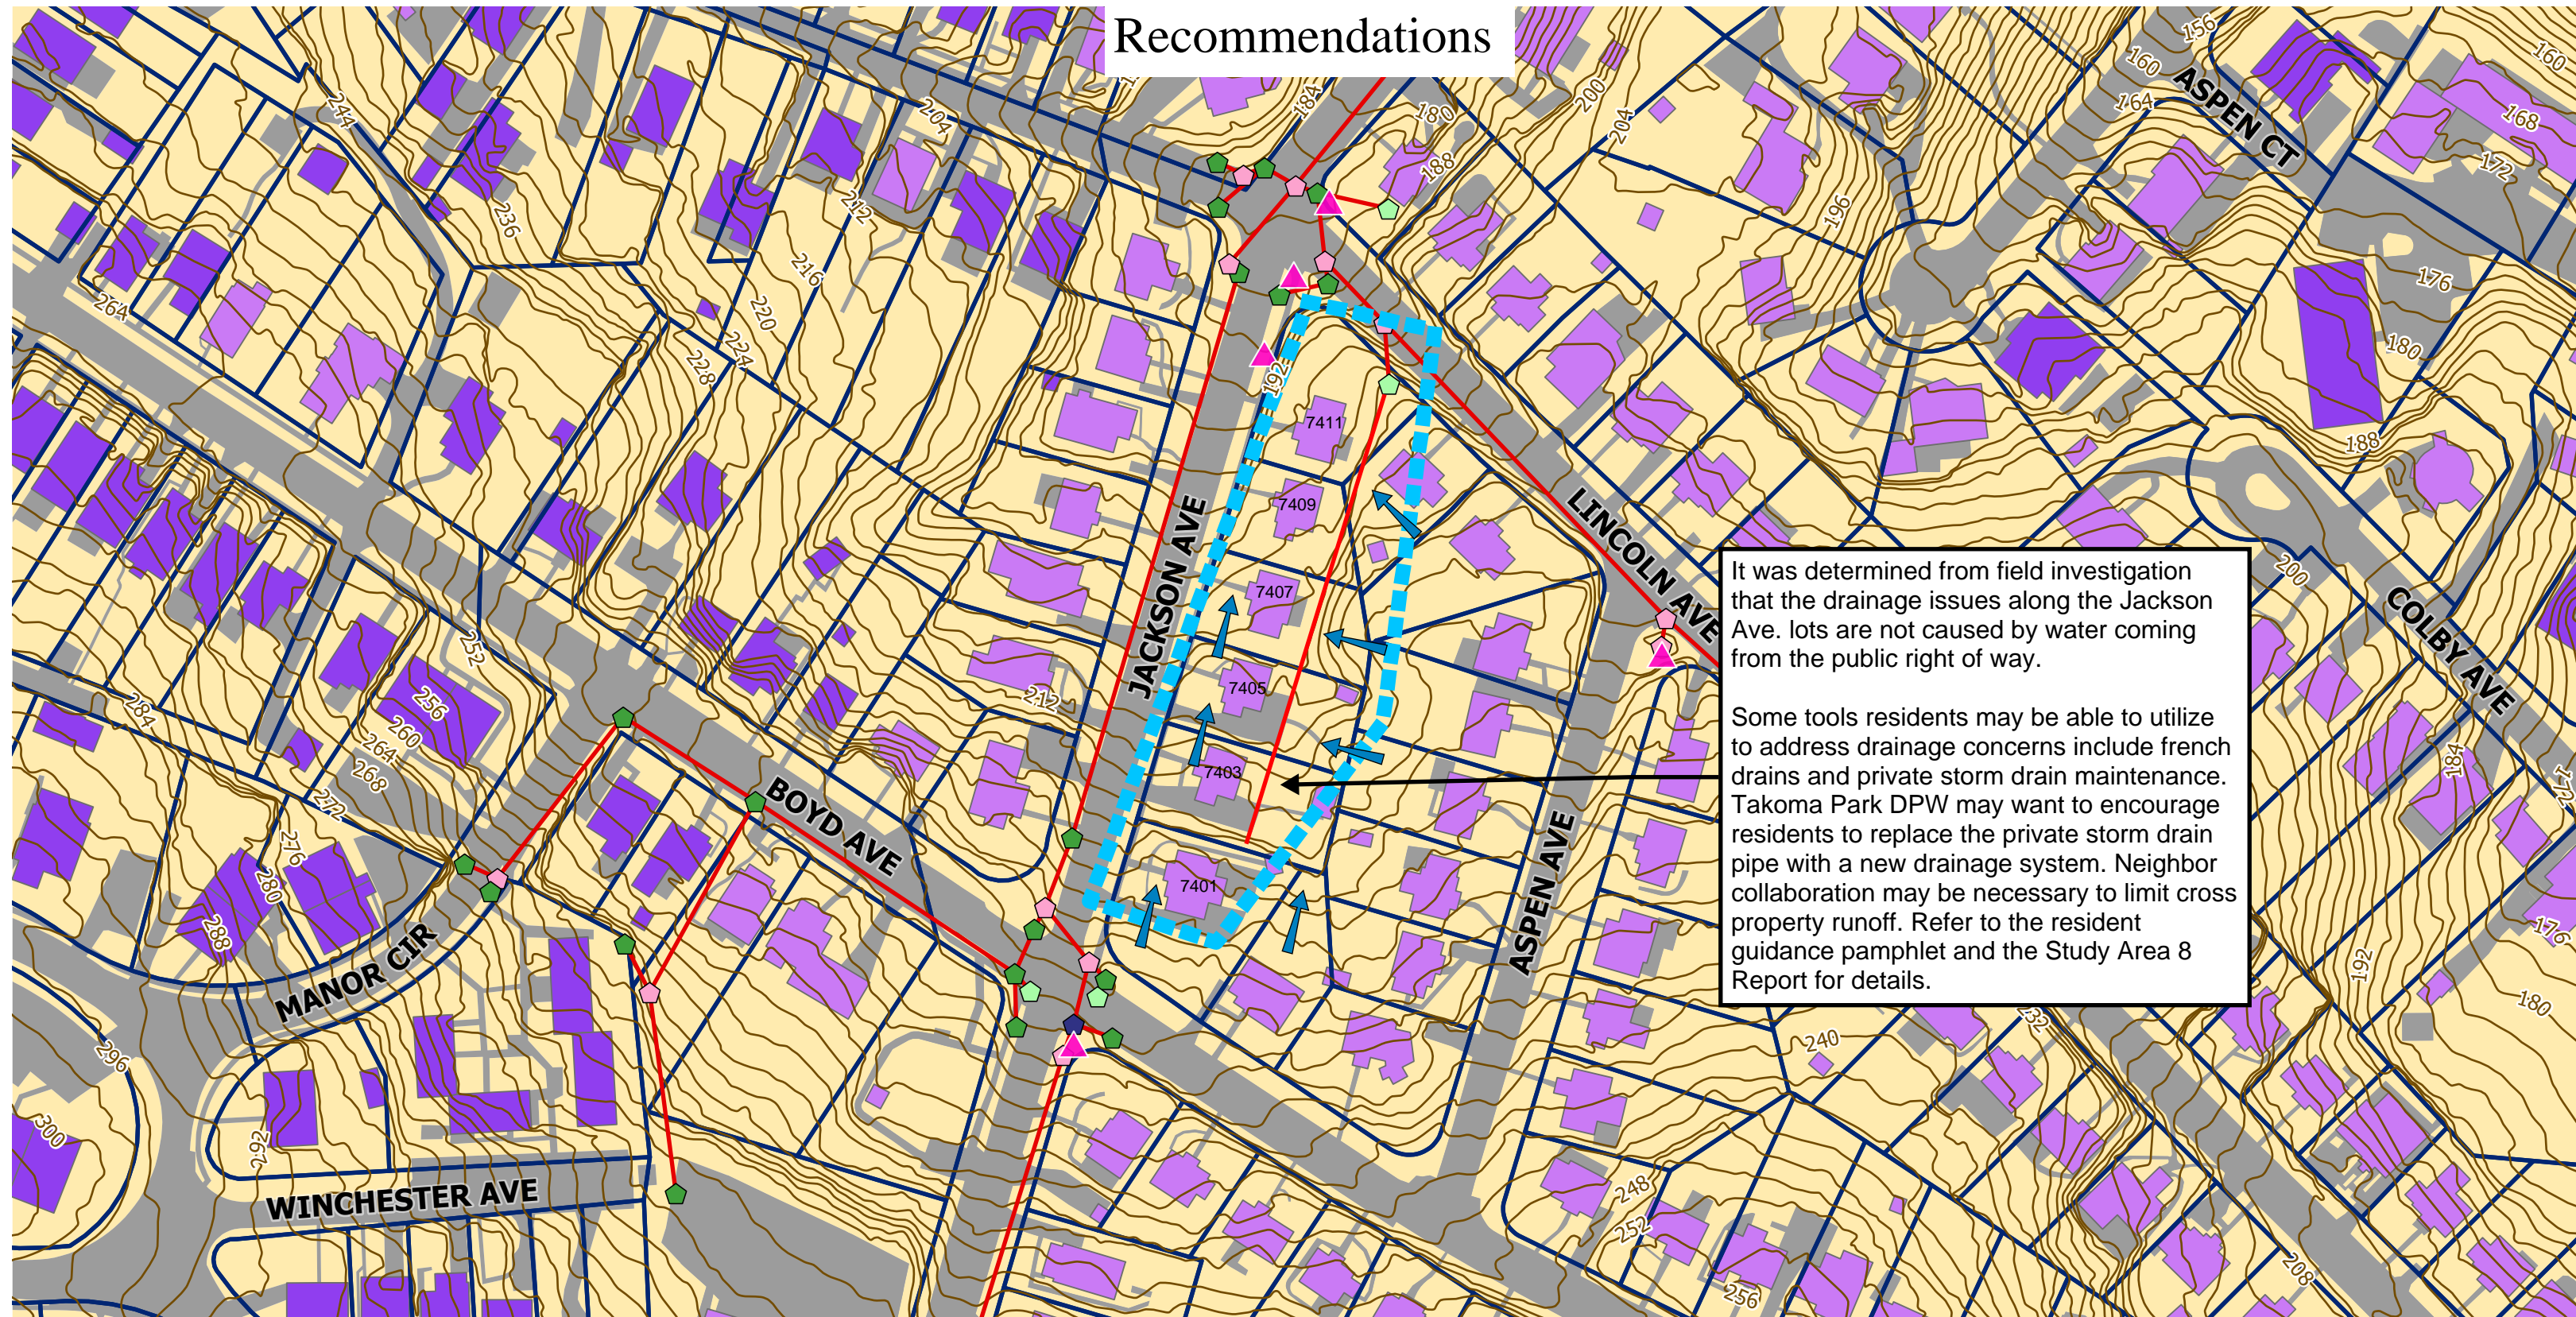
It was determined from field investigation that the drainage issues along the Jackson Ave. lots are not caused by water coming from the public right of way.

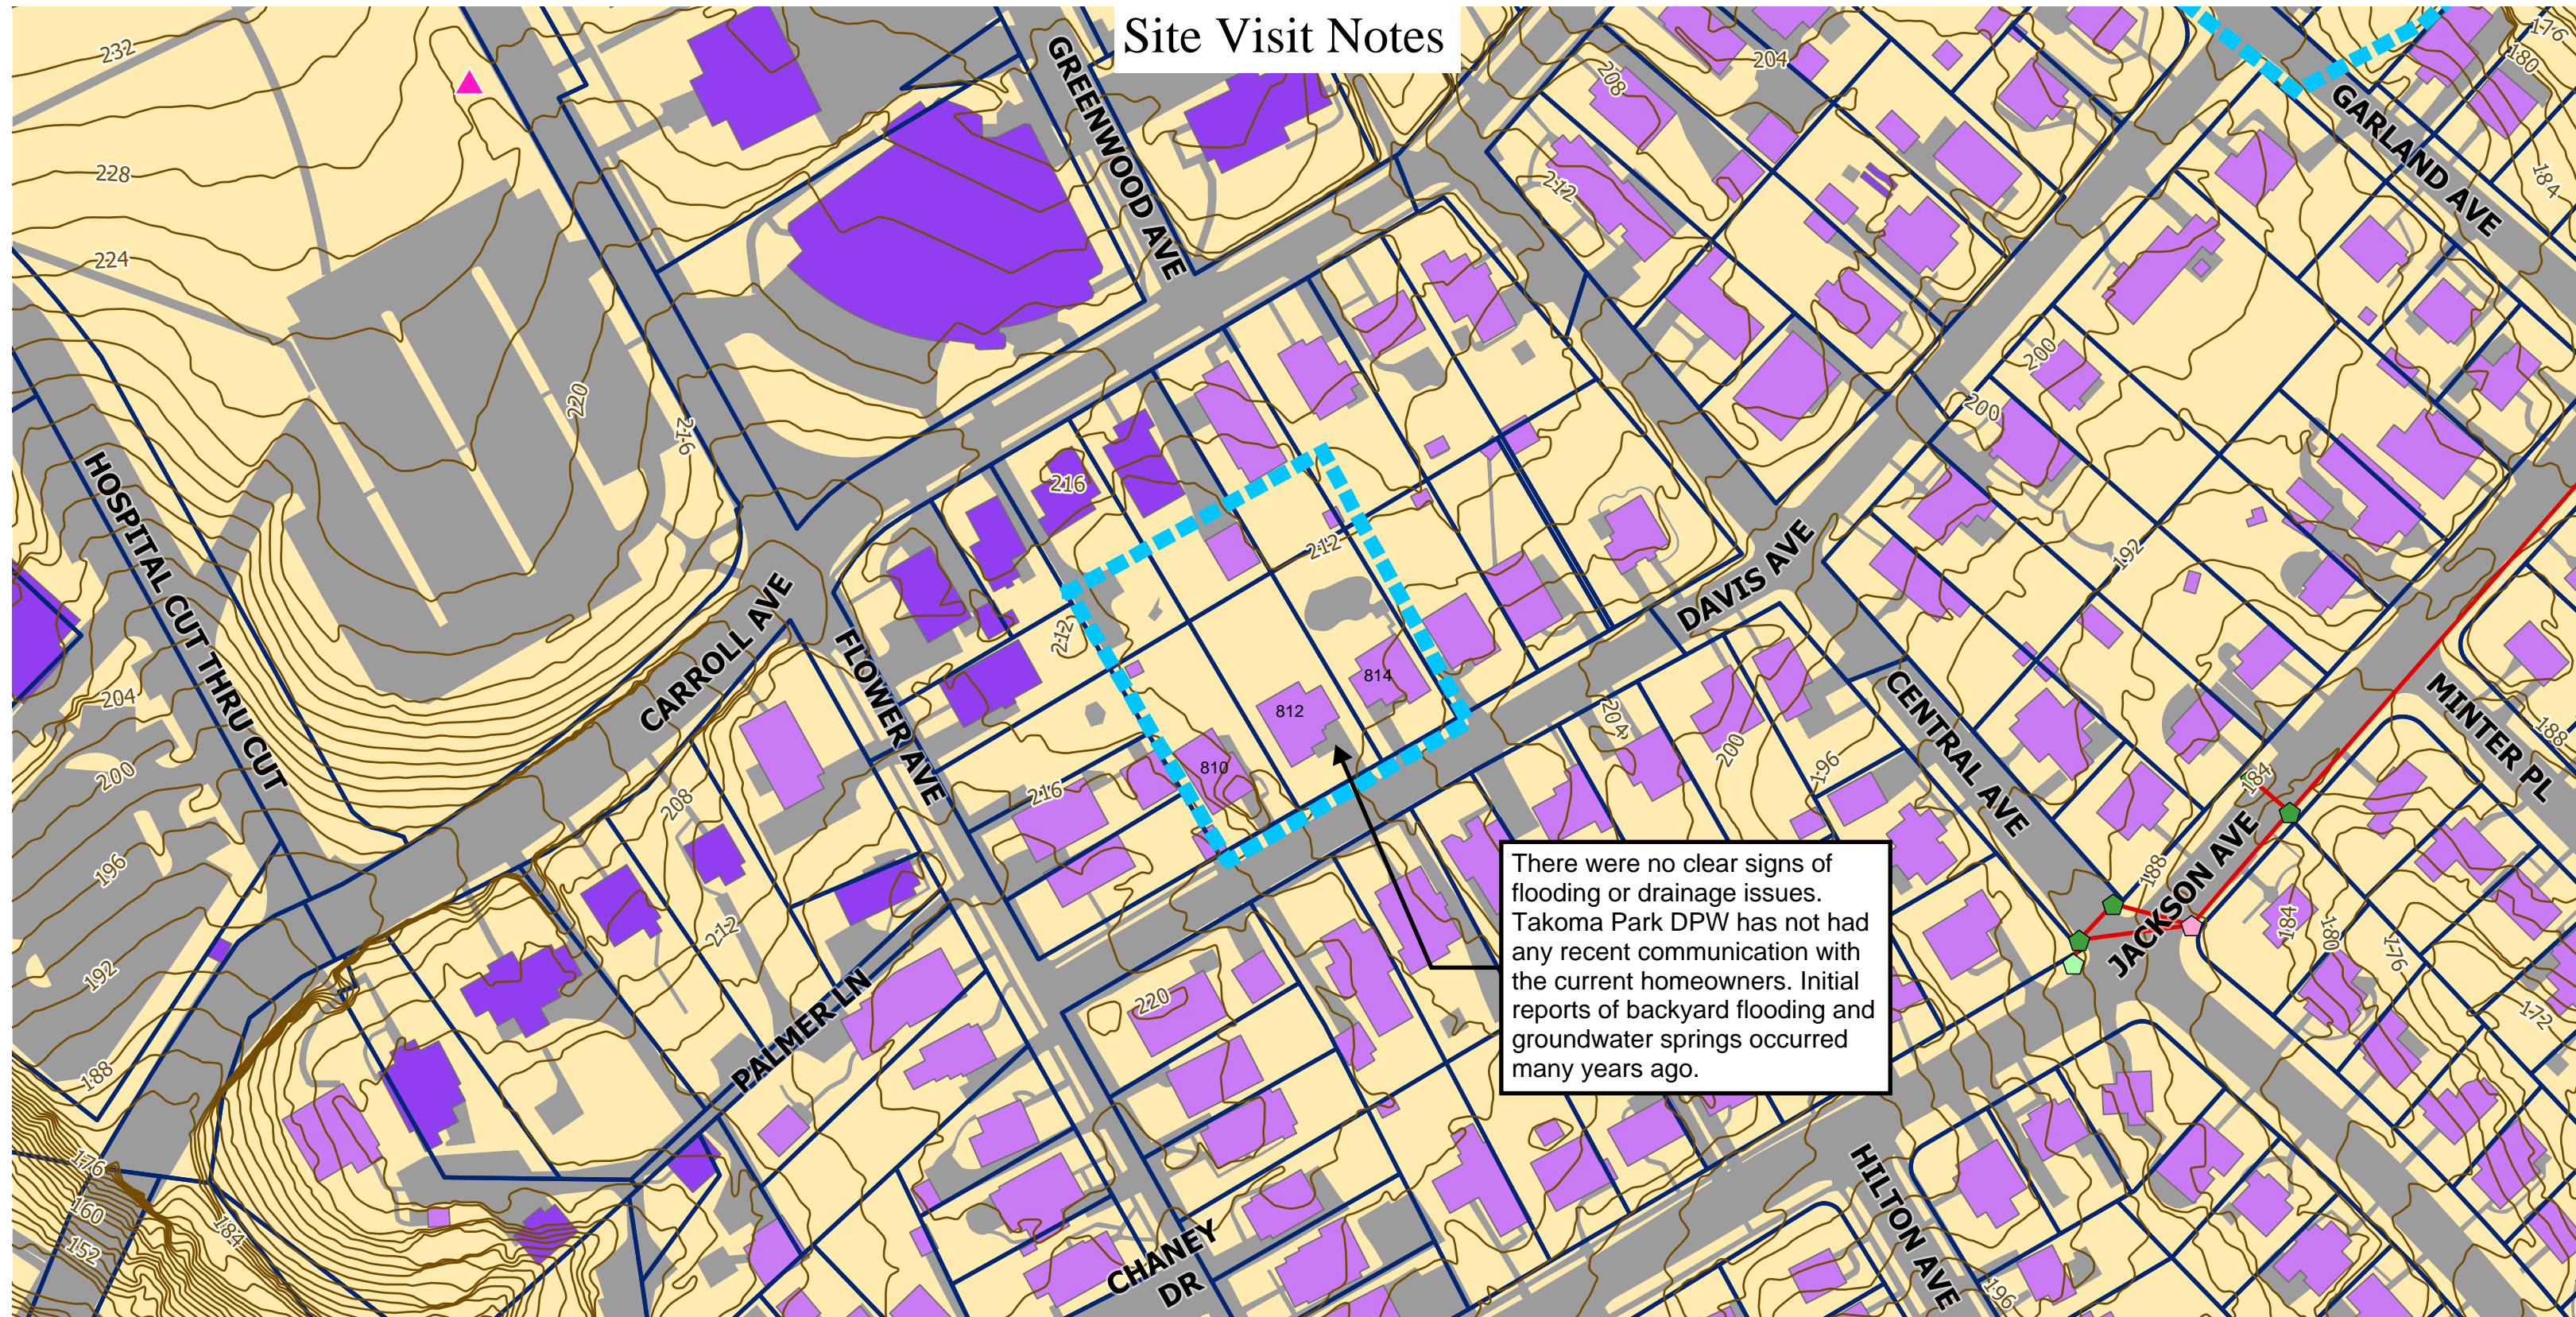
There were no clear signs of flooding or drainage issues. Takoma Park DPW has not had any recent communication with the current homeowners. Initial reports of backyard flooding and groundwater springs occurred many years ago.

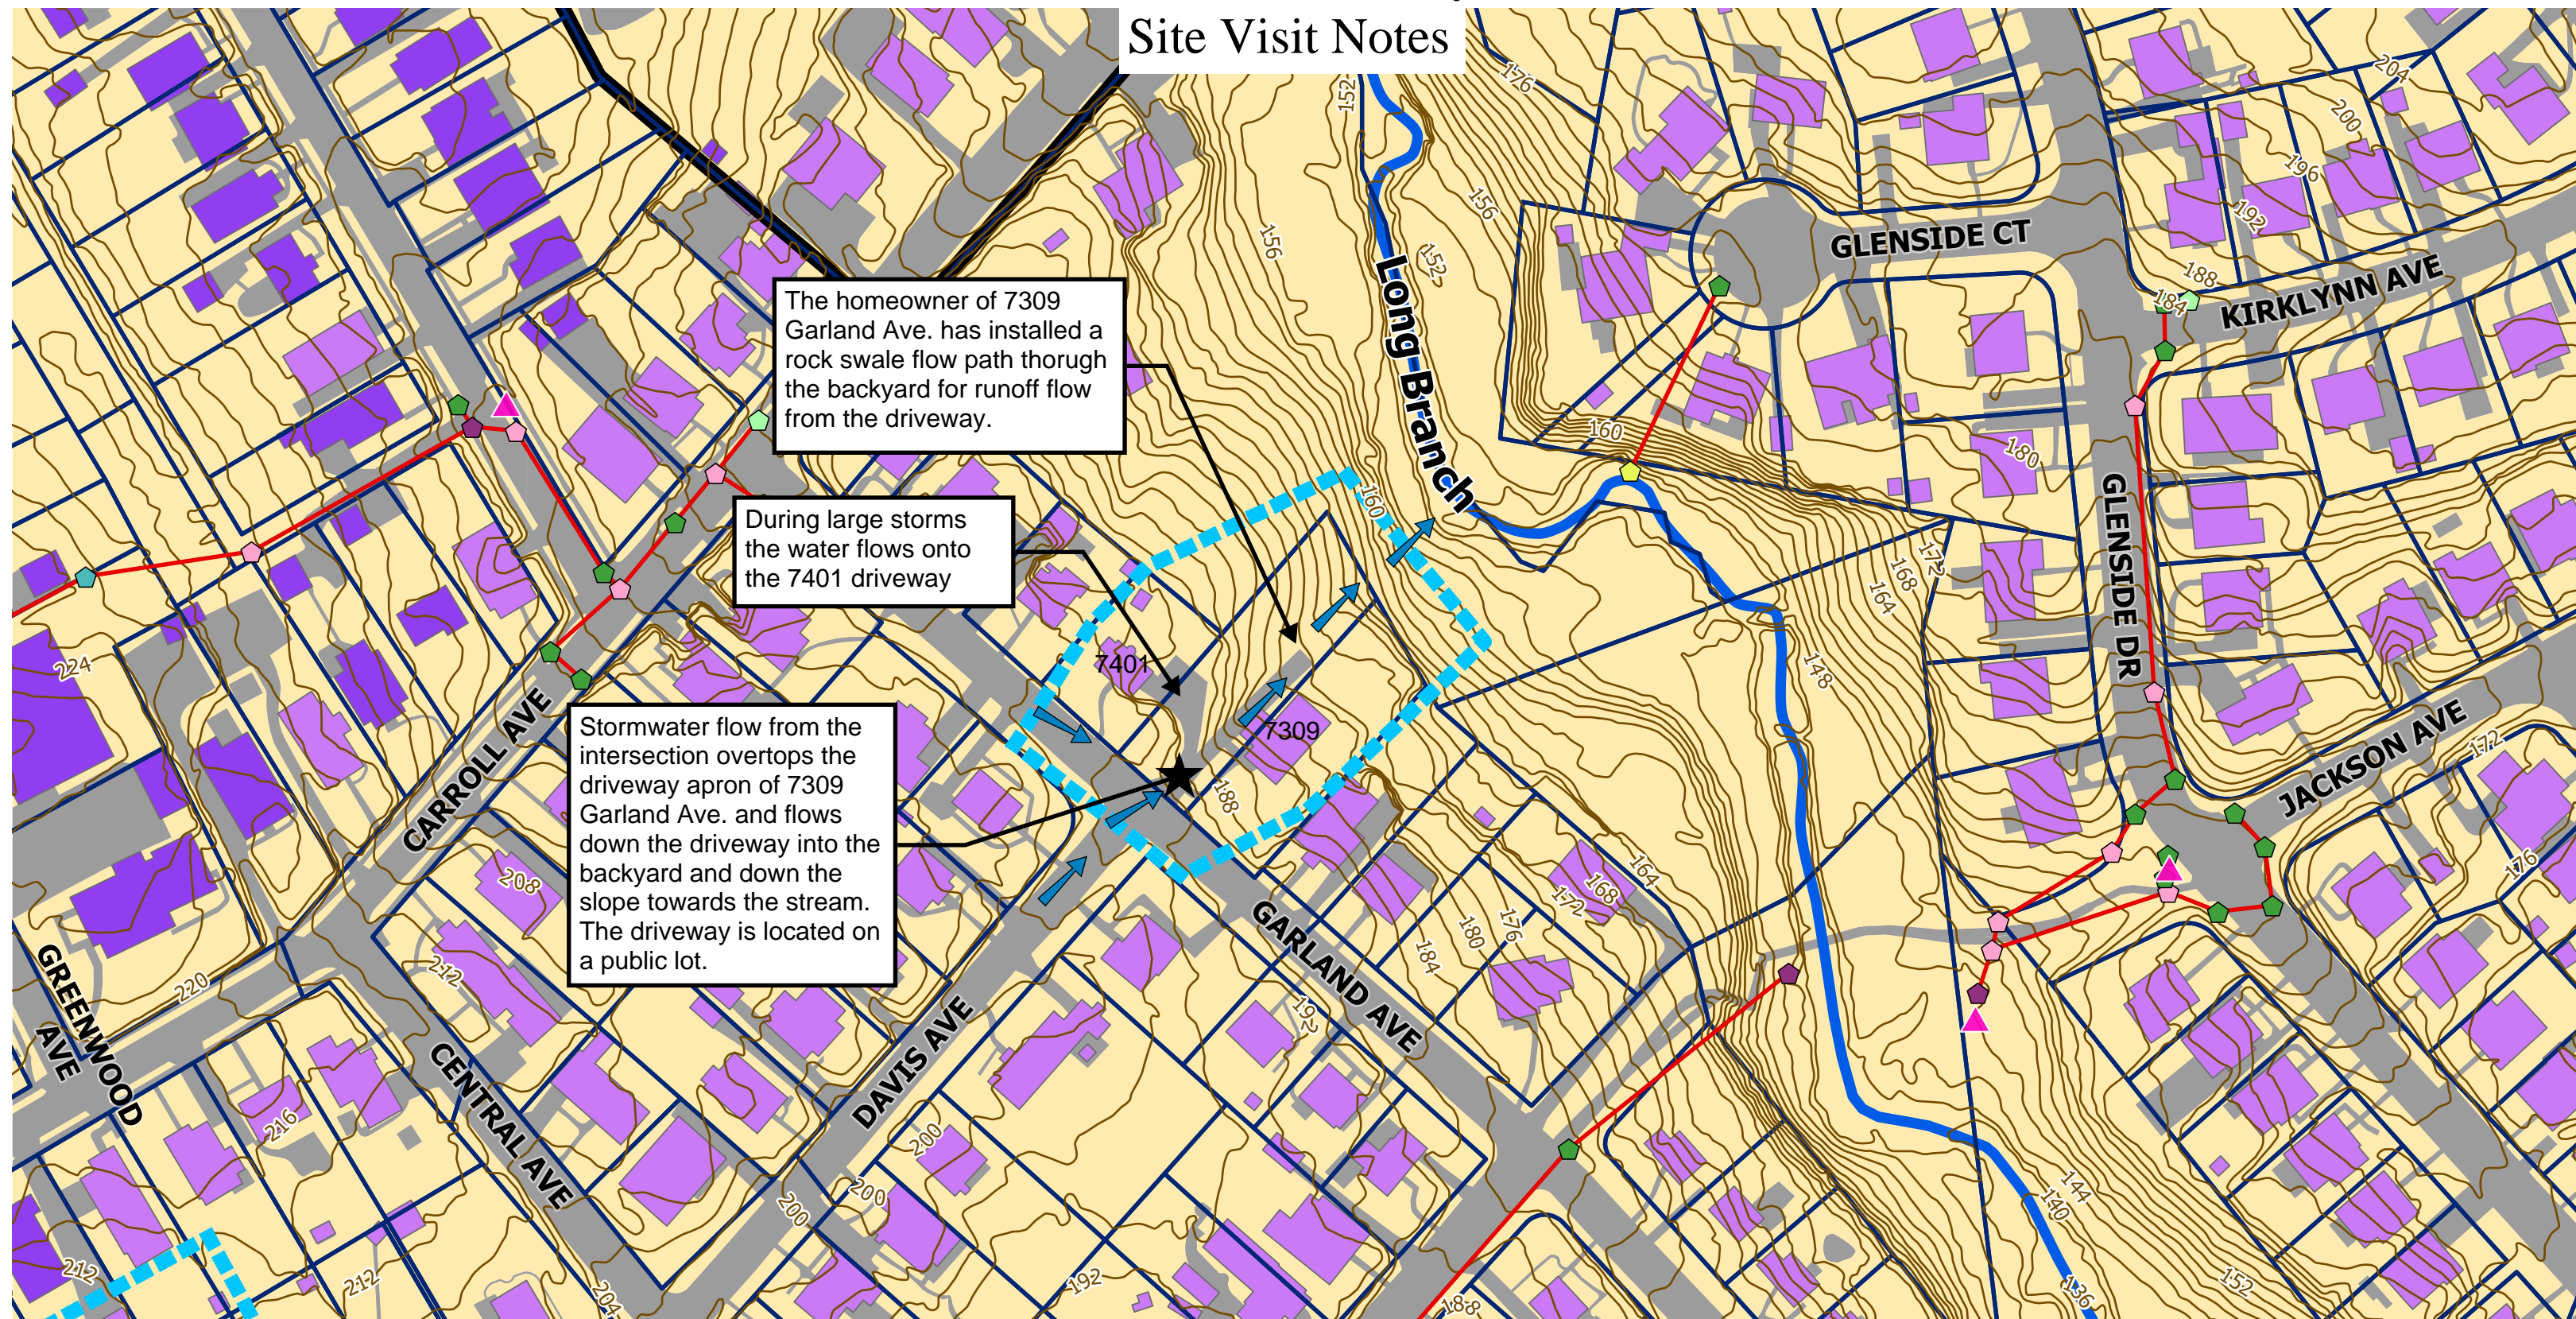
The homeowner of 7309 Garland Ave. has installed a rock swale flow path through the backyard for runoff flow from the driveway.
