Stormwater Climate Adaptation Plan Report for the City of Takoma Park, Maryland

Prepared by:
The Low Impact Development Center for The City of Takoma Park

June 2024

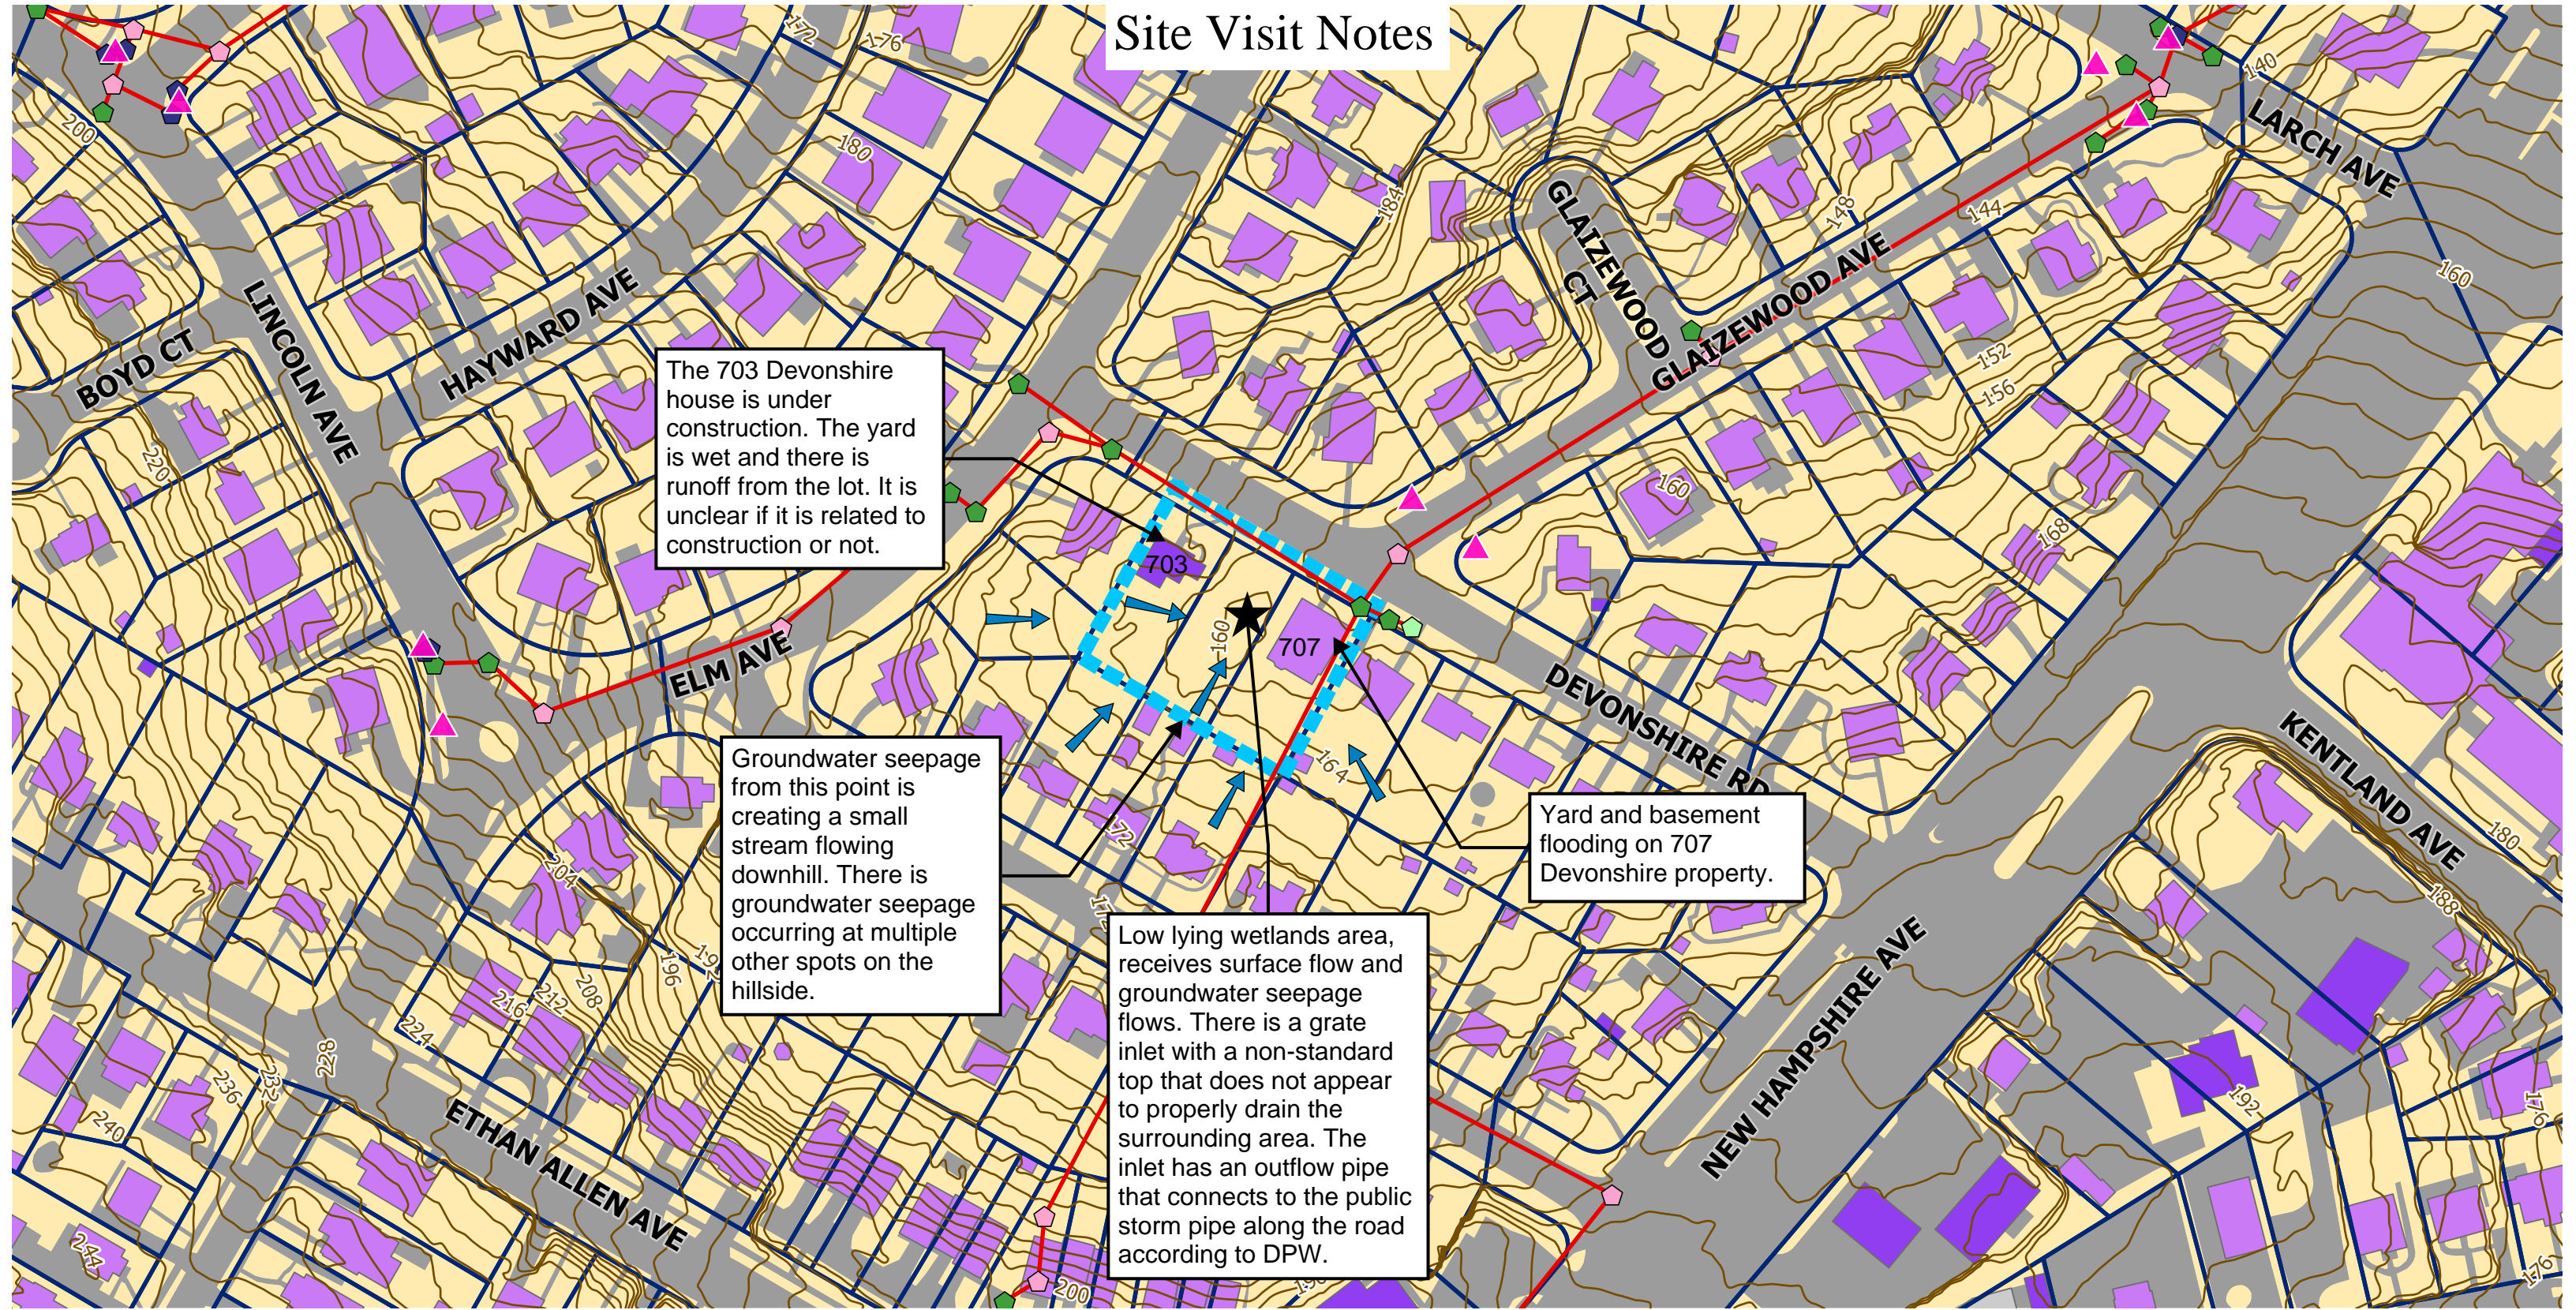
The 703 Devonshire house is under construction. The yard is wet and there is runoff from the lot. It is unclear if it is related to construction or not.

Takoma Park DPW may consider engaging the 703 Devonshire Rd. property owner to discuss replacement of the grate inlet or creation of a wetlands BMP area.

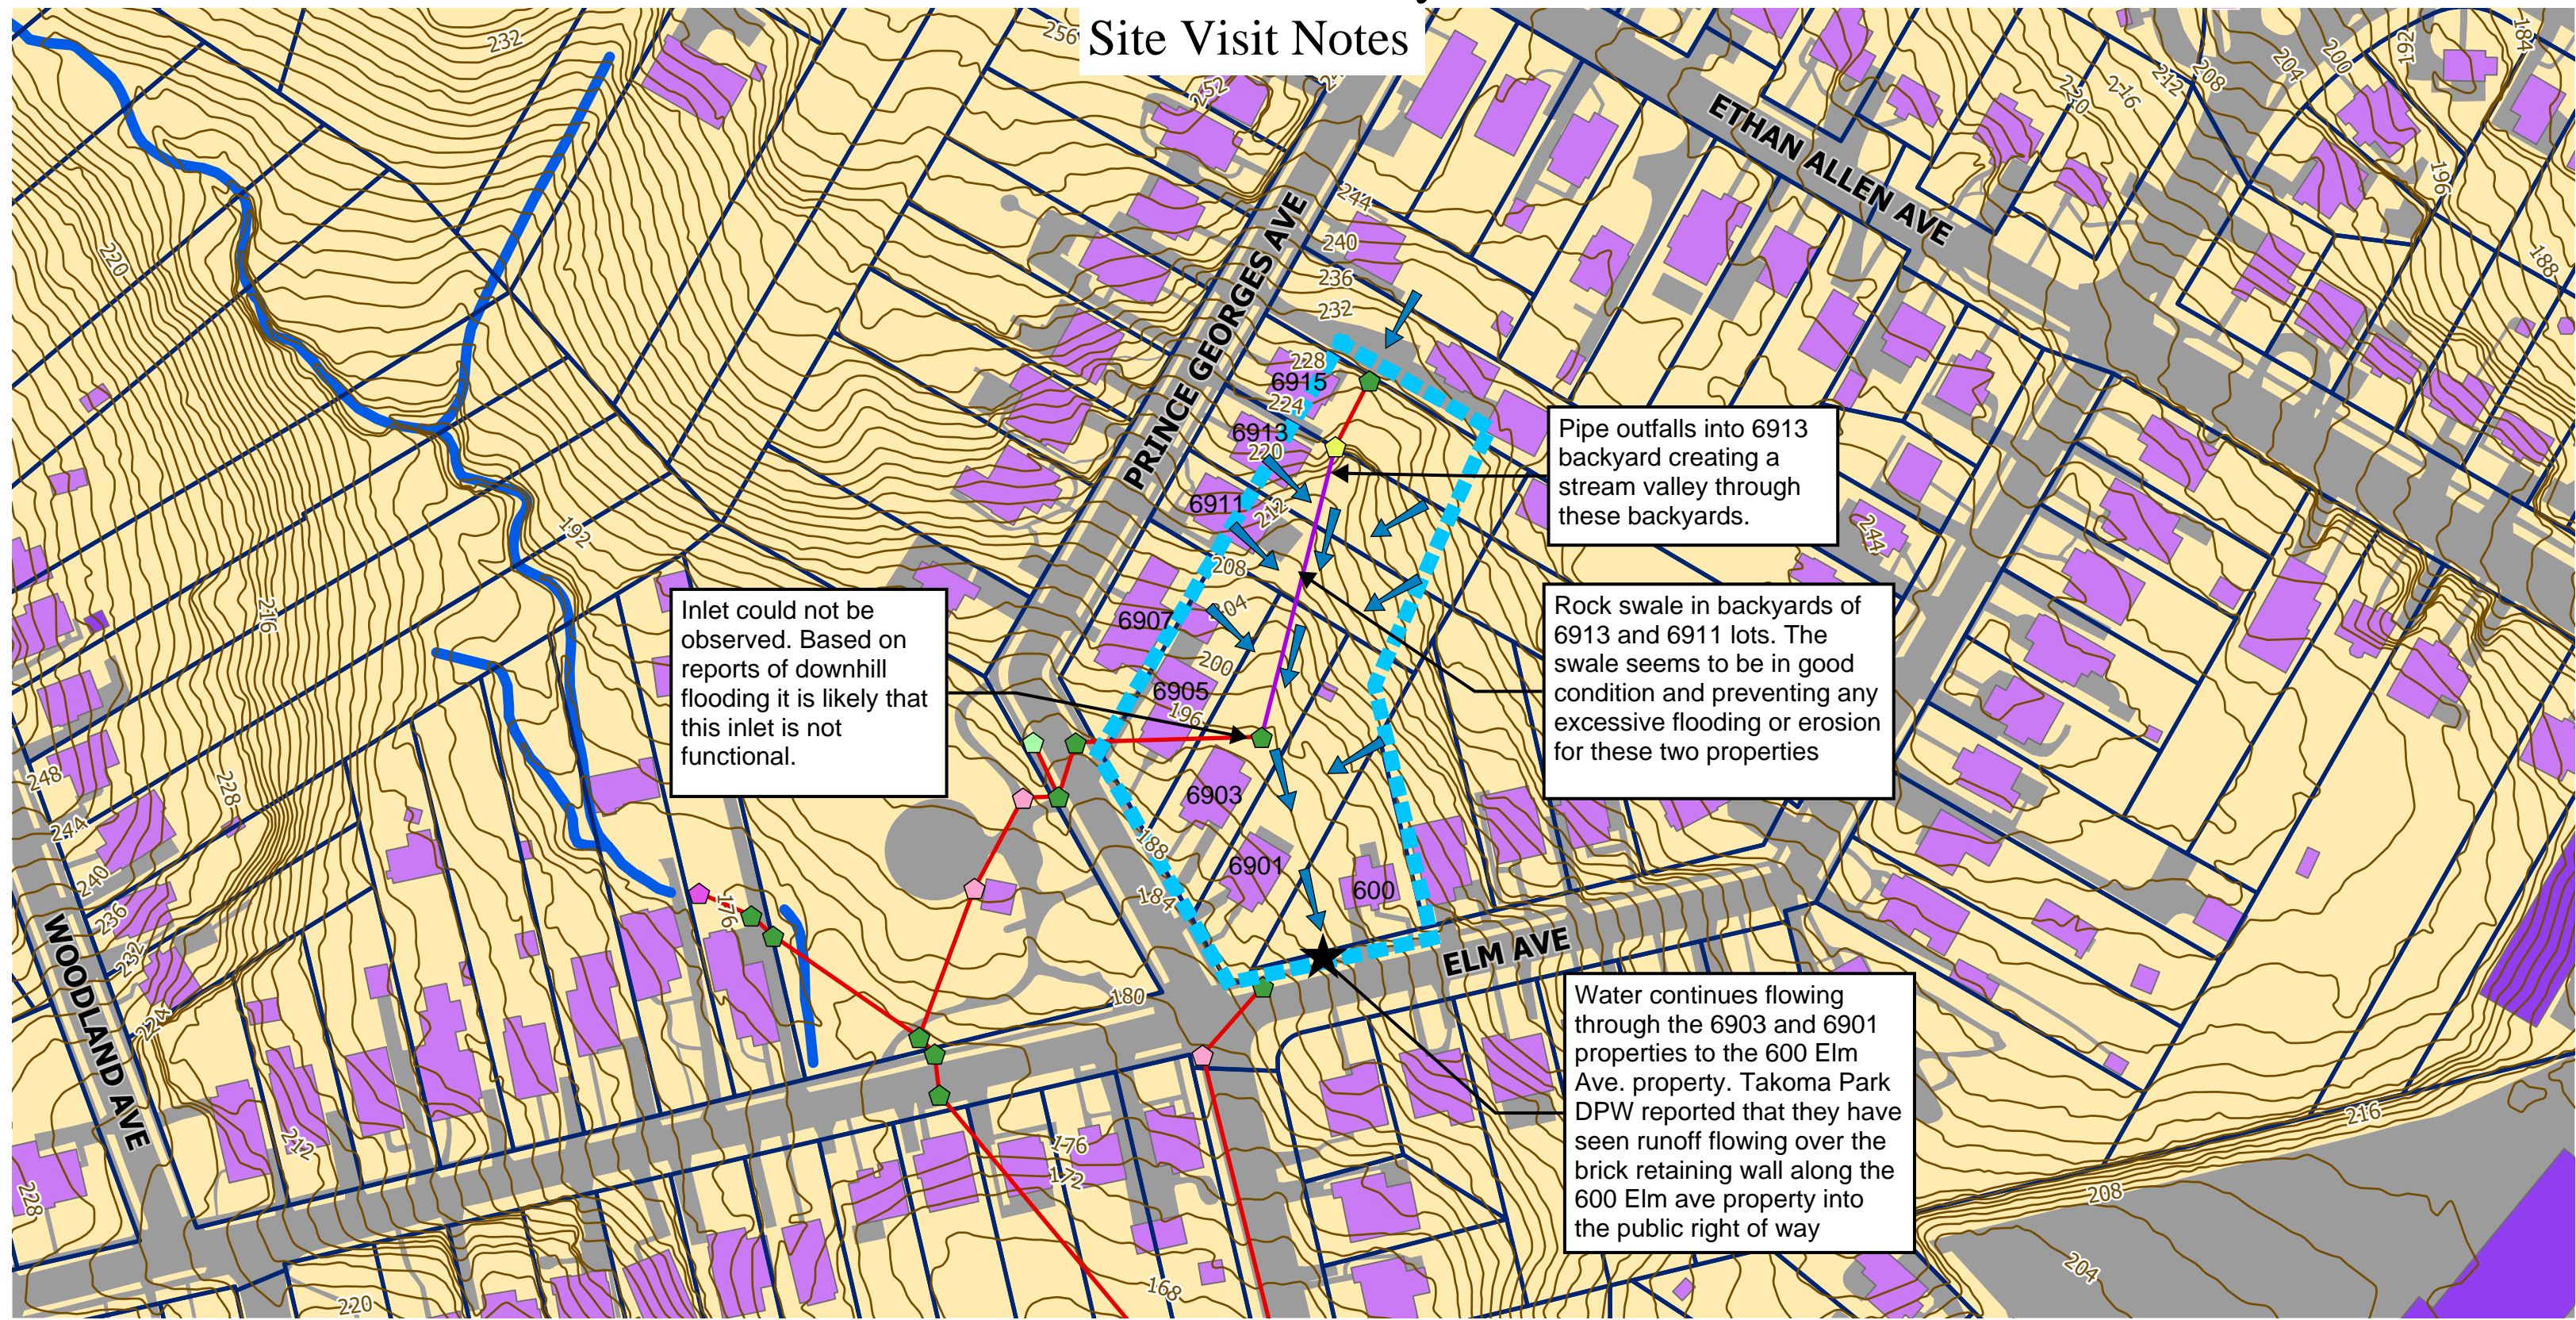
Inlet could not be observed. Based on reports of downhill flooding it is likely that this inlet is not functional.

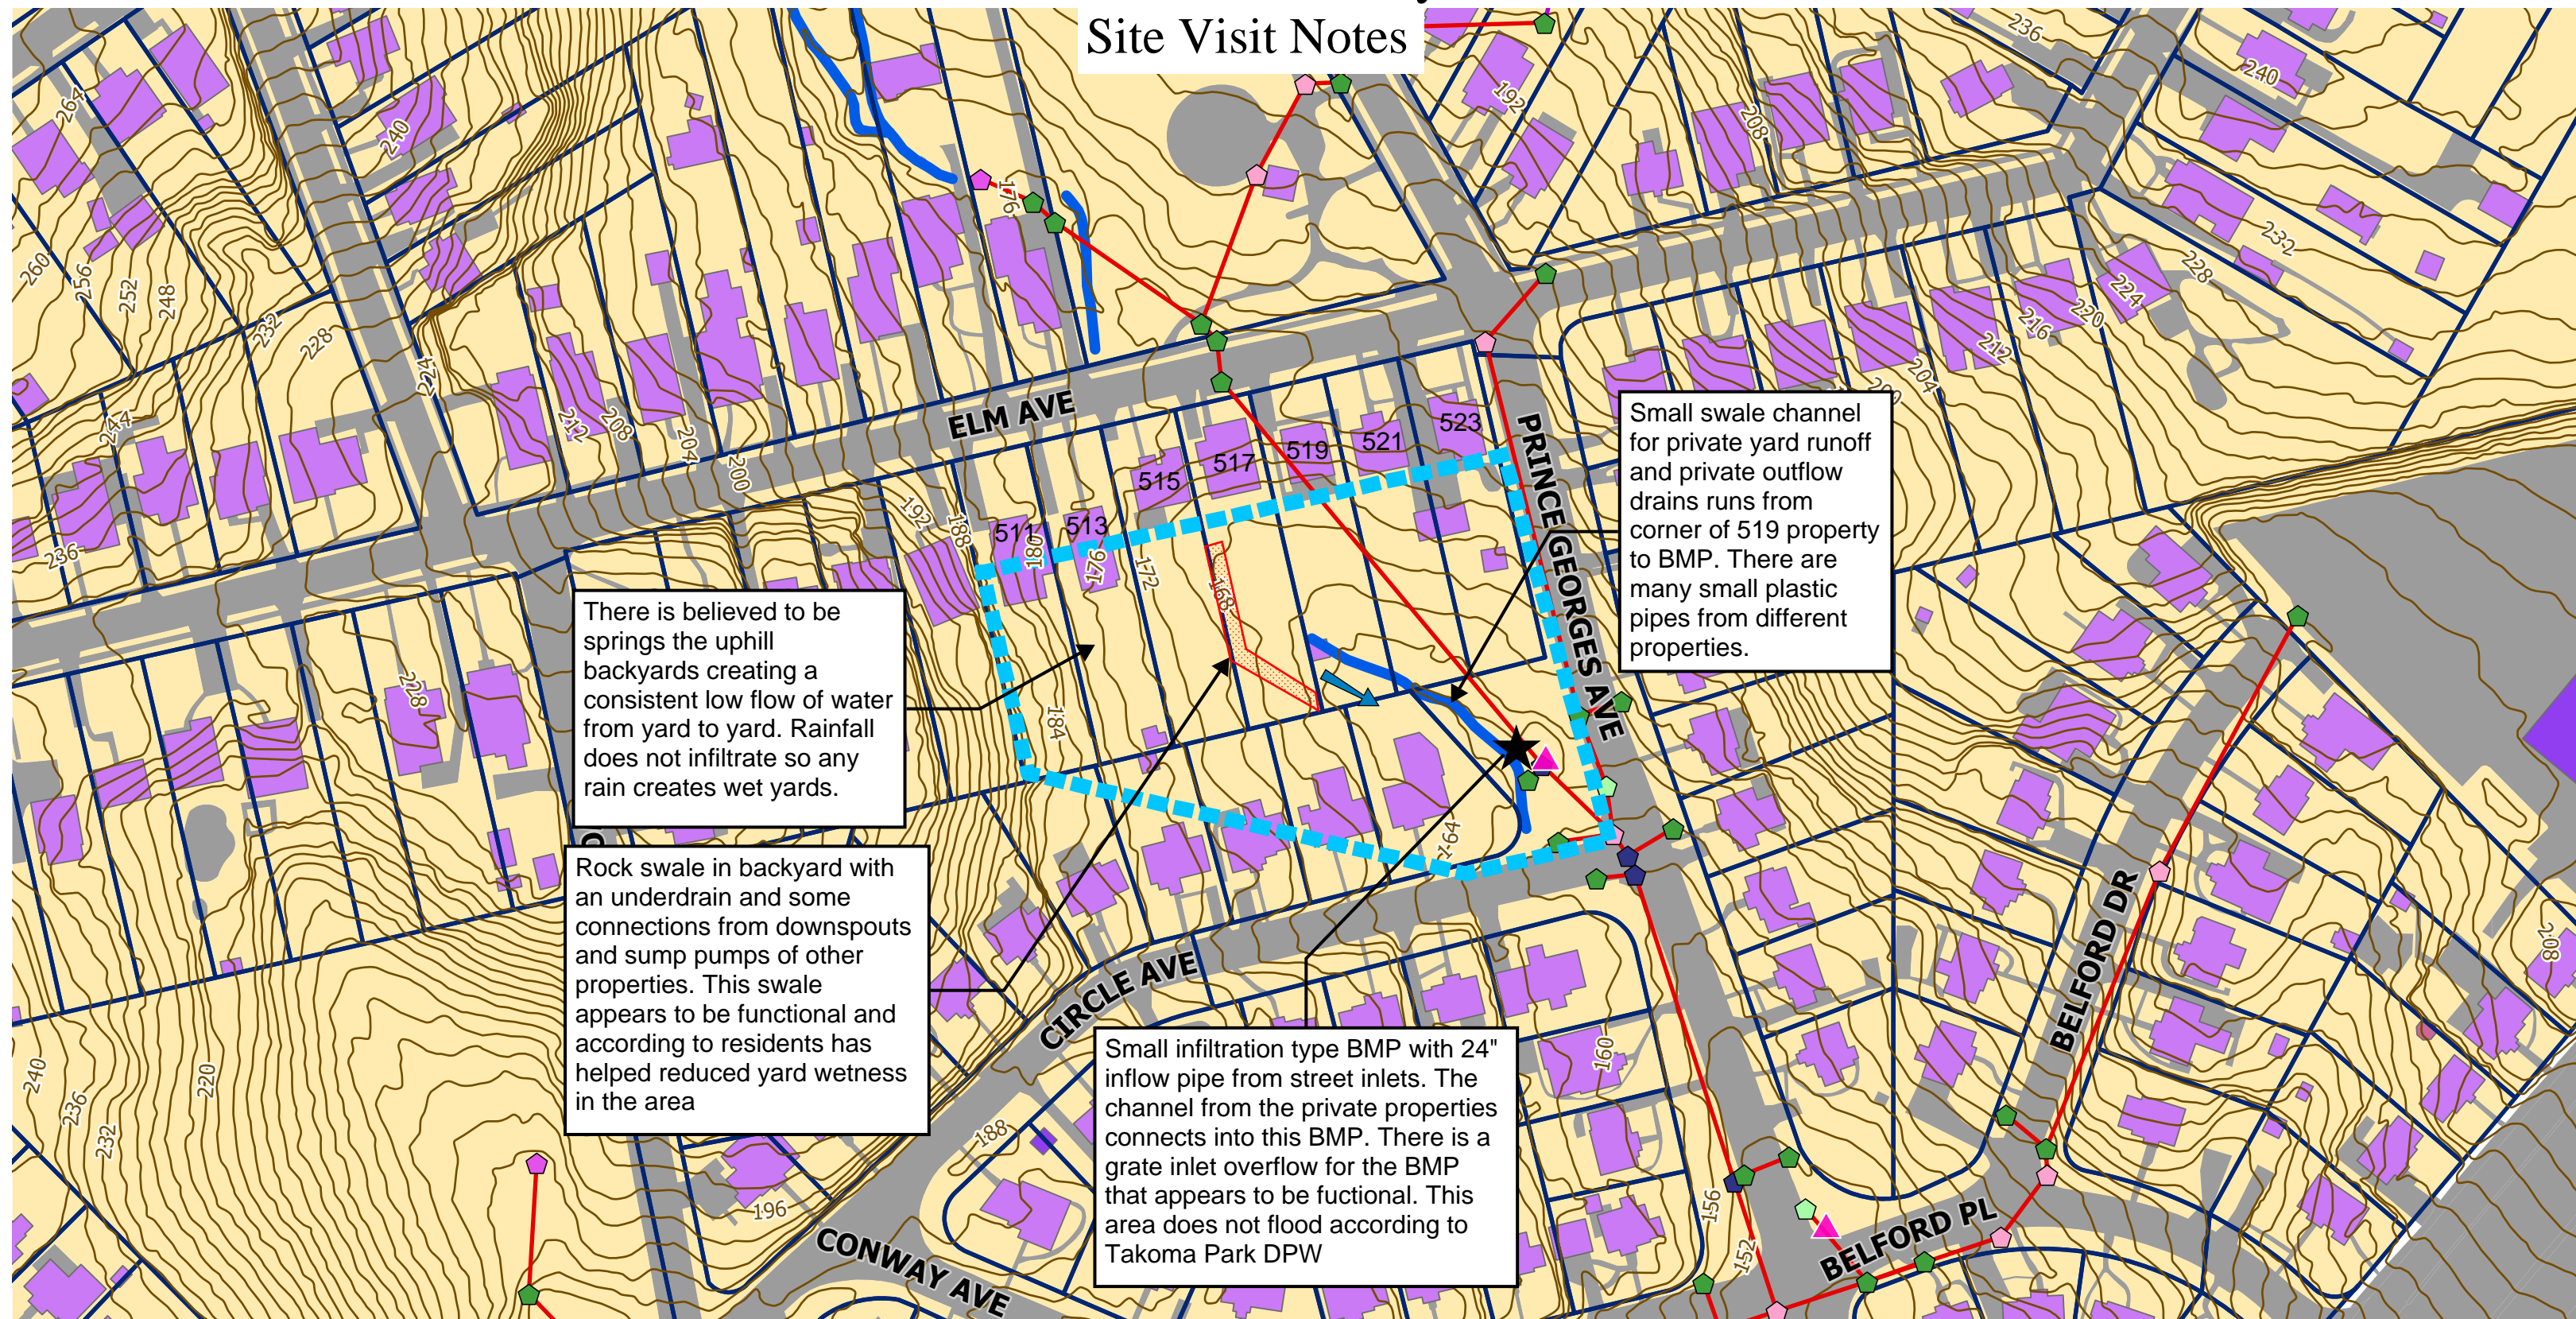
There is believed to be springs the uphill backyards creating a consistent low flow of water from yard to yard. Rainfall does not infiltrate so any rain creates wet yards.

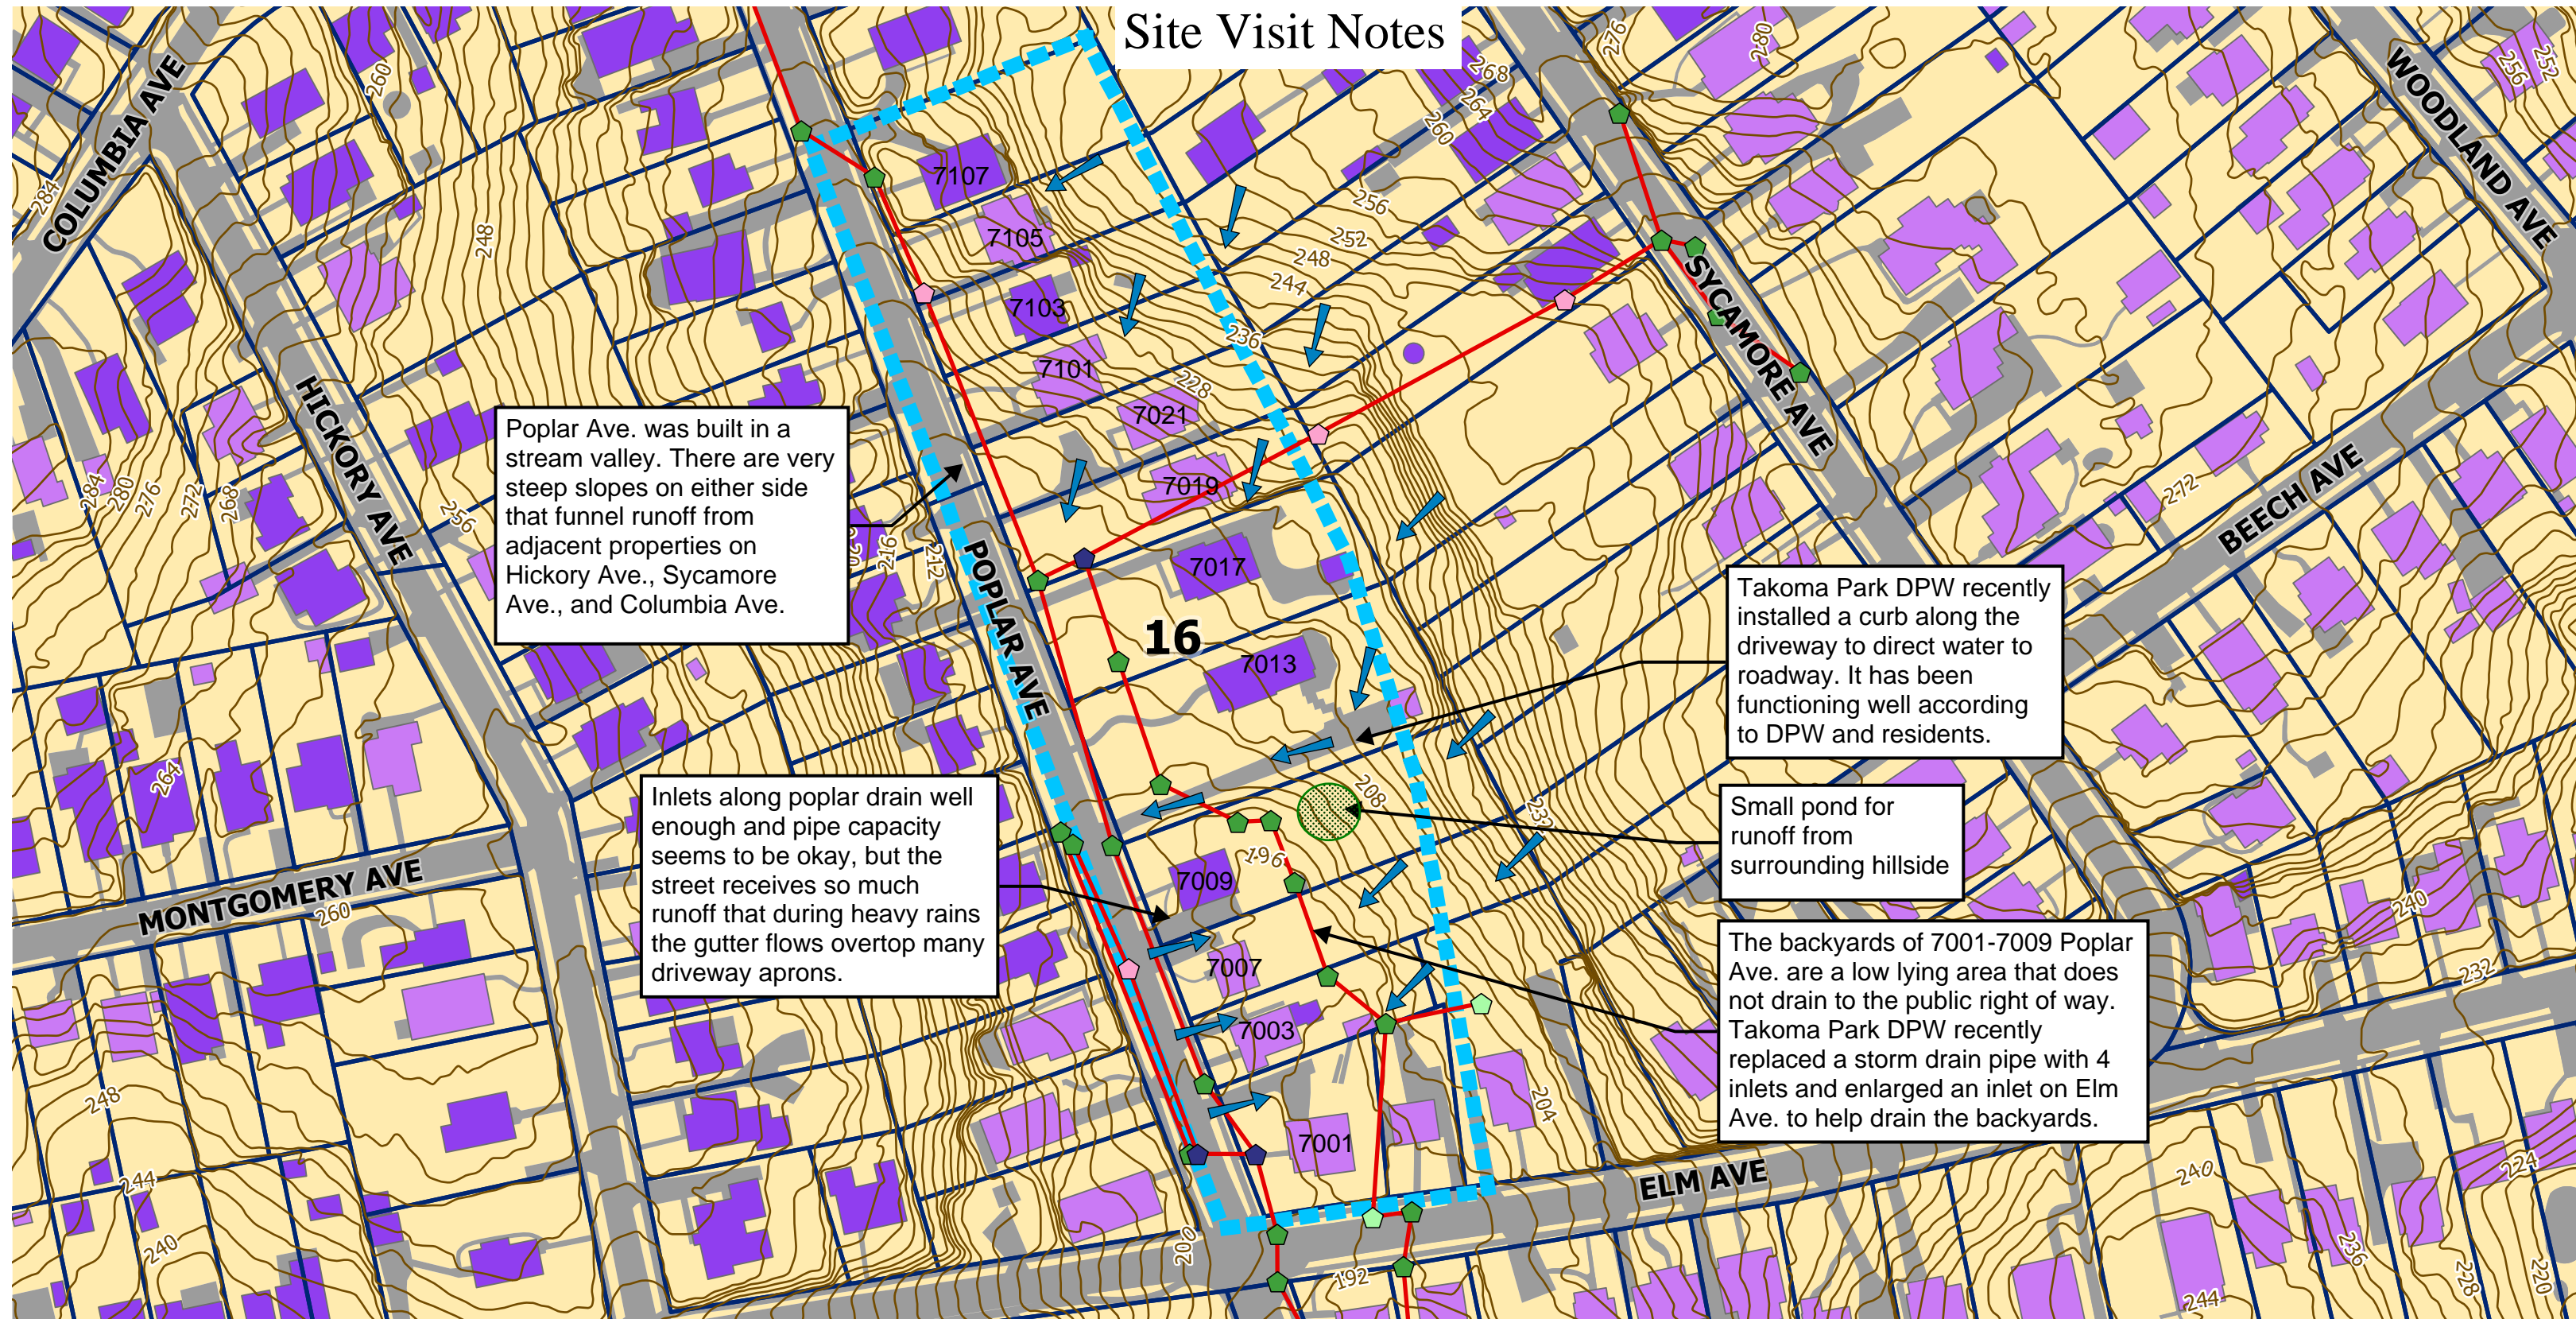
Poplar Ave. was built in a stream valley. There are very steep slopes on either side that funnel runoff from adjacent properties on Hickory Ave., Sycamore Ave., and Columbia Ave.

Takoma Park DPW should elevate sidewalks, curbs, and driveway aprons to limit roadway stormwater flow onto residential properties. Additionally, inlets along the south end of the block should be enlarged as appropriate to increase drainage of the road.

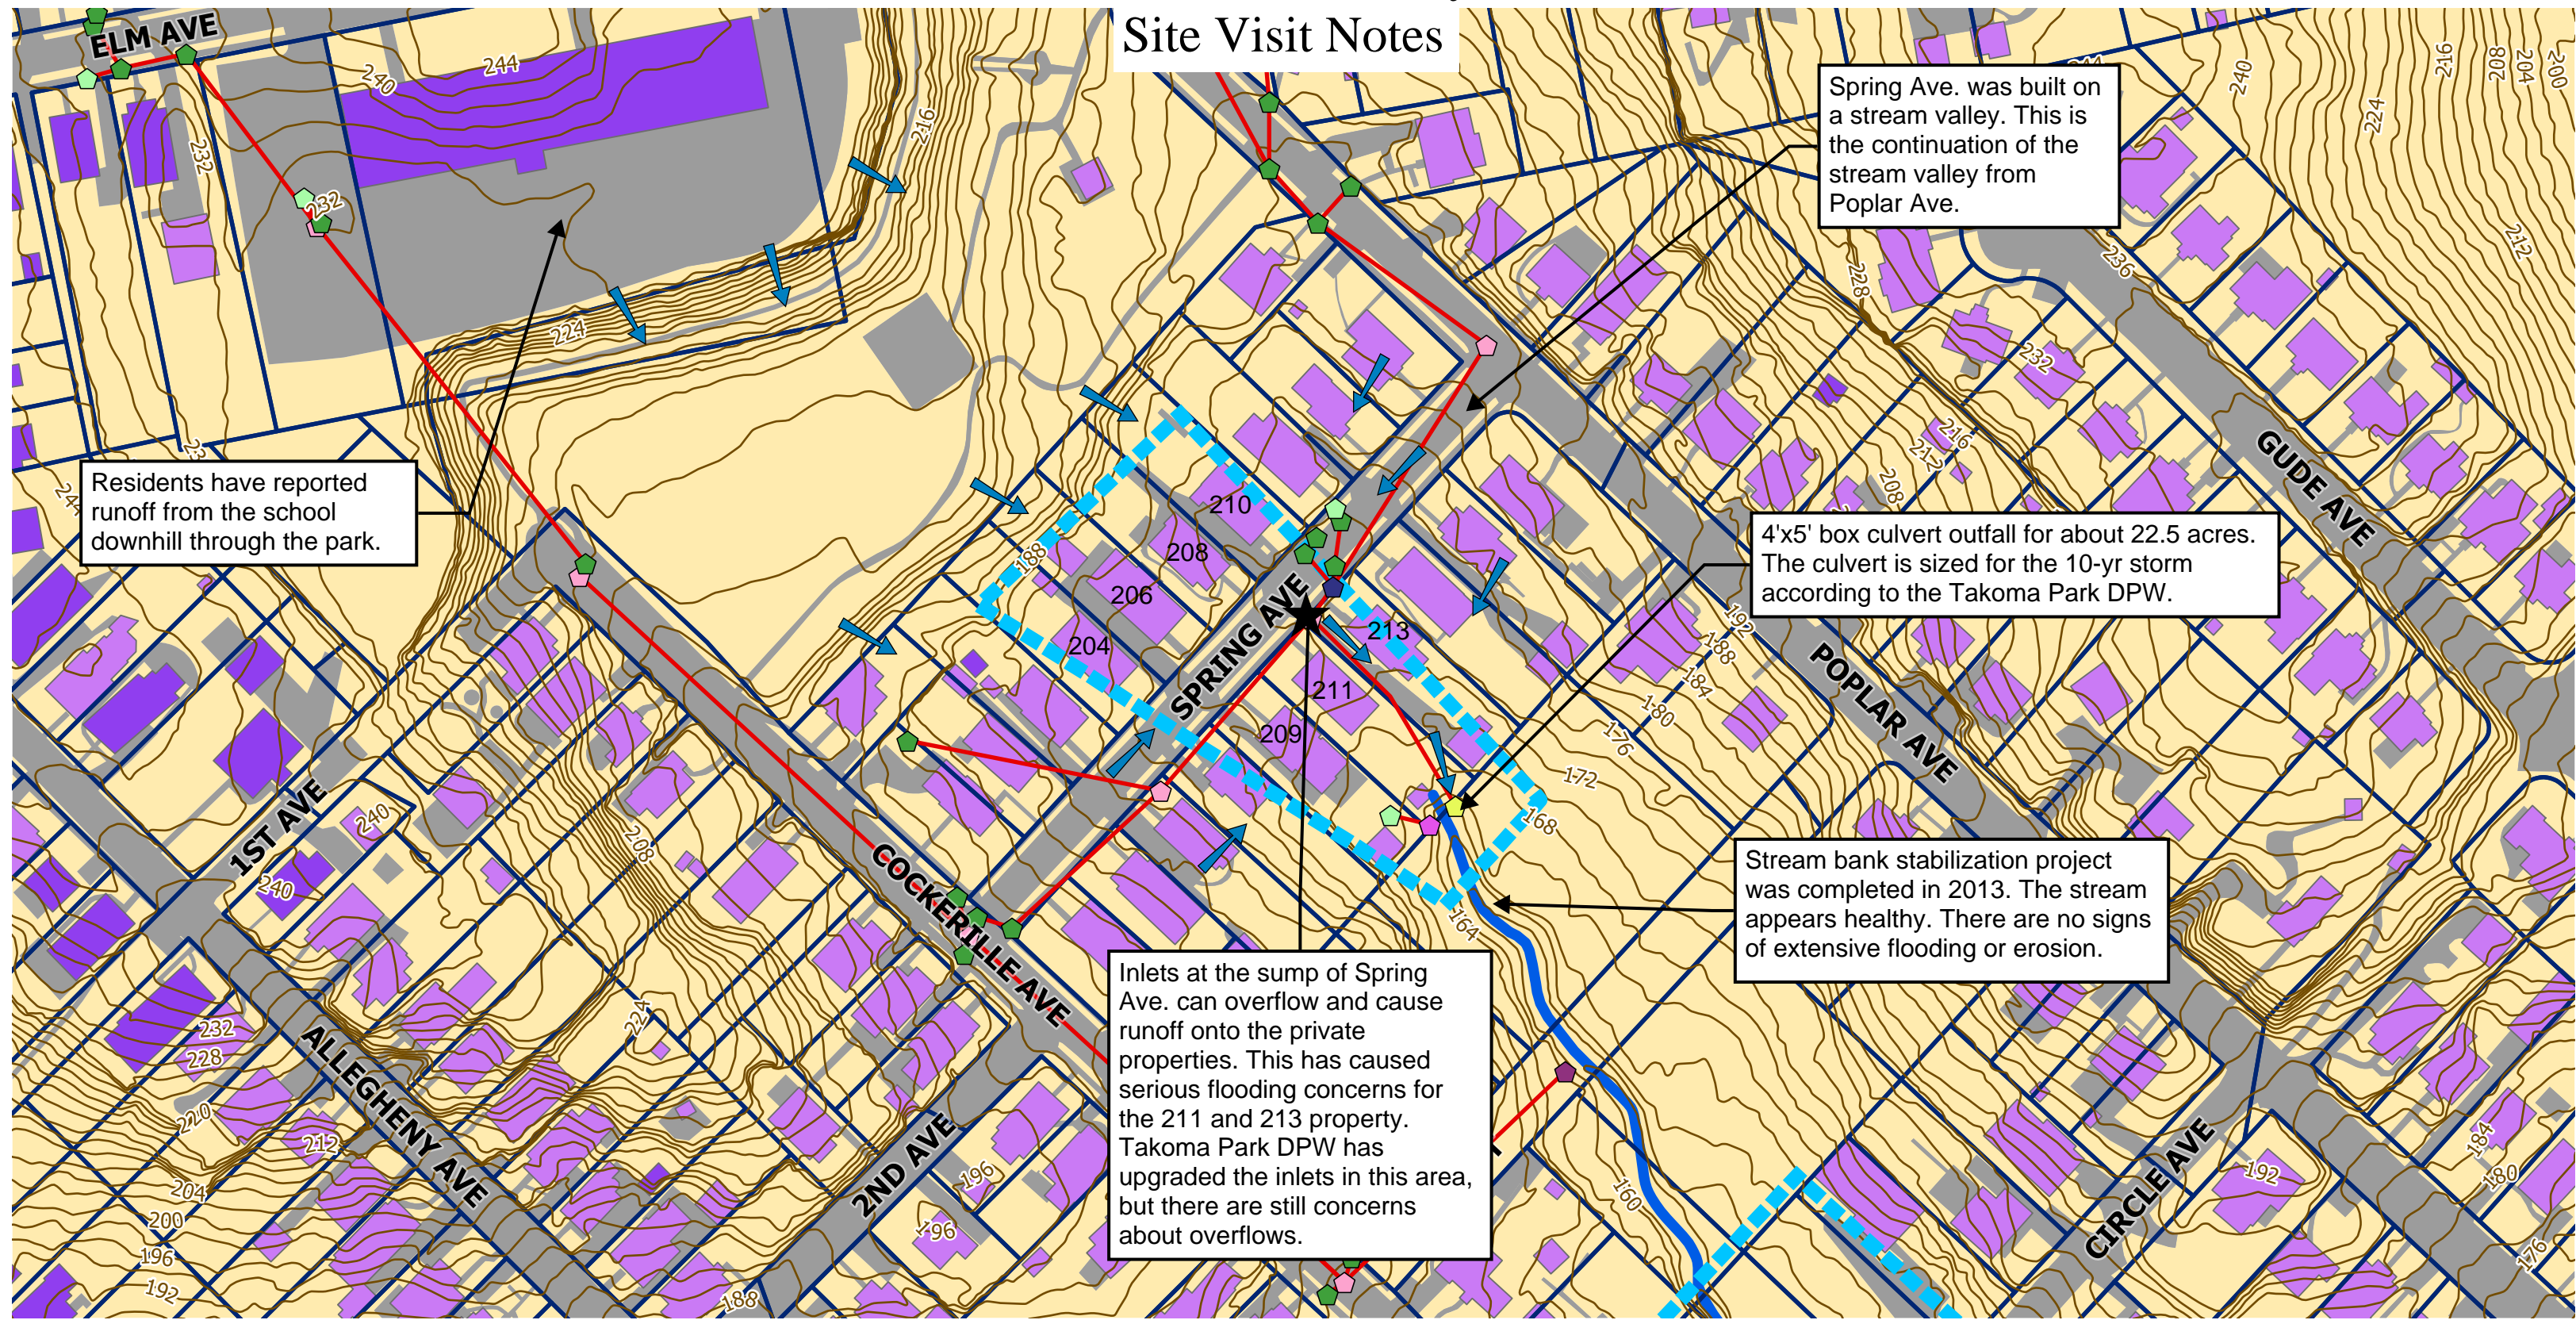
Residents have reported runoff from the school downhill through the park.

Takoma Park DPW may consider a drainage improvement project along Poplar Ave. to reduce runoff downhill to Spring Ave. Refer to Project #2 in Appendix A for details.

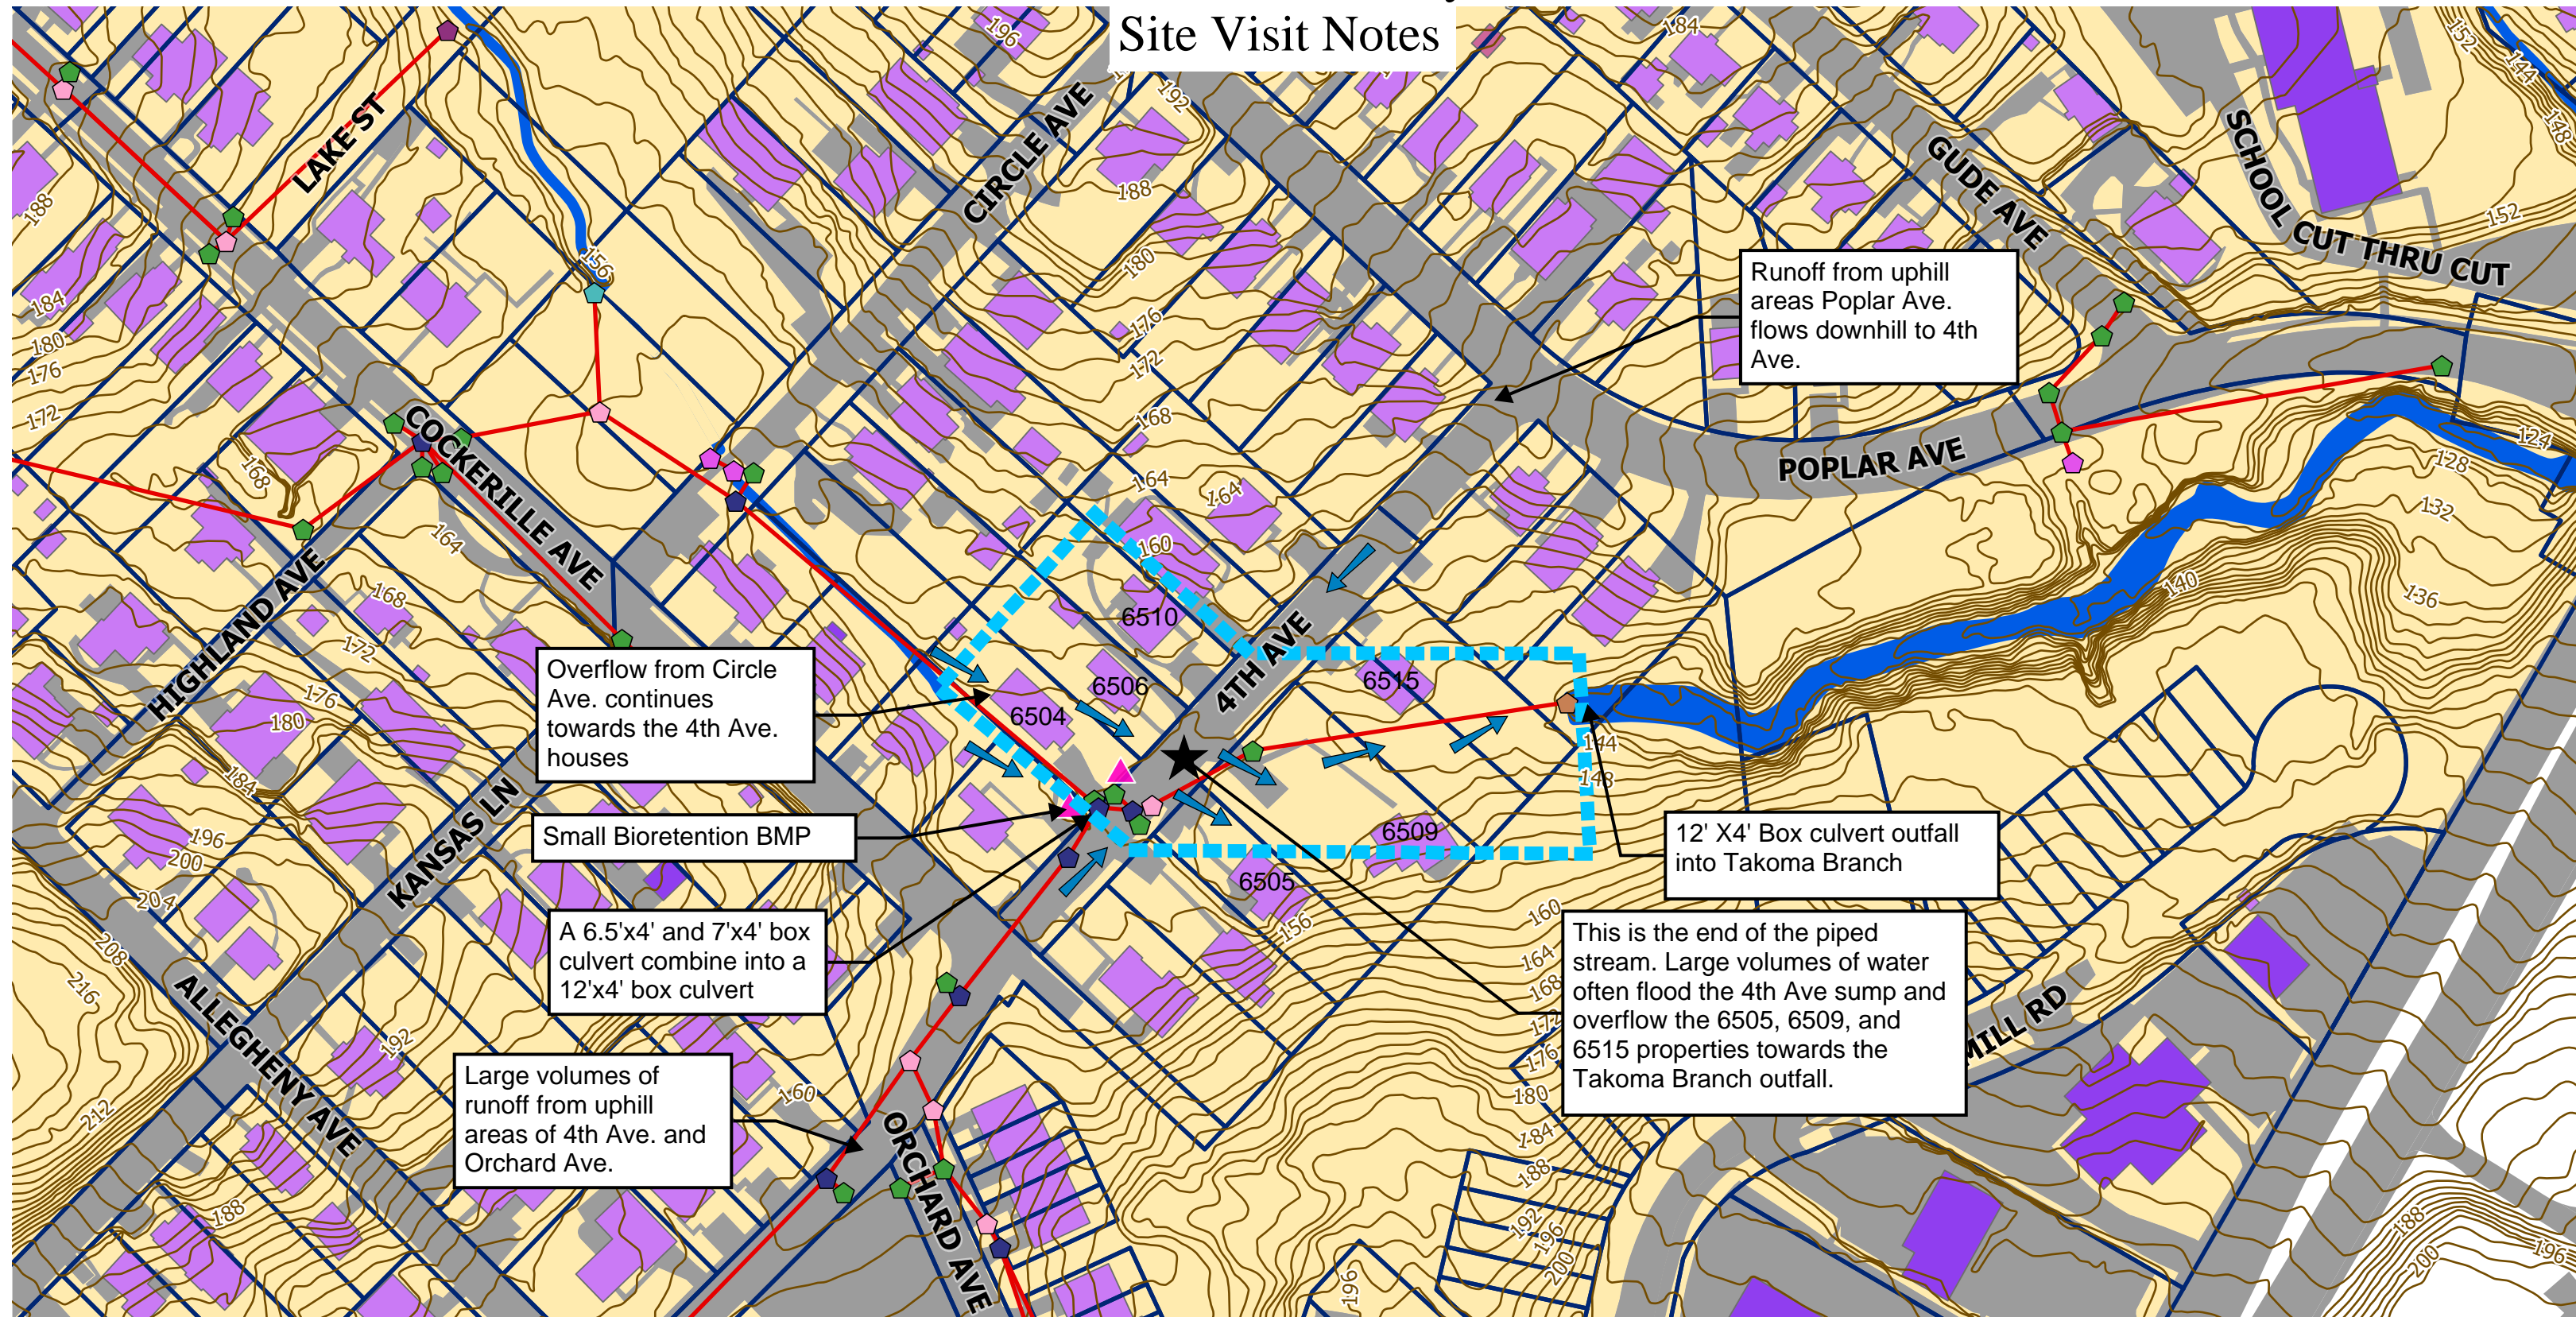
Runoff from uphill areas Poplar Ave. flows downhill to 4th Ave.

Takoma Park DPW may consider an inlet improvement project in this area. Refer to Project #4 in Appendix A for details.
