TAKOMA PARK STORMWATER RESILIENCY STUDY

Study Area Investigation

Takoma Park Study Area 14

Site Visit Notes

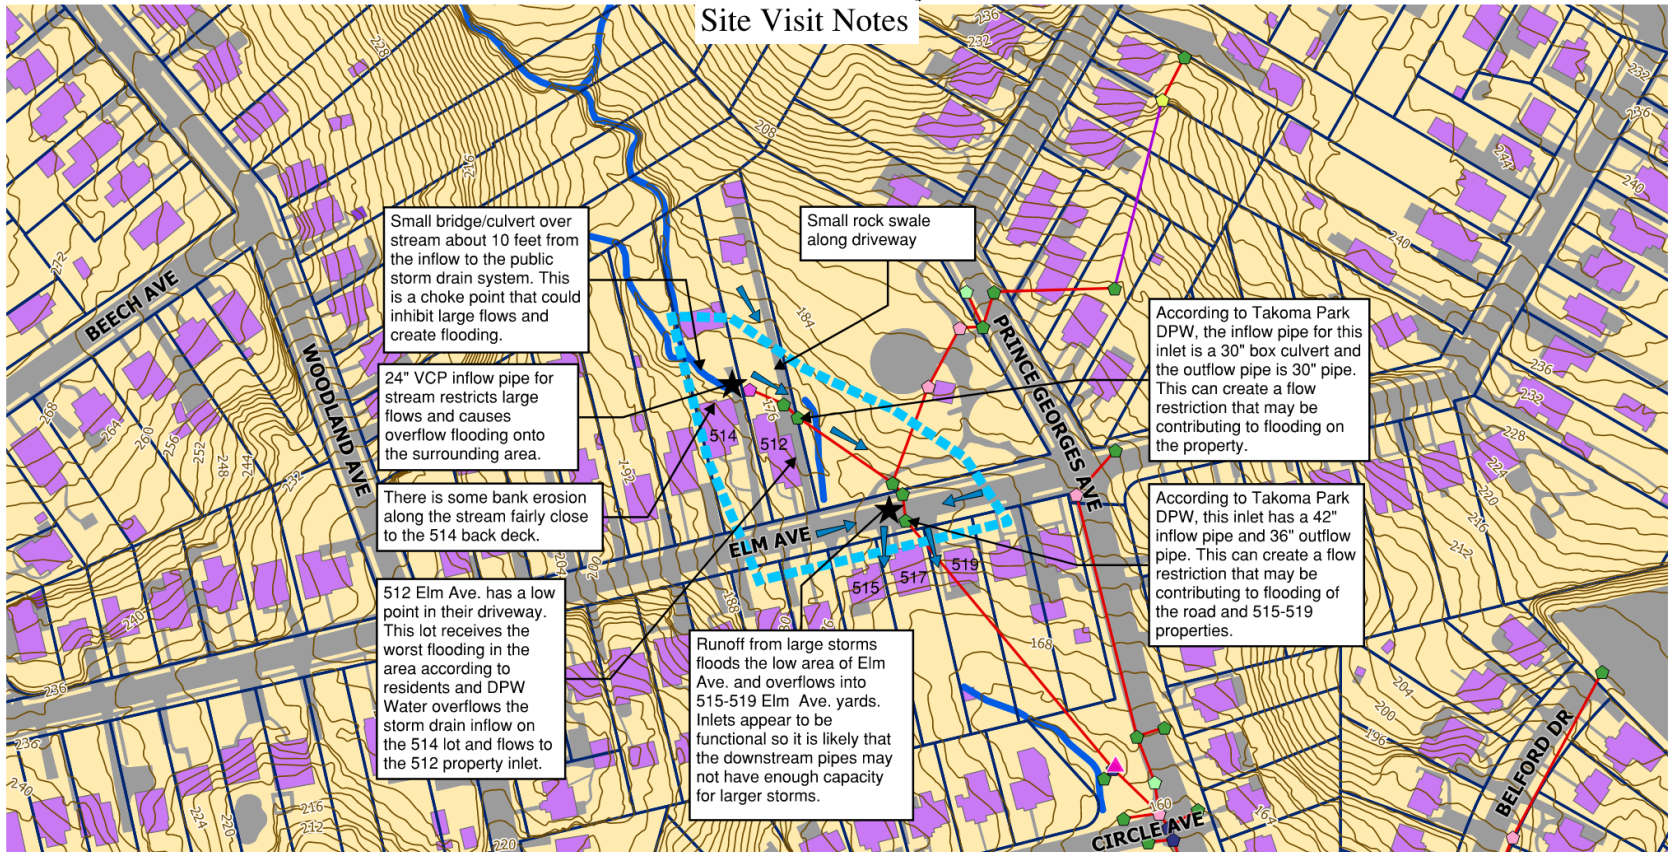
Small bridge/culvert over stream about 10 feet from the inflow to the public storm drain system. This is a choke point that could inhibit large flows and create flooding.

24" VCP inflow pipe for stream restricts large flows and causes overflow flooding onto the surrounding area.

There is some bank erosion along the stream fairly close to the 514 back deck.

512 Elm Ave. has a low point in their driveway. This lot receives the worst flooding in the area according to residents and DPW. Water overflows the storm drain inflow on the 514 lot and flows to the 512 property inlet.

Small rock swale along driveway

Runoff from large storms floods the low area of Elm Ave. and overflows into 515-519 Elm Ave. yards. Inlets appear to be functional so it is likely that the downstream pipes may not have enough capacity for larger storms.

According to Takoma Park DPW, the inflow pipe for this inlet is a 30" box culvert and the outflow pipe is 30" pipe. This can create a flow restriction that may be contributing to flooding on the property.

According to Takoma Park DPW, this inlet has a 42" inflow pipe and 36" outflow pipe. This can create a flow restriction that may be contributing to flooding of the road and 515-519 properties.

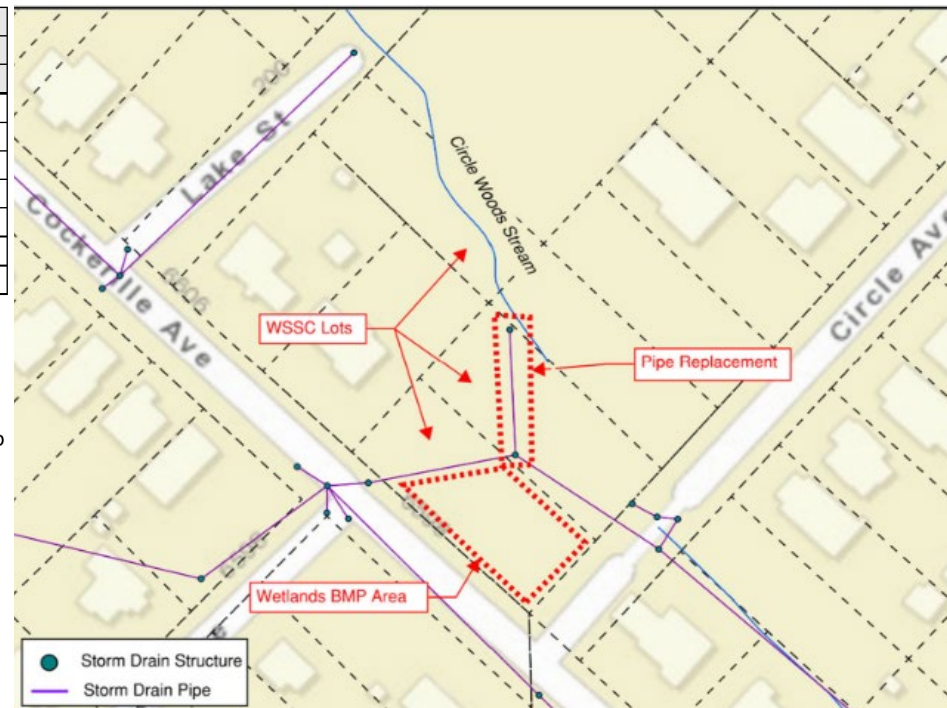
PROJECT #1: CIRCLE WOODS

- The Circle Woods stream overflows the 48" inflow pipe during large storm events. This has led to substantial surface flooding of the surrounding residential properties, Circle Avenue, and downhill Cockerille Avenue properties. Takoma DPW has taken action to limit flooding by installing a high curb along Circle Avenue and a small culvert under the Circle Avenue asphalt path. These measures have been effective in limiting excessive downhill flooding; however, the area directly around the stream inflow still experiences flooding when stream levels rise. LID Center's preliminary stormwater modeling results suggest the stream inflow pipe could benefit from an increased capacity. The pipes in this area are on undeveloped WSSC lots with a large open grass area. WSSC plans to sell their properties in this area and the City has notified WSSC of their interest in acquiring the lots.

- Purchase the WSSC lots if feasible and use the area for stormwater management. Replace the 48" pipe stream inflow with a large box culvert at least 6' wide and 4' high. The culvert will allow for increased capacity and decreased head losses as the stream enters the pipe system. A more detailed hydrologic and storm drain analysis will be required as part of the design.

- Design and install a large wetlands BMP in the open grass area. The BMP will store stormwater runoff thereby reducing overland flooding and peak flows in the storm drain system. The wetlands system will also filter stormwater pollutants and provide impervious area restoration credits towards the City's NPDES permit requirements. The BMP may be designed to take runoff from the road and/or divert flow from the nearby storm drain culverts. A detailed engineering assessment will be required to determine the size and configuration of this facility.
