City of Takoma Park Department of Public Works

# Takoma Park Source ID and Elimination Recommendations

### June 2021

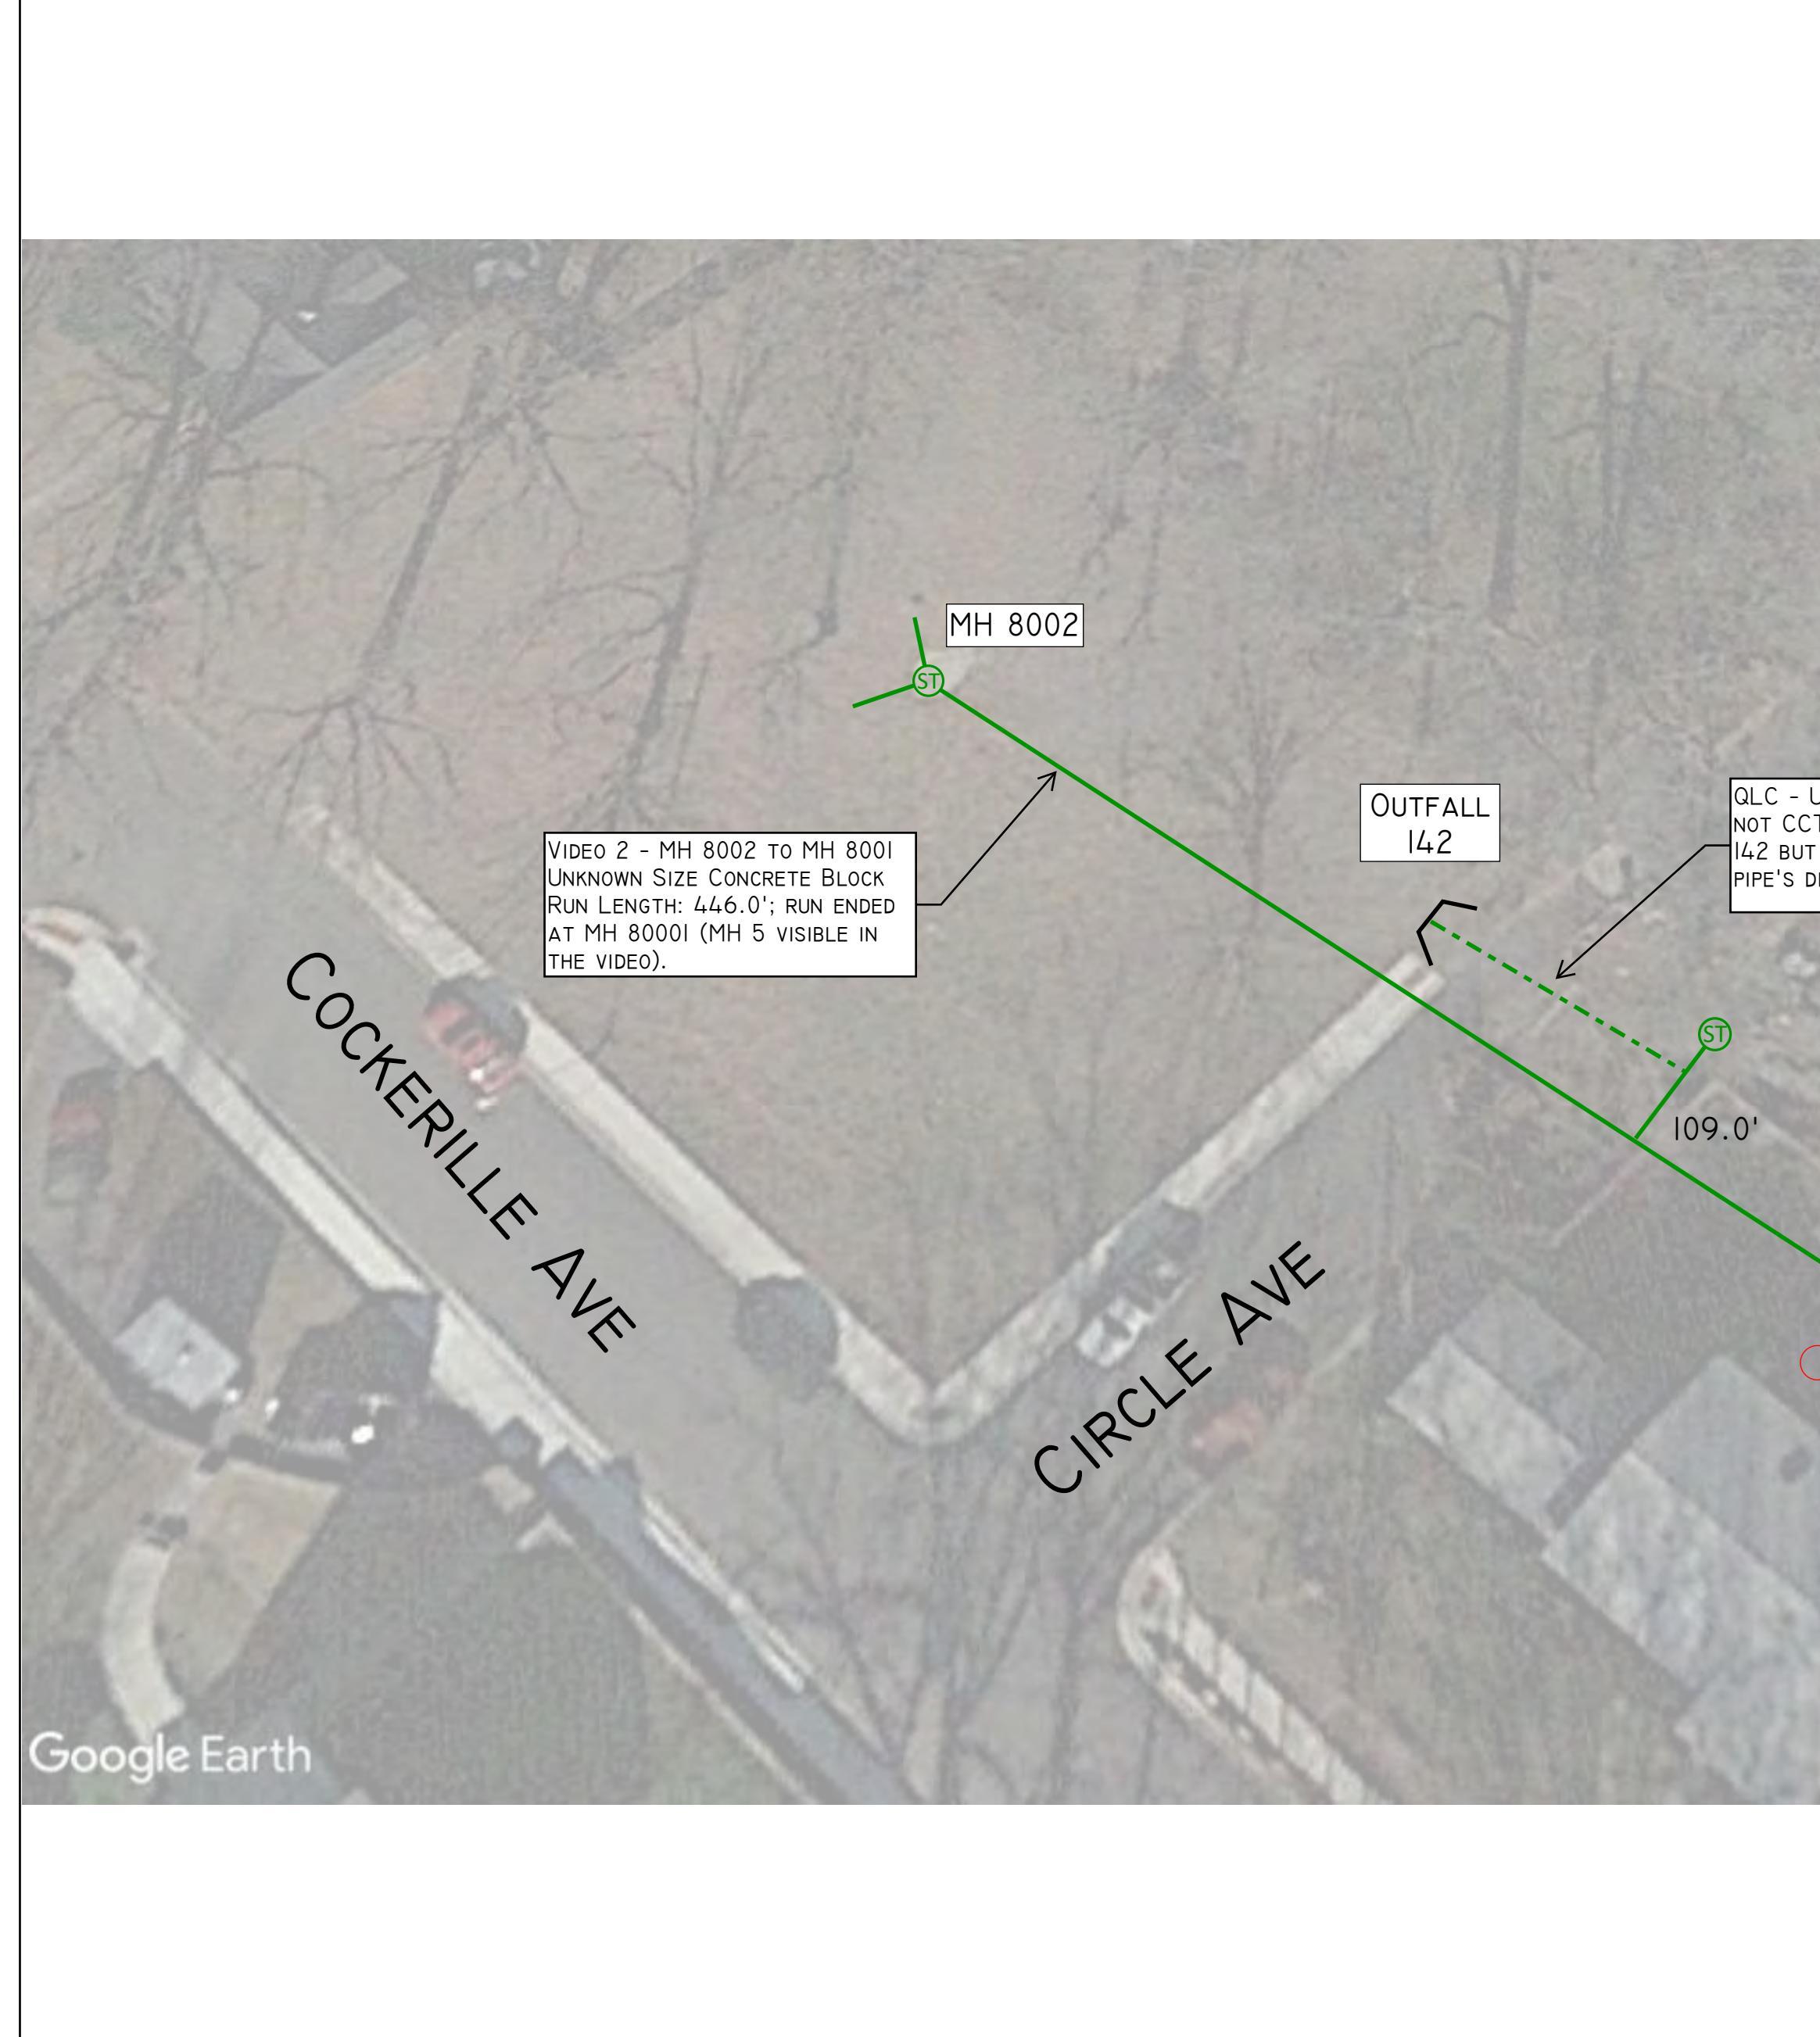
154.0'	Unknown tie-in at 12 o'clock at 154'		CLARIFICATIONS   ALL FIELD SKETCHES ARE NOT TO SCALE   AND ARE FOR RELATIVE LOCATION PURPOSES   ONLY. SOFTDIG EXERCISES ITS BEST   PROFESSIONAL EXPERTISE & GEOPHYSICAL   PROFESSIONAL EXPERTISE MARKED CONSTITUTE   ALL UTILITIES WITHIN THE PROJECT AREA. PRIOR   TO ACTUAL CONSTRUCTION, UTILITIES MUST BE   SUBSURFACE LOCATED BY SOFTDIG AT   POTENTIAL CONFLICT POINTS TO AVOID   PROFENTIAL CONFLICT POINTS TO
		N	OTILITIES WITHIN THE TROGECT LIMITS. ALL   UTILITIES SHOWN AS QL-B EXCEPT AS NOTED.   QUALITY LEVEL C: INFORMATION OBTAINED BY   SURVEYING AND PLOTTING VISIBLE ABOVE-   GROUND UTILITY FEATURES AND BY USING   PROFESSIONAL JUDGEMENT IN CORRELATING   THIS INFORMATION TO QUALITY LEVEL D   INFORMATION.   UTILITIES DESIGNATED AS QL-C ARE   REPRESENTED BY DASHED LINES. THESE MAY NOT   HAVE CORRESPONDING FIELD MARKS. DEPTH   READINGS SHOWN ARE ESTIMATIONS ONLY. THIS   INFORMATION IS NOT GUARANTEED AND IS NOT TO   BE USED FOR DESIGN OR BASIS FOR   CONSTRUCTION. CLIENTS RELYING ON   INSTRUMENT READINGS DO SO AT THEIR OWN   RISK. TRUE DEPTH IS ONLY OBTAINED BY   EXPOSING THE UTILITY.   QUALITY LEVEL D: INFORMATION DERIVED FROM
