TAKOMA PARK STORMWATER RESILIENCY STUDY

Takoma Park Study Area 14

Recommendations

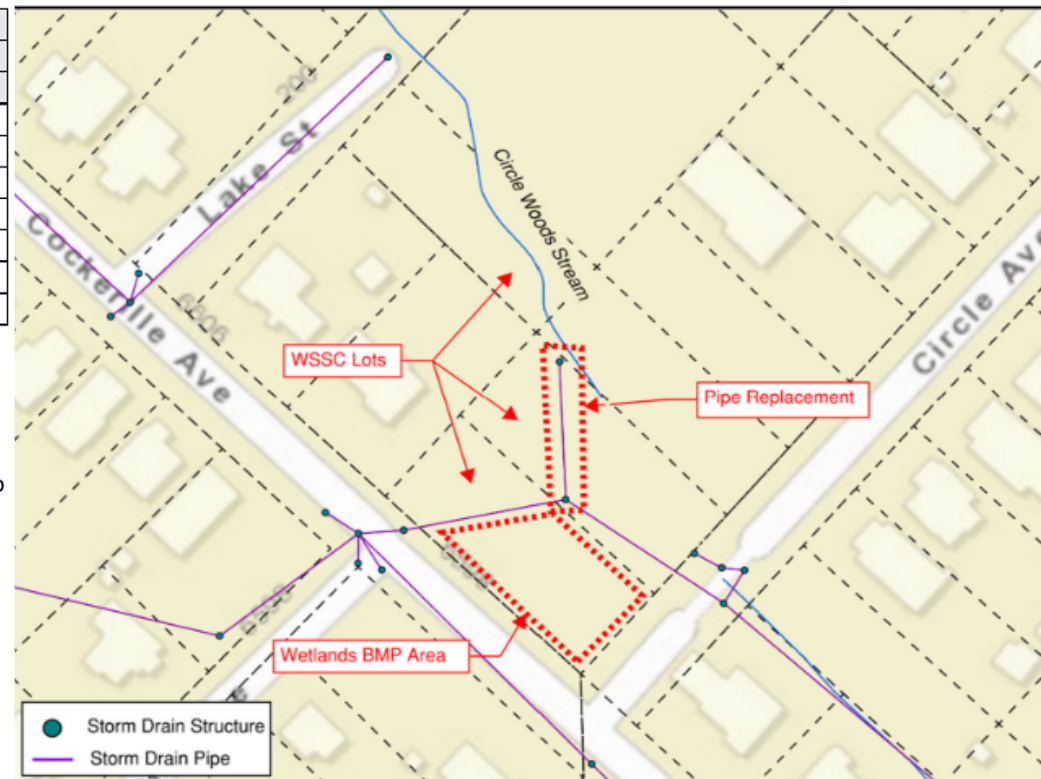
PROJECT #1: CIRCLE WOODS

- The Circle Woods stream overflows the 48" inflow pipe during large storm events. This has led to substantial surface flooding of the surrounding residential properties, Circle Avenue, and downhill Cockerille Avenue properties. Takoma DPW has taken action to limit flooding by installing a high curb along Circle Avenue and a small culvert under the Circle Avenue asphalt path. These measures have been effective in limiting excessive downhill flooding; however, the area directly around the stream inflow still experiences flooding when stream levels rise. LID Center's preliminary stormwater modeling results suggest the stream inflow pipe could benefit from an increased capacity. The pipes in this area are on undeveloped WSSC lots with a large open grass area. WSSC plans to sell their properties in this area and the City has notified WSSC of their interest in acquiring the lots.

- Purchase the WSSC lots if feasible and use the area for stormwater management. Replace the 48" pipe stream inflow with a large box culvert at least 6' wide and 4' high. The culvert will allow for increased capacity and decreased head losses as the stream enters the pipe system. A more detailed hydrologic and storm drain analysis will be required as part of the design.

- Design and install a large wetlands BMP in the open grass area. The BMP will store stormwater runoff thereby reducing overland flooding and peak flows in the storm drain system. The wetlands system will also filter stormwater pollutants and provide impervious area restoration credits towards the City's NPDES permit requirements. The BMP may be designed to take runoff from the road and/or divert flow from the nearby storm drain culverts. A detailed engineering assessment will be required to determine the size and configuration of this facility.

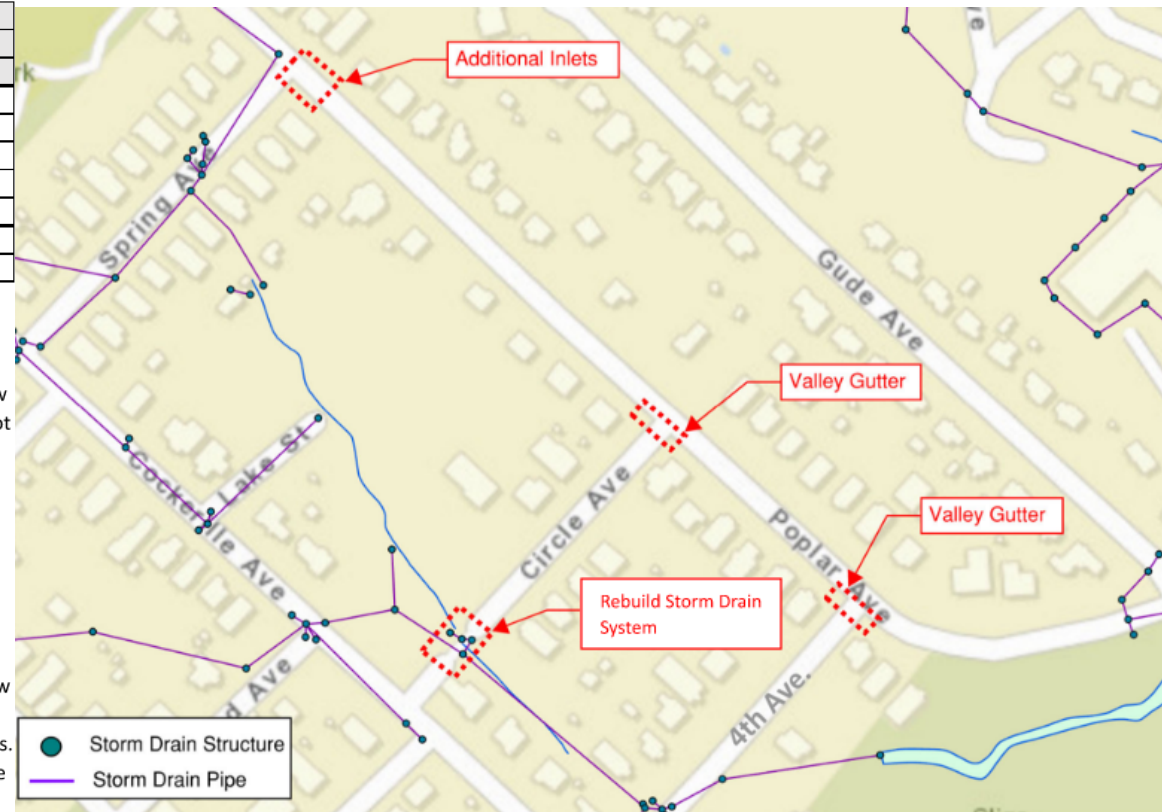
PROJECT #2: CIRCLE AVE. & POPLAR

- The low points of Spring Avenue, Circle Avenue, and 4th Avenue often flood during large storm events. Stormwater runoff from Poplar Avenue flows downhill onto each of the three roads. The low point of Circle Avenue floods from surrounding stream overflow and roadway runoff. Water does not easily drain into the small inlet and runoff often flows onto the residential lots downhill. At the low point of Spring Avenue and 4th Avenue stormwater can overflow the inlets and pond in the road, occasionally causing overflow onto the adjacent residential properties. Takoma DPW has recently upgraded inlets on Spring Avenue to improve drainage and plans to upgrade inlets on 4th Avenue as well.

- Rebuild the drainage infrastructure at the low point of Circle Avenue. Remove the small culvert under the asphalt walkway and abandon the small inlet behind the asphalt path and close the inflow curb cut to it. Install inlets on either side of the dead end and in the adjacent grass area and install pipes to connect all inlets. Adjust road grades and curbs as needed to facilitate drainage to the inlets. The abandoned inlet may be able to be converted to a manhole type structure for connection to the existing culvert. If this is not feasible, install a new field connection from the inlets to the culvert. Modify the driveway apron grades along Circle Avenue as needed to keep stormwater flow in the roadway. An engineer should be consulted in the drainage redesign efforts.

- Install valley gutters along Poplar Avenue across the Circle Avenue and 4th Avenue intersections to redirect flow towards the outfall further east on Poplar Avenue. Enlarge the inlet on Poplar Avenue as needed. Proceed with plans to upgrade the inlets at the low point of 4th Avenue. Install a pair of curb inlets on the east side of the intersection of Spring Avenue and Poplar Avenue and connect into the nearby manhole. The inlets will intercept runoff that currently flows down to Spring Avenue. This will reduce ponding at the low point of Spring Avenue during large storm events. A hydrologic analysis will be needed to confirm the pipes in this area have capacity for the additional stormwater flow from the new inlets.

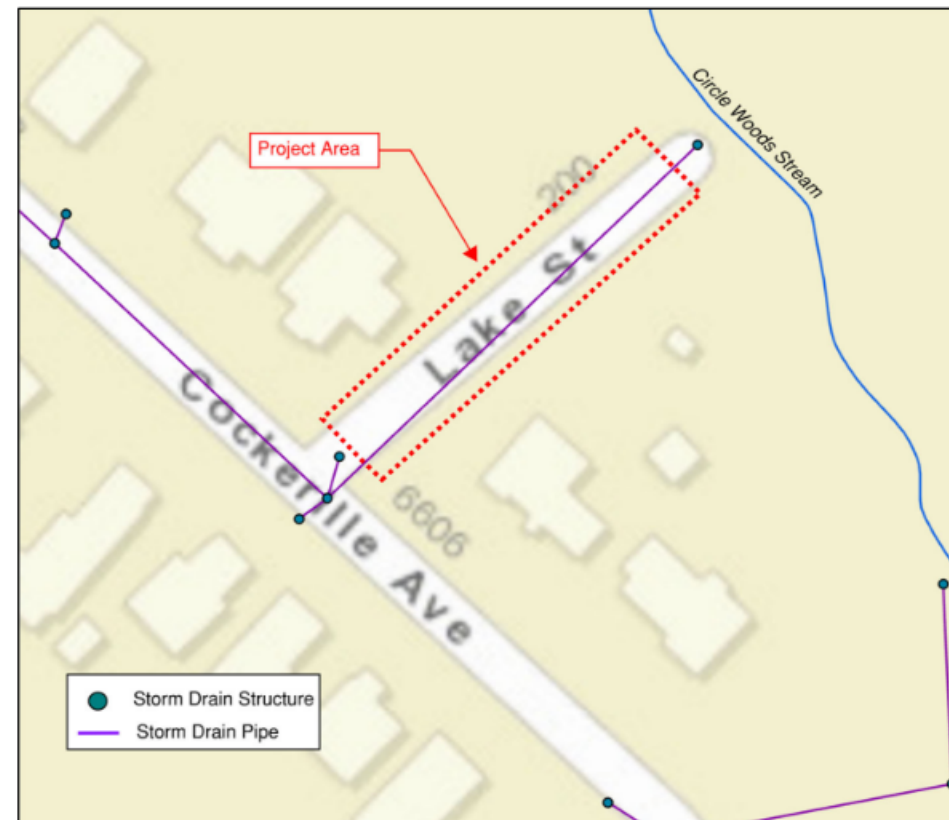
PROJECT #3: LAKE STREET BMP

- The stormwater outflow from the Lake Street outfall contributes to flooding downstream at the stream inflow point and along Circle Avenue and 4th Avenue. Lake Street is a publicly owned paper street with open space to install flood control infrastructure.

- Design and install a surface BMP in conjunction with an underground peak flow attenuation system adjacent to the Lake Street storm main. The storage system will alleviate peak flows in the downstream storm drain system while the BMP will provide a water quality benefit as well as a modest storage benefit. A detailed engineering assessment will be required to determine the size and configuration of each facility.

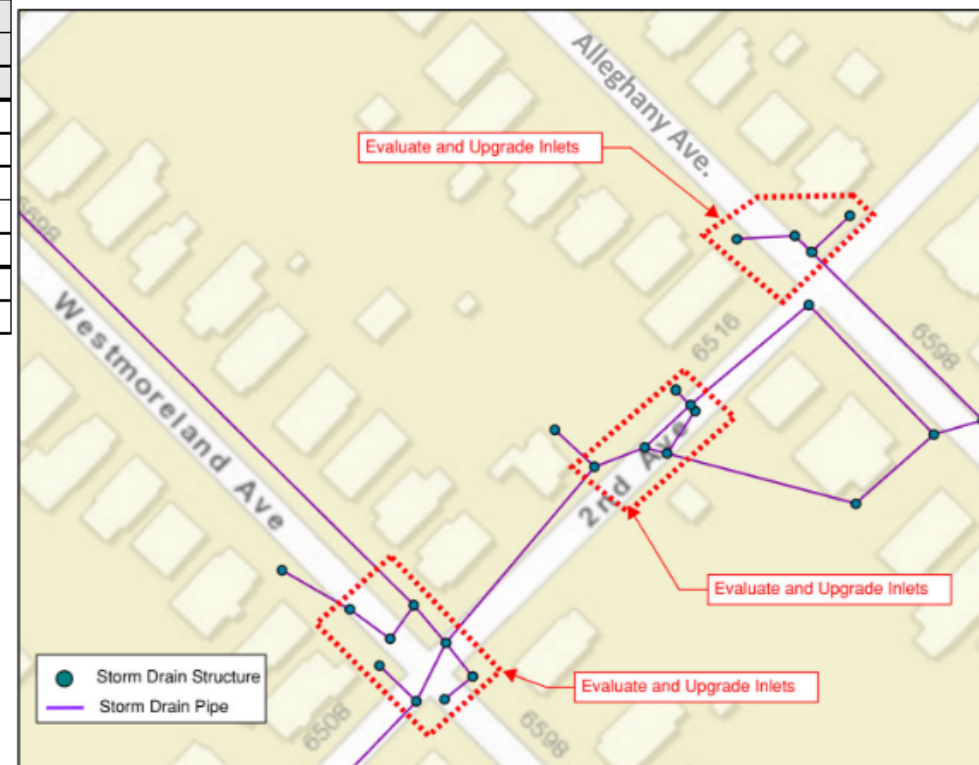
PROJECT #4: 2ND AVENUE INLET

- The low point of 2nd Avenue between Alleghany Avenue and Westmoreland Avenue floods during large storms. Water has ponded multiple feet and caused traffic hazards. There is an old 48" storm main that goes through private property near a house. Takoma DPW has installed a 24" public pipe and a weir wall in the inlet structure that the two pipes outflow from in order to divert flow away from the 48" pipe under private property.

- Evaluate all existing inlets at the Westmoreland Avenue and Alleghany Avenue intersections to ensure they are properly capturing water to limit runoff downhill to 2nd Avenue. Upgrade any inlets that do not provide sufficient drainage. Modify the weir wall in the inlet on 2nd Avenue to allow increased flow into the 48" pipe through private property. This will increase the capacity of the storm drain system in this area.

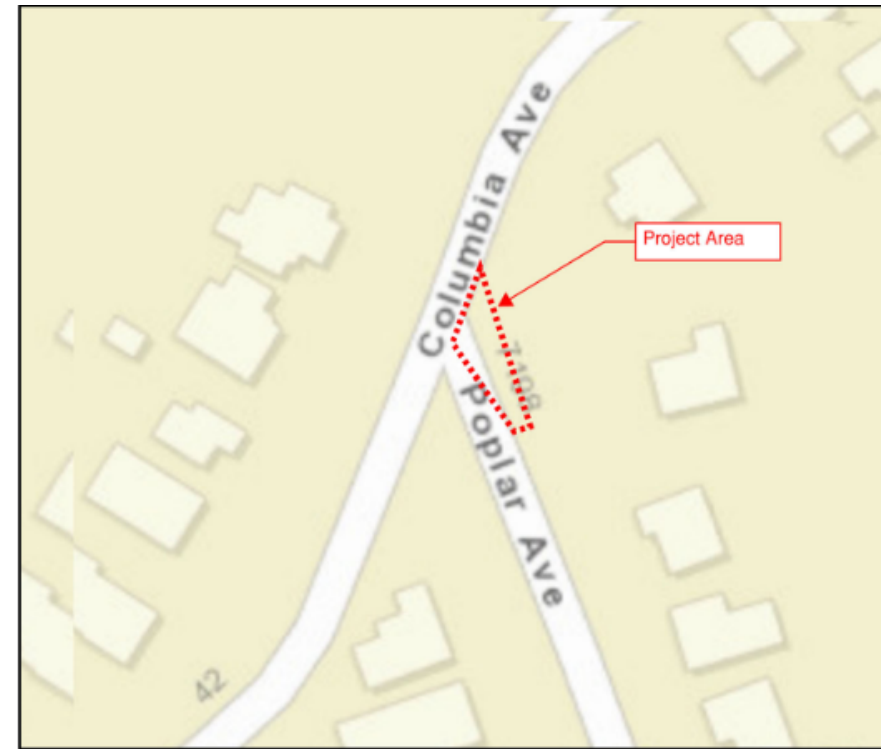
PROJECT #5: COLUMBIA & POPLAR BMP

- Stormwater runoff from Columbia Avenue collects at the intersection with Poplar Avenue and flows down the road. LID Center's preliminary stormwater modeling results suggest the storm drain pipes in this area may benefit from increased capacity. Takoma DPW has already successfully installed a bump-out bioretention BMP at the intersection. The large three-way intersection provides additional space for a BMP.

- Install a bump out filtration-type BMP at the intersection in conjunction with an underground peak flow attenuation system. A detailed engineering assessment will be required to determine the size and configuration of these facilities. A flow splitter device should be installed to direct runoff to the attenuation system only during peak flow events.

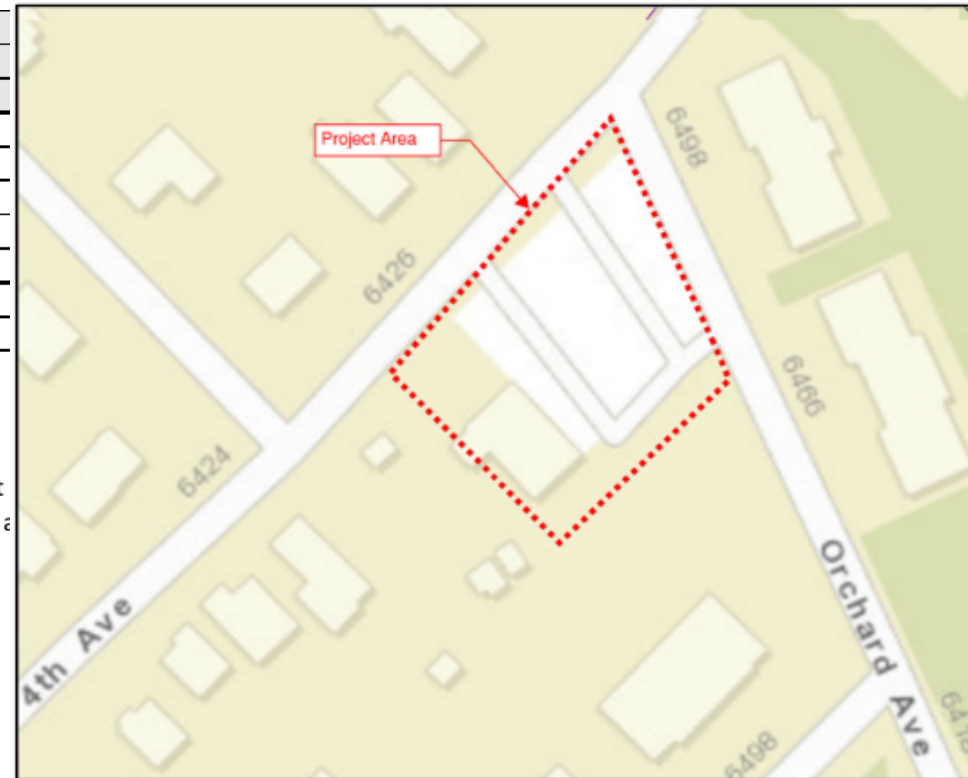
PROJECT #6: VFW PARKING LOT

- The VFW parking lot is a large impervious area near the bottom of the Takoma Branch watershed's stream valley. The lot produces a significant quantity of overland runoff. Field observations suggest that there could be bypass of the nearby curb inlets which would contribute to the flooding issues at the 4th Avenue low lying area.

- Engage and partner with property owners to implement a green drainage improvement project. Install curbs and inlets around the parking lot to capture runoff. Regrade the asphalt as needed to redirect surface runoff. Install a filtration-type BMP such as a swale to provide a modest flood reduction and water quality benefit for the area. An underground peak flow attenuation system could also be used as an alternative to a surface BMP. An engineer should be consulted in the drainage and BMP design efforts.

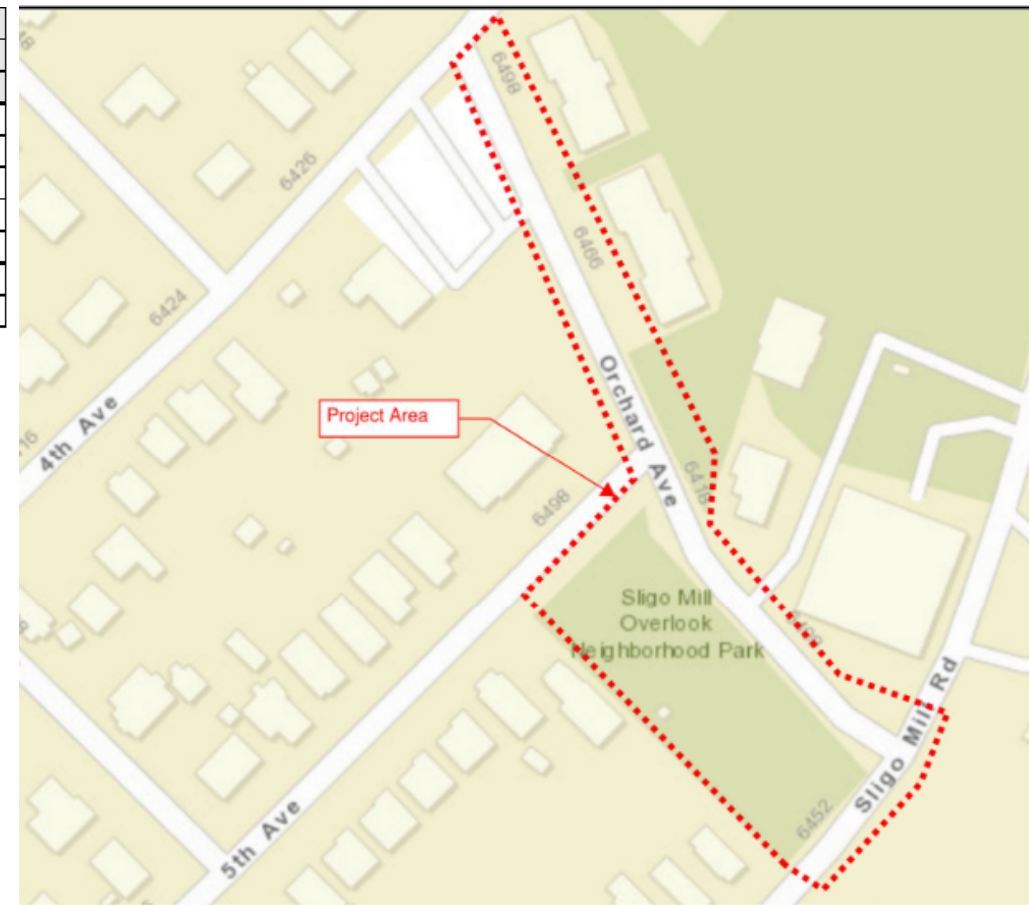
PROJECT #7: ORCHARD AVE.

- Orchard Avenue connects to 4th Avenue near the bottom of the Takoma Branch watershed's stream valley. At the uphill end of Orchard Avenue there are impervious commercial and industrial lots that are a significant source of the runoff down Orchard Avenue. There is minimal storm drain infrastructure in this area. LID Center's preliminary stormwater modeling results suggest the storm drain system in this area may benefit from increased capacity. Parallel to the Orchard Avenue storm main there is a 60" pipe for excess stormwater storage that has become defunct due to sediment infill. Takoma DPW has already begun renovating this area through the Sligo Mill Overlook Park redevelopment and there is more opportunity to uplift the area through adjacent green infrastructure and street beautification. A green street project will go together with the existing environmental motif of Sligo Mill Park's community garden and the Takoma Branch natural area.

- Design and install green infrastructure along Orchard Avenue and Sligo Mill Overlook Park. Multiple streetside and bump out filtration-type BMPs can be installed on the uphill end of Orchard Avenue to provide a modest flood reduction and water quality benefit. Storm drain inlets and pipes can be included with the BMPs to decrease runoff downhill and increase the capacity of the existing system. The existing 60" storage pipe should be fully cleaned and modified so that it can be used as a functional peak flow attenuation system. A pretreatment system can be installed to limit sediment inflow to the pipe. Street beautification including tree plantings and landscaping can also be installed where feasible in order to provide community aesthetics.

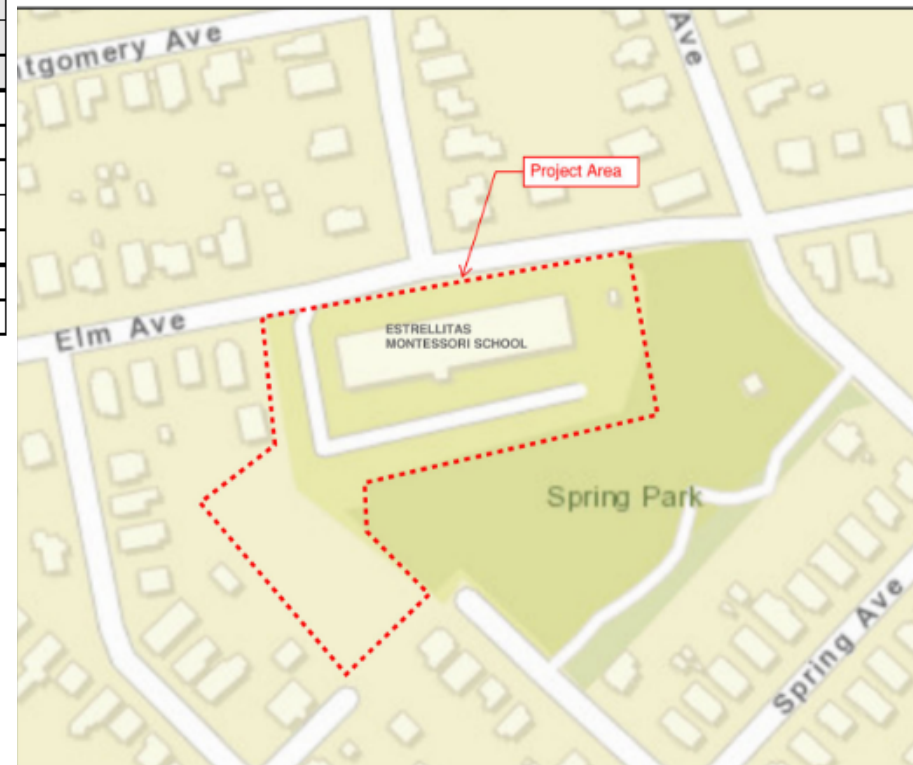
PROJECT #8: ESTRELLITAS BMP

- The Estrellitas Montessori School is a large impervious area contributing to stormwater runoff into the downstream storm drain system. The large property may have areas that are suitable for stormwater management devices that can alleviate flooding downstream.

- Engage and partner with the private property owner to implement a stormwater BMP project. Conduct an initial BMP feasibility assessment and subsequent BMP design. Filtration type BMPs may be feasible in some of the open grass areas around the property and a peak flow attenuation system may be feasible underneath the parking lot. Install one or both as deemed appropriate during the initial assessment. A detailed engineering analysis will be required for any design plans.

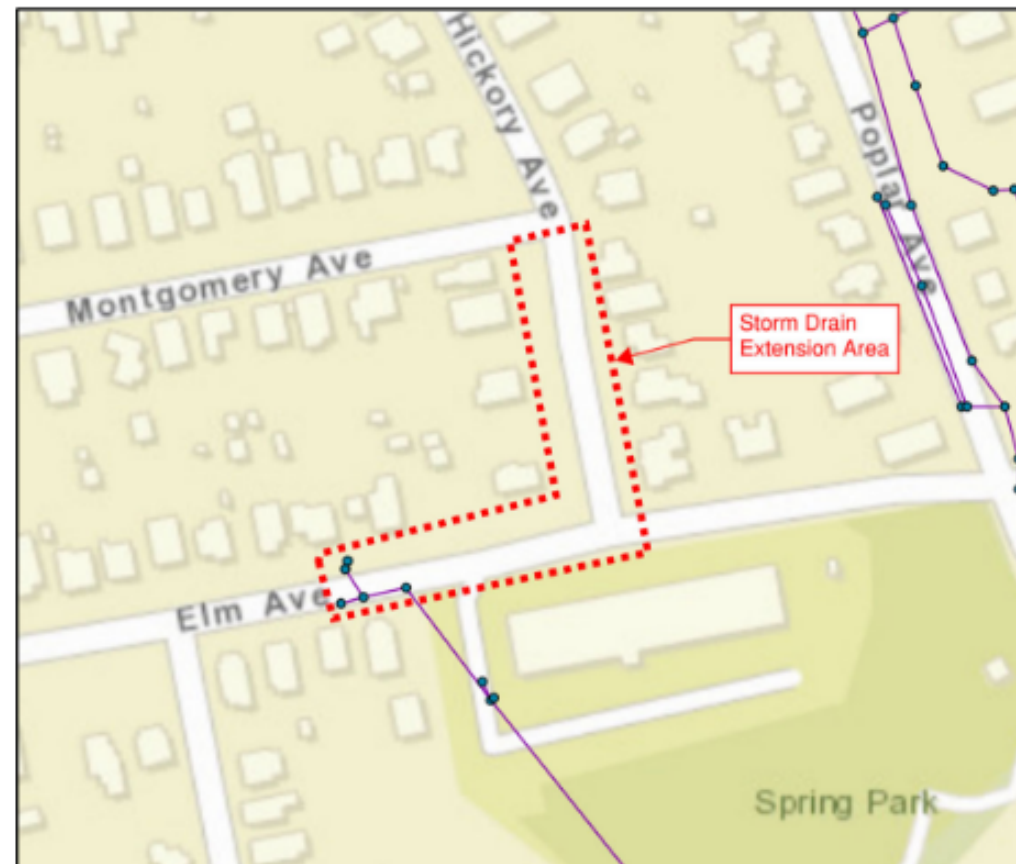
PROJECT #9: HICKORY AVE.

- There is minimal storm drain infrastructure in the uphill areas of the Takoma Branch watershed, specifically along Hickory Avenue. The primary inflow points of the storm drain systems at Elm Avenue near the Estrellitas Montessori school has a large drainage area from this upland area. LID Center's preliminary stormwater modeling results suggest some of these primary inflow points to the storm drain system could benefit from increased capacity uphill of this area.

- Conduct a desktop assessment to determine the benefit and feasibility of installing storm drain infrastructure along Hickory and Elm Avenue uphill of the existing storm drain system at Elm Avenue. Additional inlets and pipes can reduce overland flooding, provide additional storage, and reduce peak flow. The capacity of the downstream system will need to be verified via a hydrologic analysis in order to justify diverting any substantial amounts of stormwater runoff. Depending on the results of the study, perform a subsequent design and installation of the new storm drain system extension. In coordination with this project, it may be valuable to pursue projects #3 (Lake Street BMP) and #8 (Estrellitas Montessori BMP) to offset the increase in flows due to diverting additional stormwater to the Elm Avenue/Cockerille Avenue storm main.
