Takoma Park Maryland Library

Council Meeting – March 20, 2019

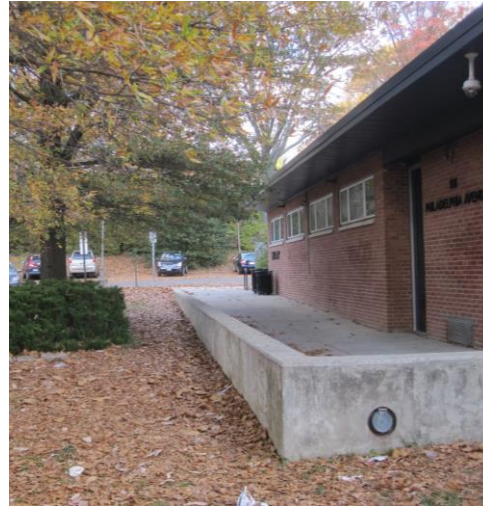
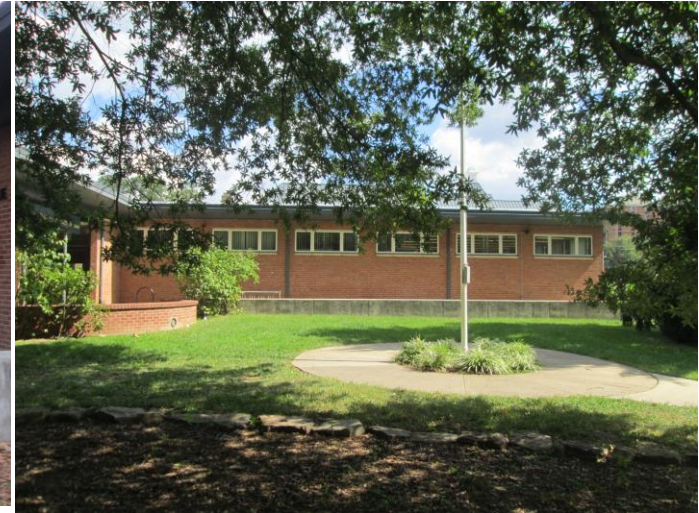
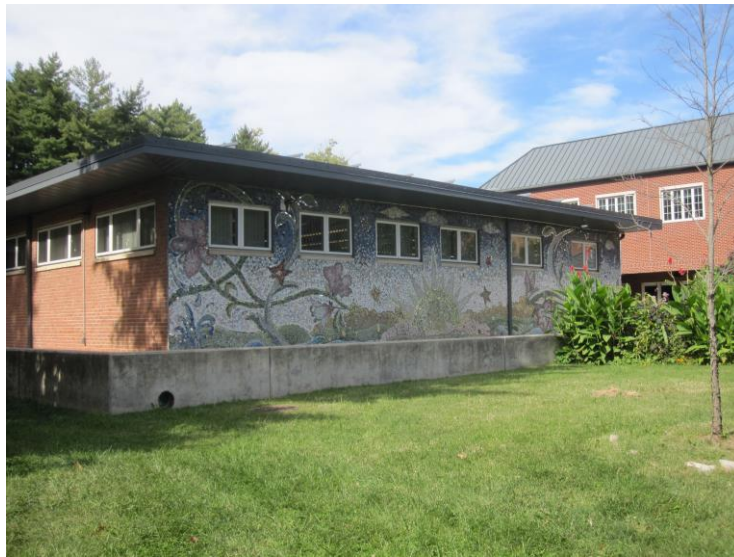
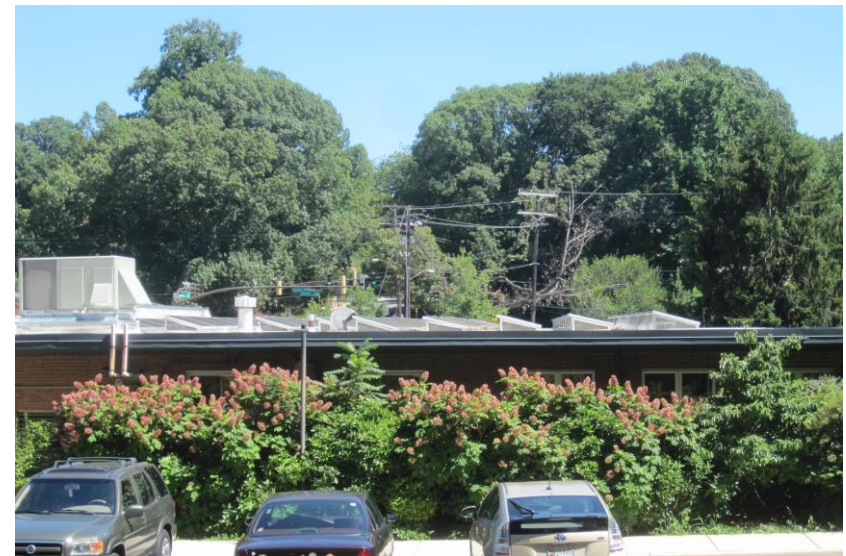
Building Conditions - Exterior

- Code deficiencies including
 - ADA clearances
 - Lack of sufficient & accessible restrooms
- Lack of sprinkler system
- Outdated HVAC system
 - No humidity control
- Lack of space for ductwork
- Outdated electrical system
- Inefficient lighting
- Lack of power for patrons
- Lack of space for staff
 - Staff decentralized
- Computer spaces outside library yet library staffs these spaces
- No meeting or program spaces
- Furniture & finishes have outlived their expected life
- Lack of space to house collection & deliver library services

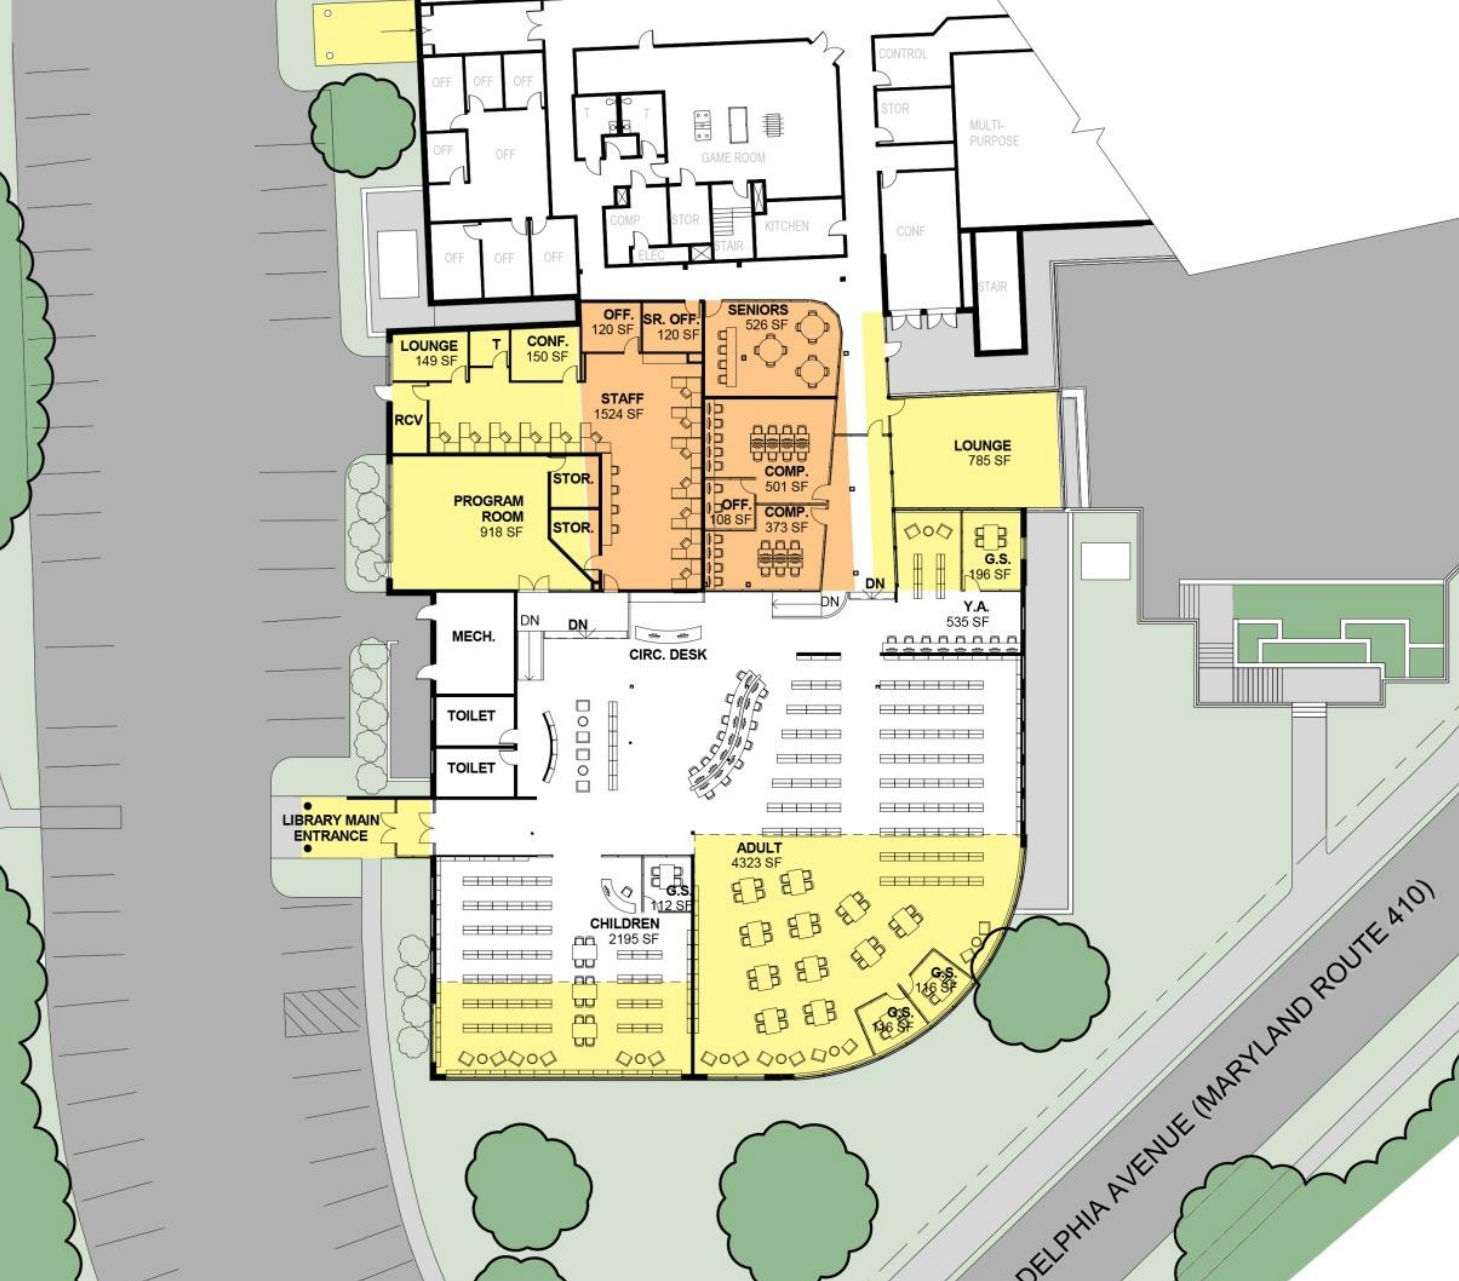
Option 1 Floor Plan— 18,800 S.F.

- Infill area at existing flagpole
- Span underground parking outside of corridor connecting community center with Library
- Use this space for a lounge/ cyber café/ study area
- Create a more dynamic Architectural Image

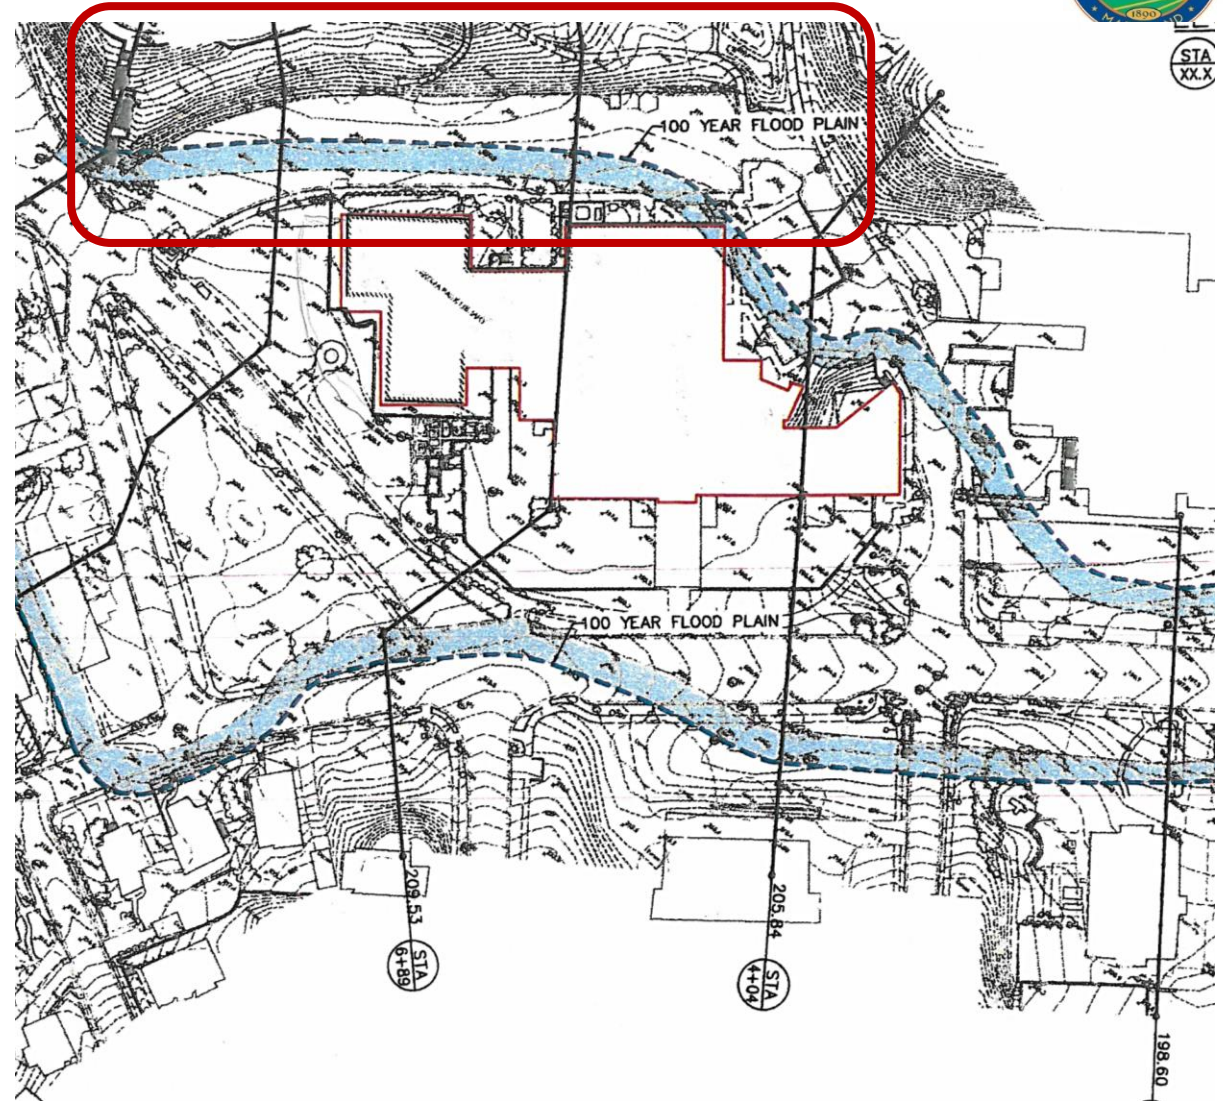
100 Year Flood Plain

- Demolish the library and rebuild new with the appropriate floor level

- Library is above the flood plain
- Library floor will be 10" above the community center floor level
- Library is not constrained by the existing wood structure and can achieve an appropriate ceiling height
- Parking lot is not closed for construction
- Cost to demo and rebuild adds approximately 10% to the cost of Option 2 and the City gains a flexible, contemporary library

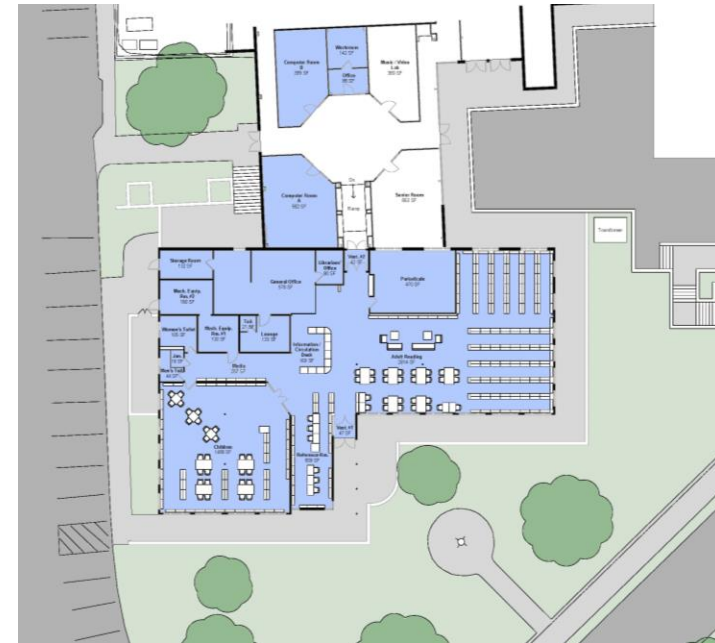
Design Goals for a Replacement Library

- Create a flexible library to have the ability to respond to the changing role of the library in the community
- Provide appropriate space for children, young adults and adults including the collection, reading choices, group study rooms and ability to use contemporary electronic media
- Provide a Program / Meeting room with AV capability that may be available outside library hours
- Include the computer rooms as part of the library
- Meet all ADA & code requirements
- Use sustainable design principals in the design and operation of the library – LEED Certified
- Visually, and physically connect the library to the community center
- Maintain the mosaic
- Enable staff to monitor all activity in the library for a safe & secure environment
- Maintain the largest trees on site

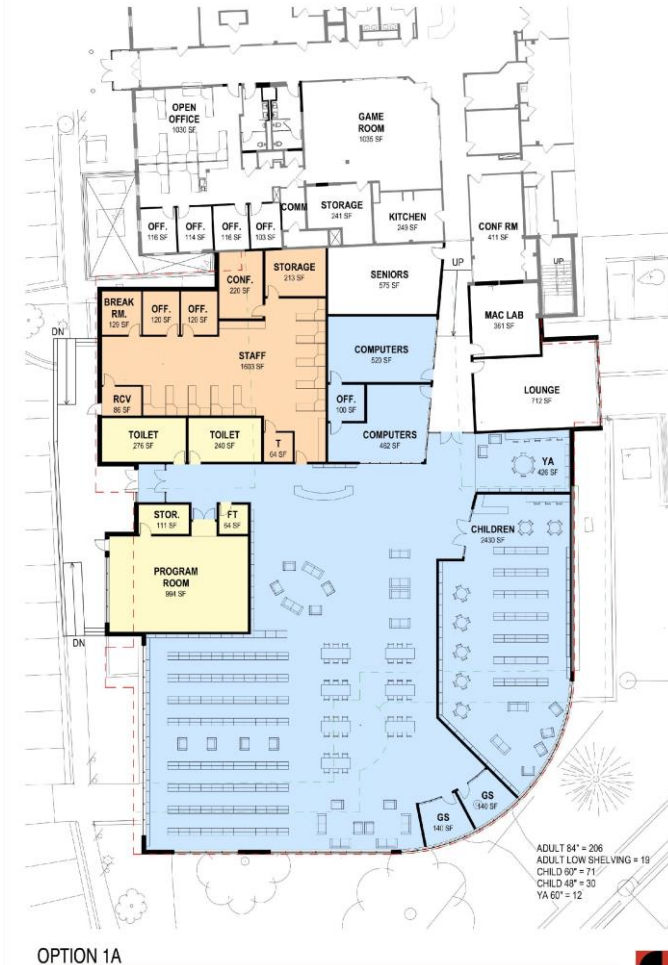
Design Option for Replacement Library

- Retains relationships previously illustrated
- Staff & Circ desk directly related
- Computer rooms are bridge between library and community center & are not “in” the library
- Program room relates directly to children
- Flexible layout between children & adults
- Patrons look into public area of library from parking lot
- Program room “hides” space behind it from front entry

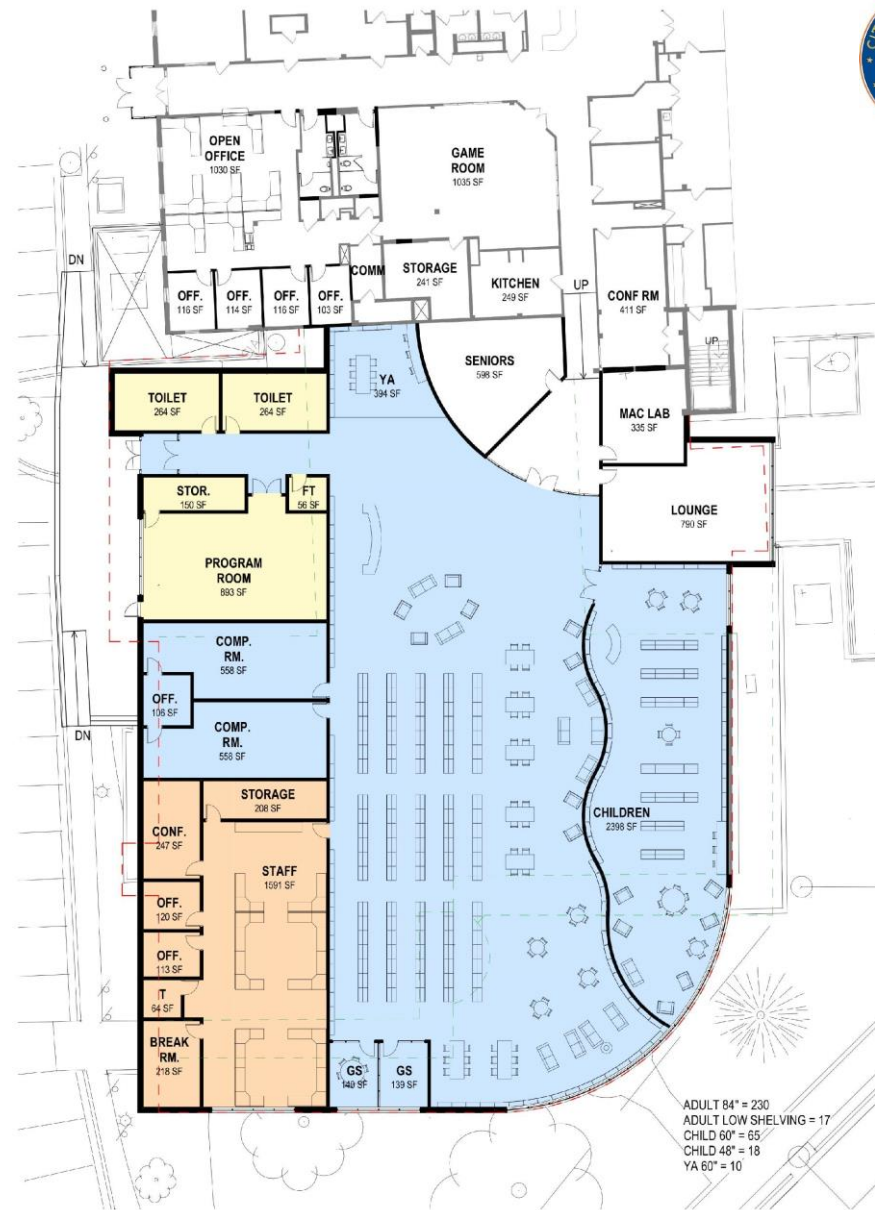
OPTION 3

- Entrance move to lowest possible flood level elevation
- Shortest distance from community center to library
- Interior entry focuses patrons on service desk
- Moves computer rooms into library
- Combines all administrative & support functions together
- Children access collection without walking through adult area
- All public areas into view from entry
- Flexible layout. All library functions are seen from both service desk and entry
- Potential for interesting architectural character

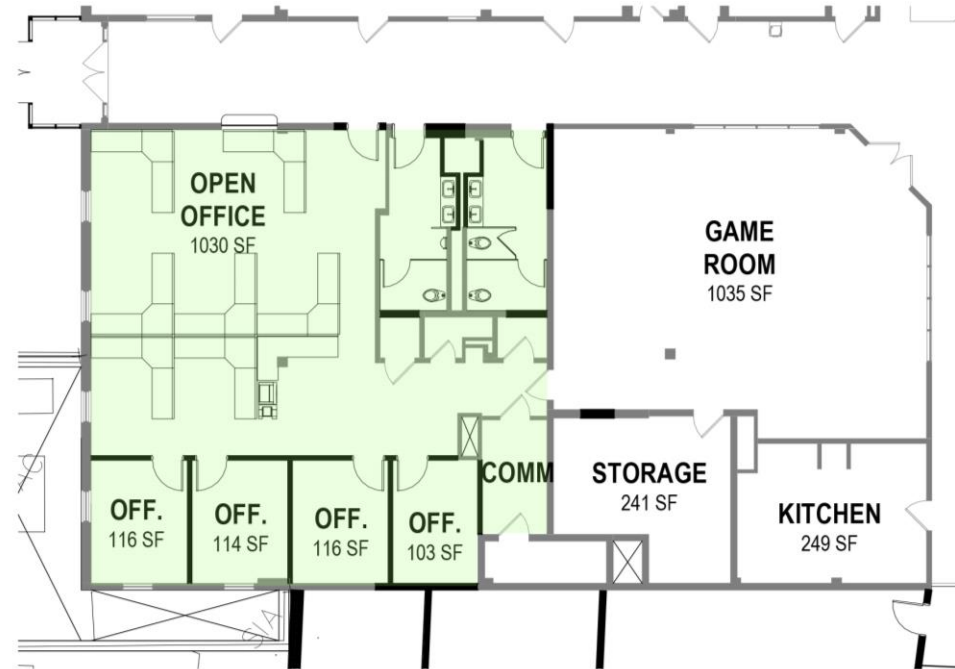
Proposed Renovation

- Eliminates corridor
- Easier access for public
- Increases staff space
- Increases toilet count and relocates them near other restrooms

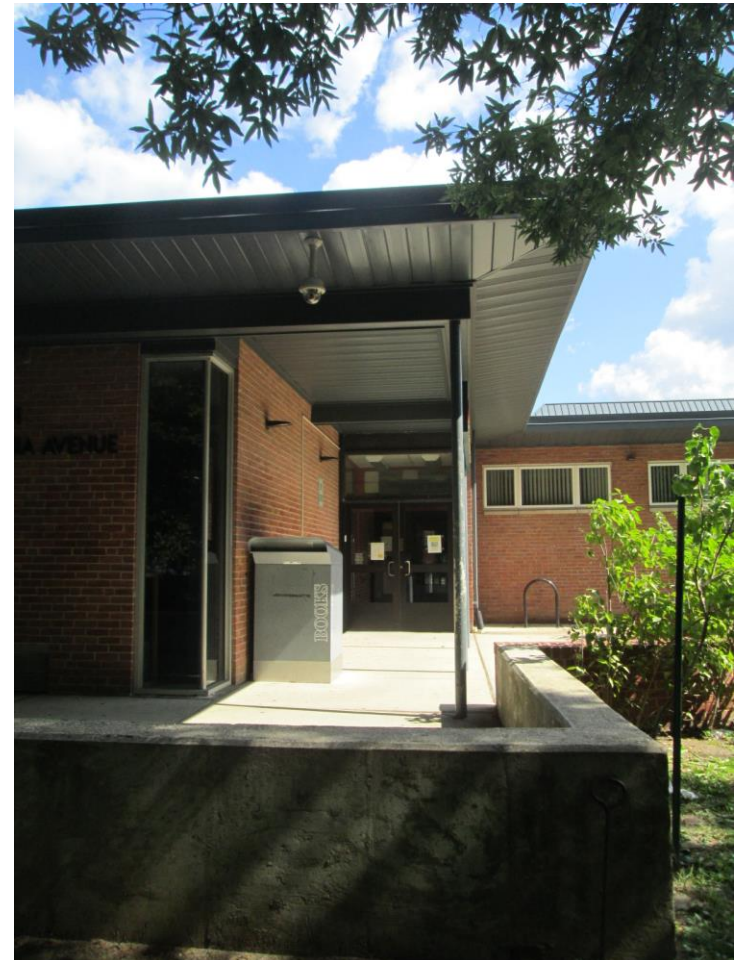
Why a new Library ?

- The Plan is not dependent on existing mechanical, electrical or plumbing locations
- It eliminates the wood roof
- It enables a higher ceiling height to accommodate the high stacks used in the library
- It allows a more flexible layout of the library
- It enables the exterior wall & roof construction to be of more energy efficient construction
- It enables the HVAC system to be more energy efficient
- It enables a larger structural span providing column free space
- It enables the library to become a more integral component of the community center
- It enables additional architectural design options
- It will result in a much better & flexible Library that reflects the significant investment by the City
