Takoma Park Maryland Library

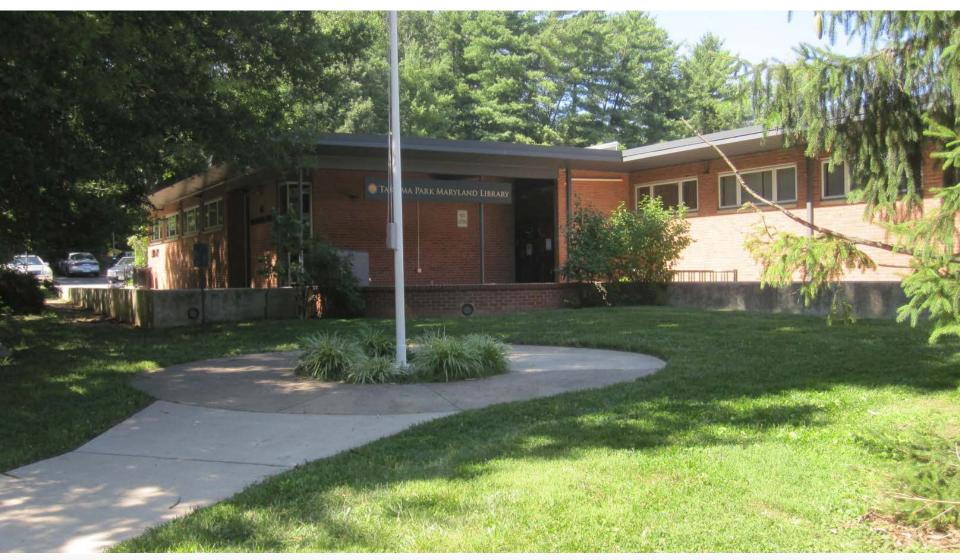
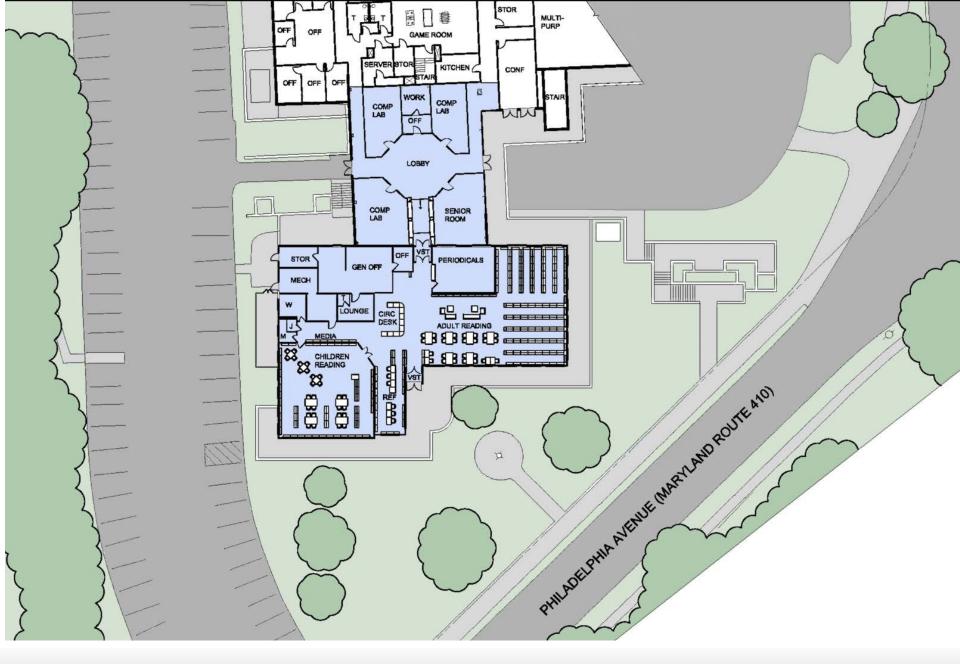
- High windows- lack of ability to see into library or out
 - Inward focused
- Flood Wall
- Use of Photovoltaics on roof
- Mosaic Wall
- Large trees between library and Philadelphia Ave.

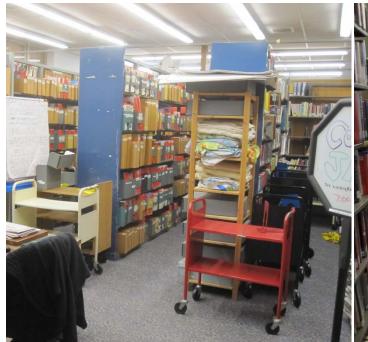
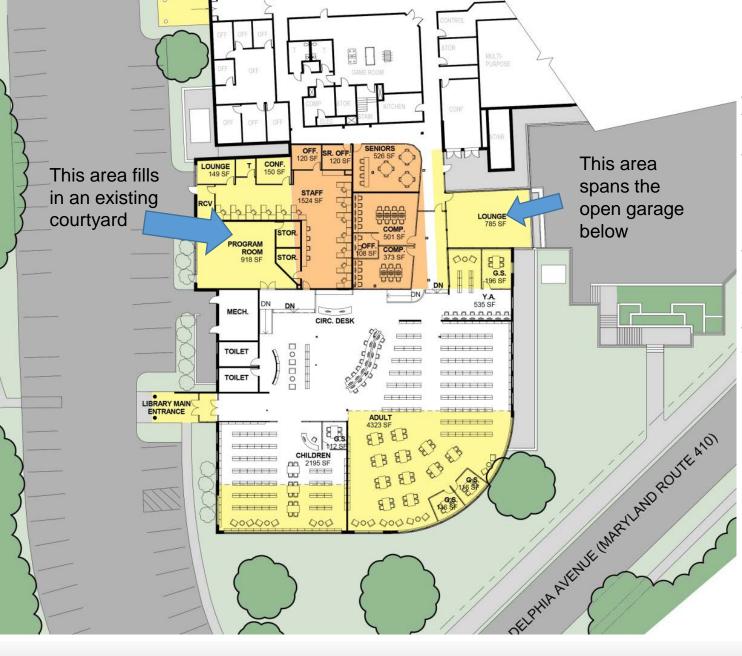
- Code deficiencies including
 - ADA clearances
 - Lack of sufficient& accessible restrooms
- Lack of sprinkler system
- Outdated HVAC system
 - No humidity control
- Lack of space for ductwork
- Outdated electrical system
- Inefficient lighting
- Lack of power for patrons
- Lack of space for staff
 - Staff decentralized
- Computer spaces outside library yet library staffs these spaces
- No meeting or program spaces
- Furniture & finishes have outlived their expected life
- Lack of space to house collection & deliver library services

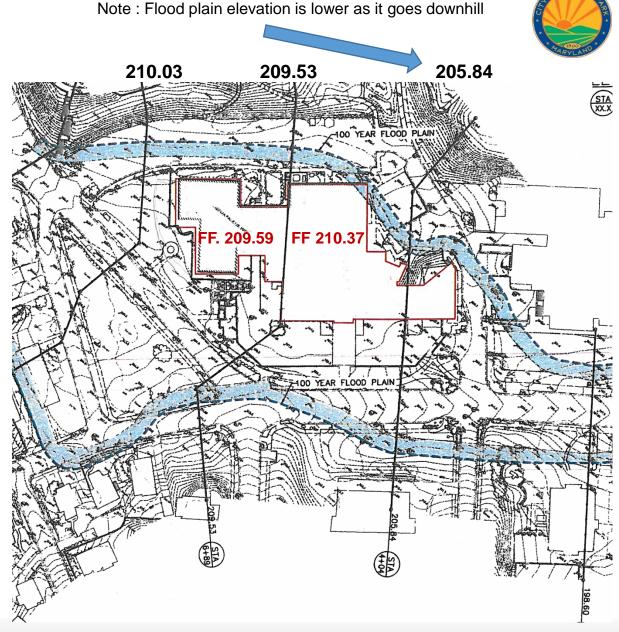
Finished floor must be 1' above the 100 Year level

Existing Conditions

- Current Top of Flood Wall is El 210.15
- Library finished floor is 10" below 100 year flood plain
- Community Center is 1' above the 100 year flood plain level at its' door, and meets regulations

Note: Flood plain elevation is lower as it goes downhill

Study established the current extent and level above sea level of the existing flood plain

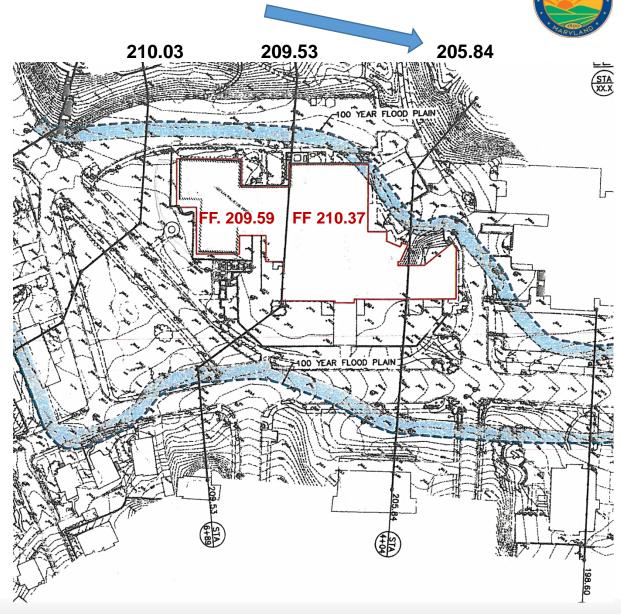
Option 3

Demolish the library and rebuild new with the appropriate floor level

- Library will be above the flood plain
- Library floor will be 10" above the community center floor level
- Library is not constrained by the existing wood structure and can achieve an appropriate ceiling height – allows for ductwork, sprinkler piping & lighting
- Entire Parking lot is not closed for construction
- Cost to demo and rebuild adds approximately 10% to the cost of Option 2 and the City gains a flexible, contemporary library

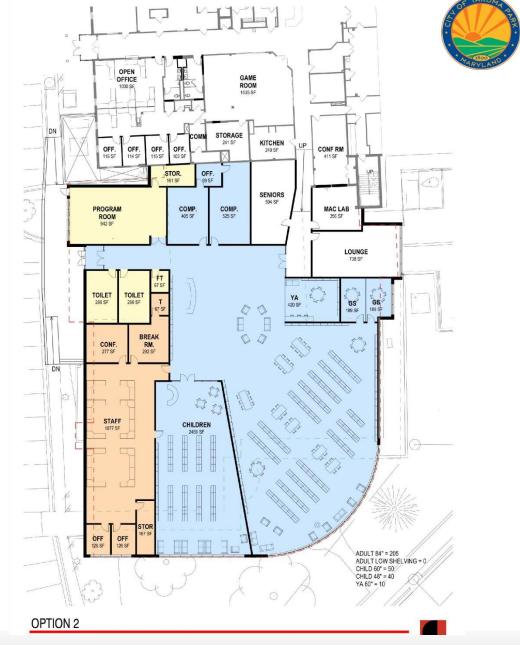
- Entrance moved to lower flood level elevation
- Shortens distance from community center to library
- Interior entry focuses patrons on service desk
- Moves computer rooms into library
- Relocates staff to parking lot side
- Shifts all public areas into view from entry
- Flexible layout. All library functions are seen from both service desk and entry
- Patrons look into administrative area from parking lot
- Potential for interesting architectural character

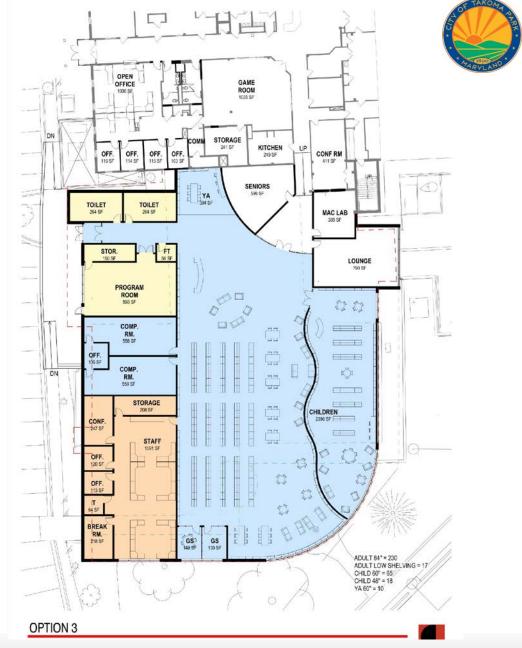
- Entrance move to lowest possible flood level elevation
- Shortest distance from community center to library
- Interior entry focuses patrons on service desk
- Moves computer rooms into library
- Combines all administrative & support functions together
- Children access collection without walking through adult area
- All public areas into view from entry
- Flexible layout. All library functions are seen from both service desk and entry
- Potential for interesting architectural character

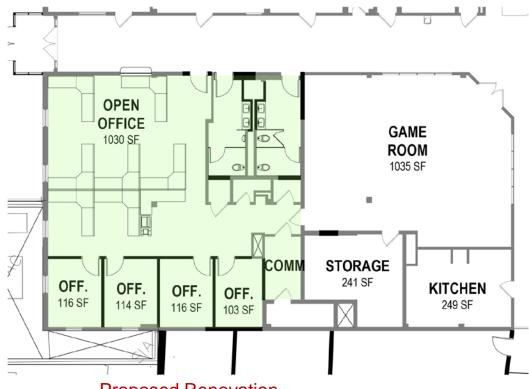
Proposed Renovation

- Eliminates corridor
- Eliminates "stair to nowhere"
- Easier access for public
- Increases staff space
- Increases toilet count and relocates near other restrooms
