# The City of Takoma Park's Bus Stop Improvement Plan

Final Report - June 2020

Prepared by the KFH Group for the City of Takoma Park  
Through the Metropolitan Washington Council of Government's  
Transportation Land-Use Connections Program

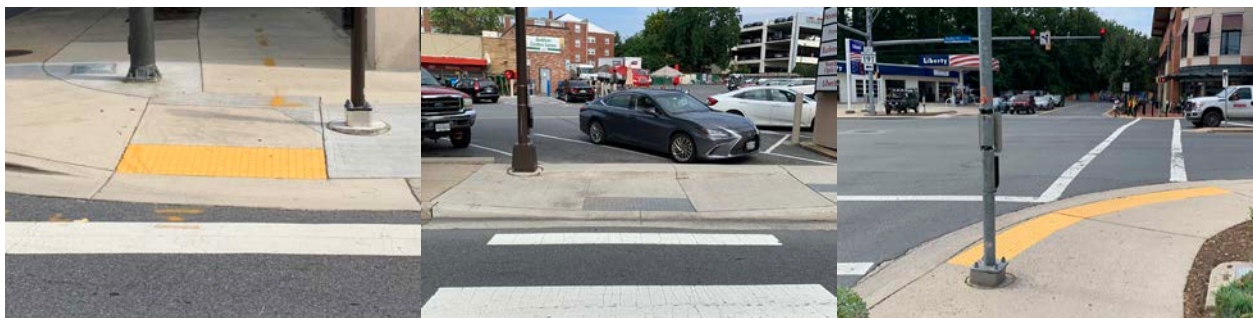
**Figure 1-3: Examples of Curb Ramps and Blended Transitions**

Perpendicular  
Curb Ramp

Parallel  
Curb Ramp

Perpendicular curb ramps are perpendicular to the street curb and permit pedestrians to cross the street perpendicular to vehicular traffic. Ideally, they are in line with the path of travel of both the sidewalk and the street crossing, but this is not always possible due to existing conditions. A common distinguishing feature of perpendicular curb ramps is that each ramp generally serves a single street crossing; i.e., at a four-way intersection, two perpendicular ramps are needed at each corner.

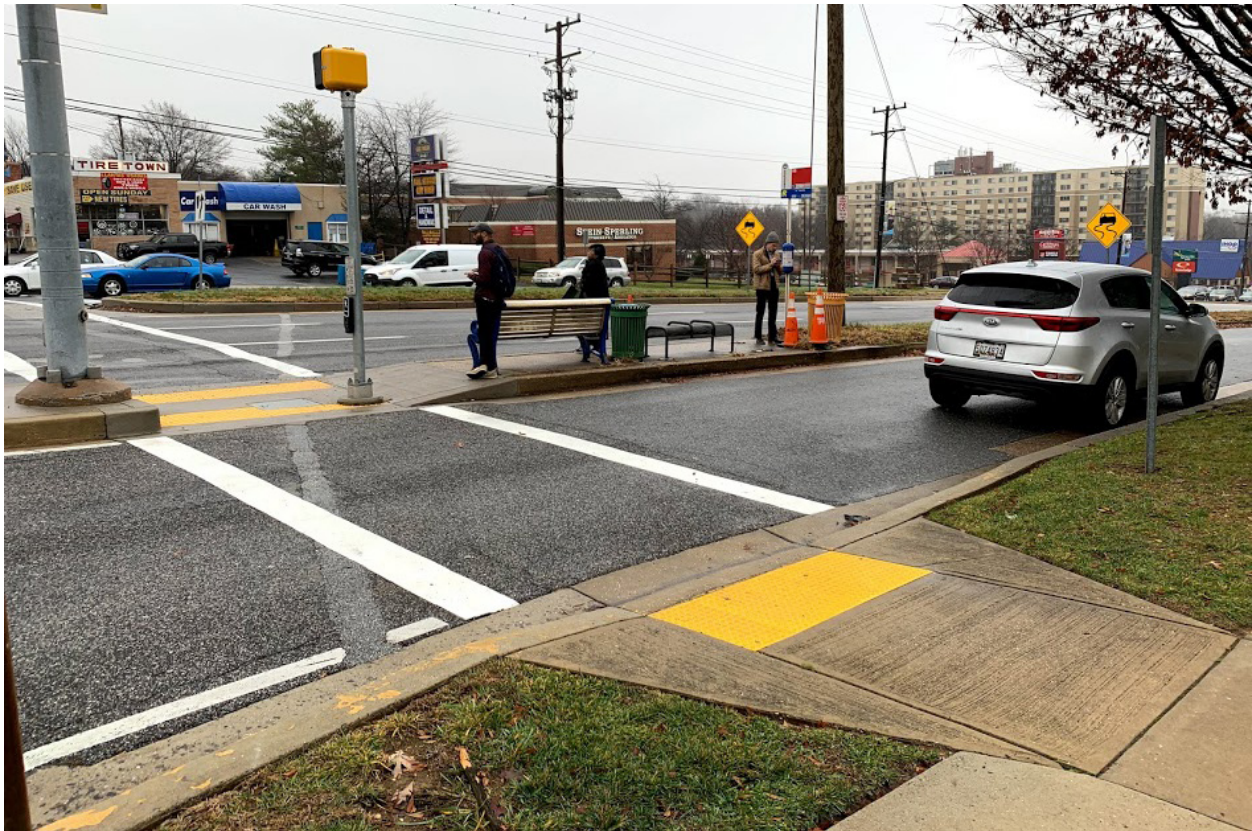
**Figure 1-4: Example of Detectable Warning Surfaces**

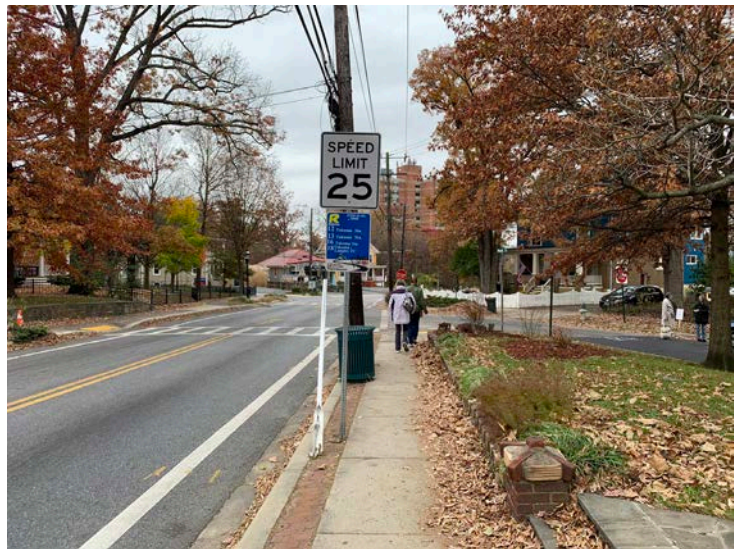
**Figure 2-7: Narrow Sidewalks are a Leading Cause of ADA Non-compliance**

Non-compliant bus stops were located across the City, but relatively large concentrations were found along Carroll Ave., Flower Ave., and Maple Ave. As seen in Figure 2-7 on Carroll Ave., many of these corridors feature narrow sidewalks that lack the required clearance for bus stop landing pads. The major intersections along Ethan Allen Ave., New Hampshire Ave., and Philadelphia Ave. were more likely to be ADA compliant than other areas of the City. A map showing ADA compliant and non-compliant stops is provided on the following page in Figure 2-8.

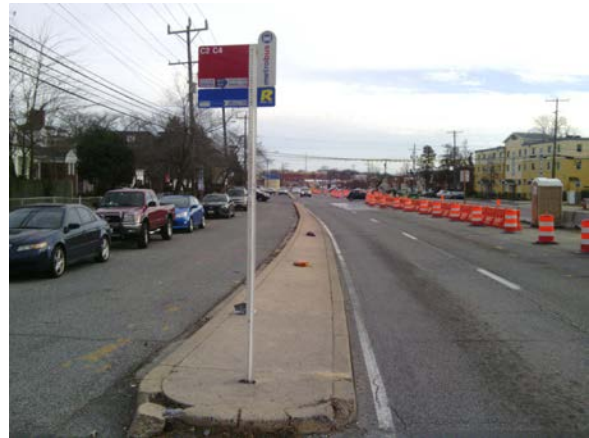
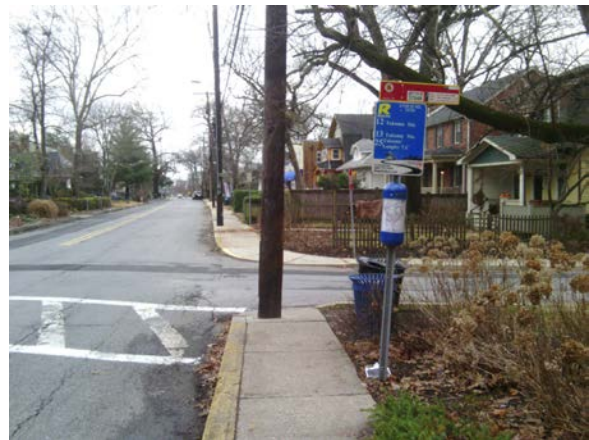
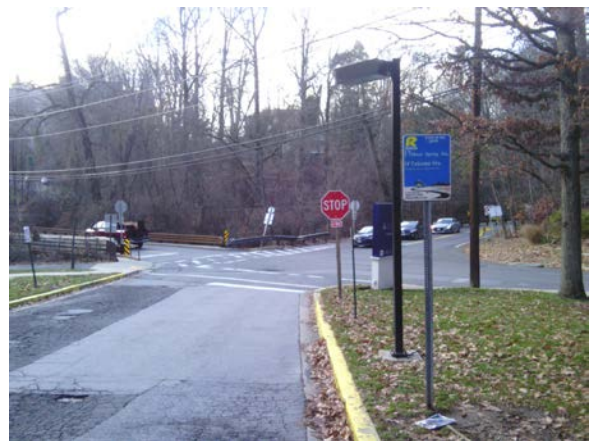
Nearly every bus stop in the City of Takoma Park has an accessible connection to the sidewalk network. However, a handful of inaccessible bus stops were observed during the field survey. Three notable standouts are shown in Figure 2-12.

Only one stop was found with no sidewalk access, pictured bottom right. The stop is located on the hospital access road near the intersection of Maple Ave. and Sligo Creek Pkwy. The stop is on hospital property; there is a sidewalk on the opposite side of the access road and along Maple Ave.

**Figure 2-12: Examples of Bus Stops Lacking Accessible Connections**

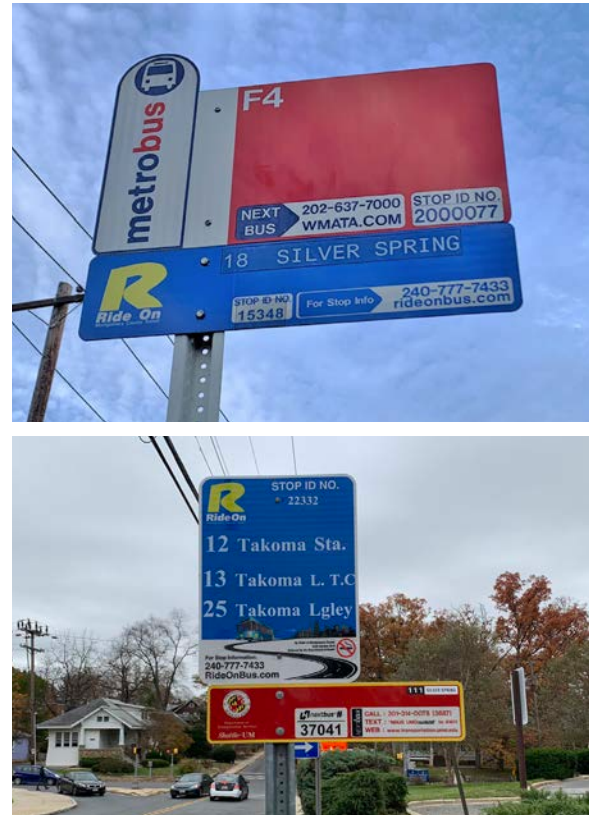
Signs are a key marketing tool for transit agencies. They advertise the service while also providing route and contact information. Seen in Figure 2-13, all Metrobus and Shuttle-UM signs are designed in the “blade” style where the sign cantilevers from the pole. Ride On signs varied between three distinct styles - full size (pictured at the shared Ride On and Shuttle-UM stop), shared blade (pictured at the shared Metrobus and Ride On stop, and a standalone blade (not pictured). Ride On is currently in the process of updating and replacing the standalone blade style signs with the two sign types pictured in Figure 2-13.

**Figure 2-13: Bus Stop Signs in the City of Takoma Park**

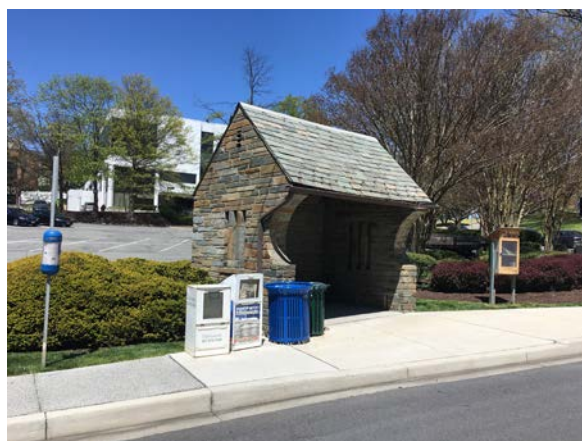
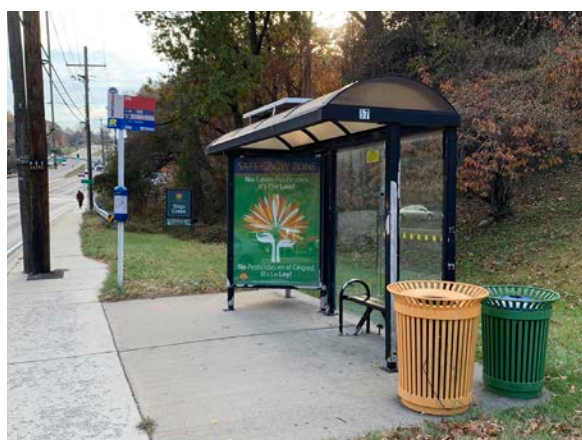
A number of the InSite bus shelters were flagged for ADA non-compliance due to inadequate interior space. The placement of the interior bench was a key determinant in the compliance of these shelters. The triangular design of the shelter's advertisement panel encroaches into the interior clear space. This coupled with an oversized or poorly placed bench reduces the clearance of the interior space to below ADA guidelines. Table 2-5 and Figure 2-17 provide additional bus shelter details.

**Figure 2-16: Examples of Bus Stops with Shelters**

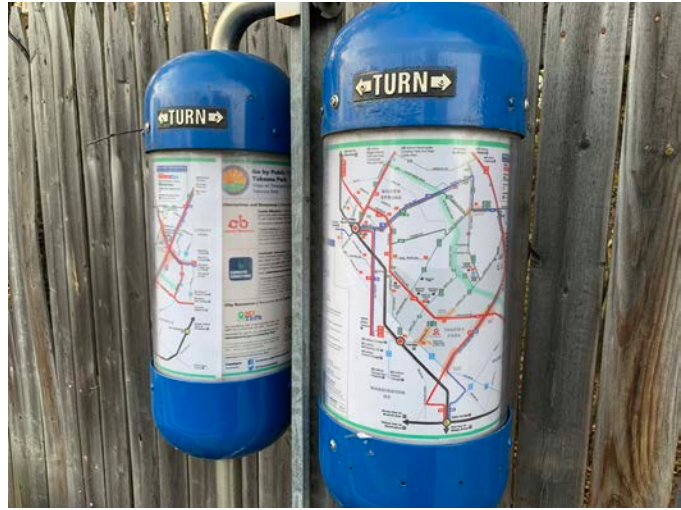
The most common information cases are the blue tube or turnable cases pictured in Figure 2-19. These cases are a notable characteristic of bus stops in Takoma Park. They are located at 29 bus stops (21%) and three of those bus stops have two turnable information cases mounted side by side.

**Figure 2-19: Information Cases**

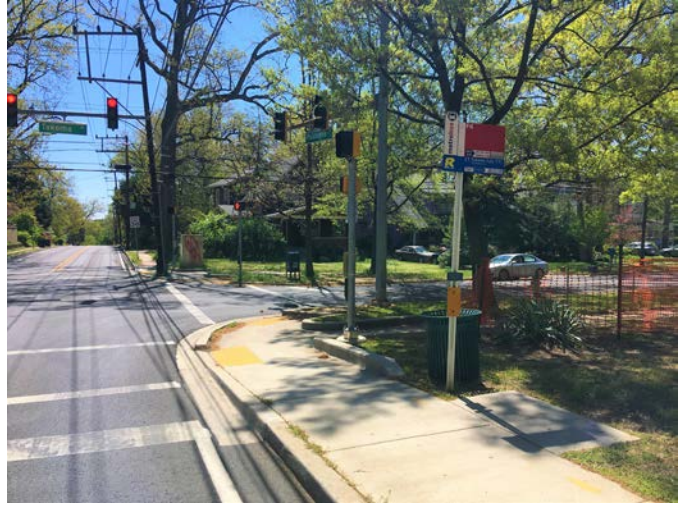
Near-side bus stops are popular due to the proximity of the stop to crosswalks and the ability to time a stopping bus with a red traffic light; note the bus stop pictured in Figure 3-2.. However, near-side bus stops can encourage other drivers to attempt to overtake the bus when turning right, leading to possible pedestrian and vehicular collisions. Use the following guidelines when deciding to place a near-side bus stop.

**Figure 3-2: Near-Side Bus Stop on Philadelphia Ave.**

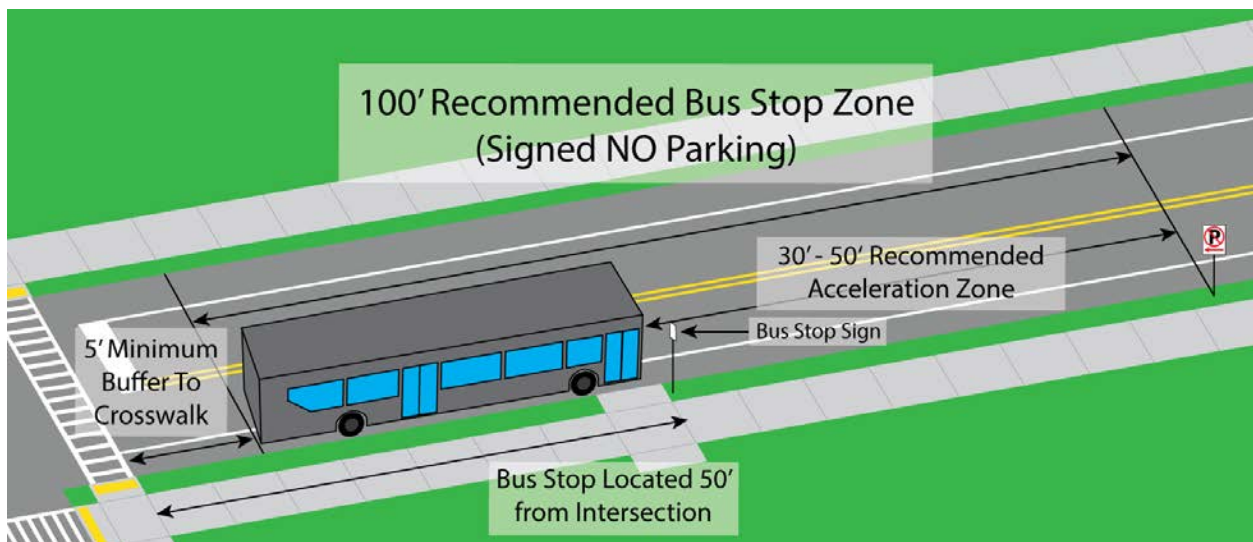
**Figure 3-4: Far-Side Bus Stop Design Considerations**

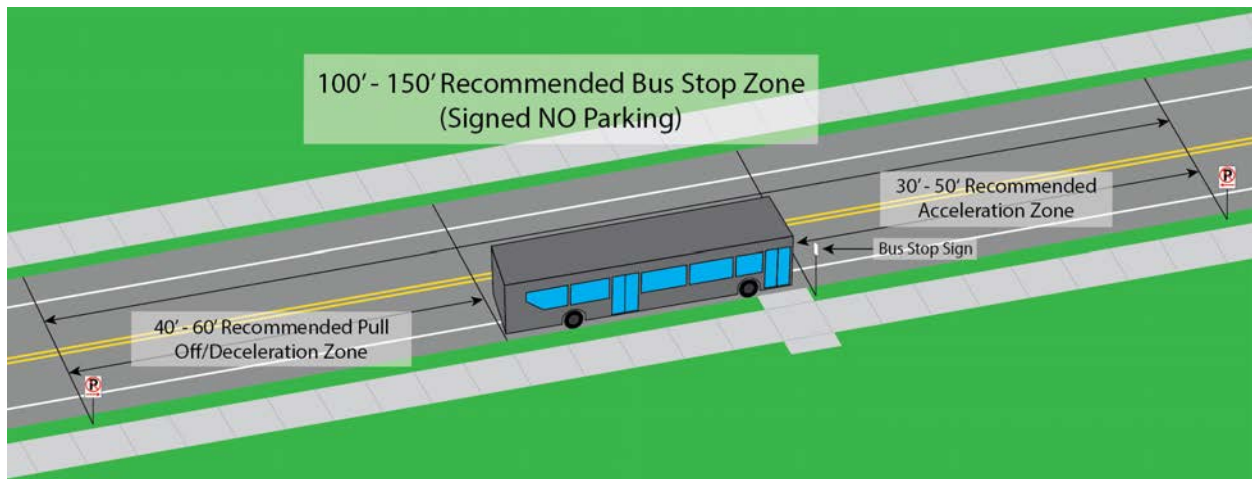
**Figure 3-5: Mid-Block Bus Stop Design Considerations**

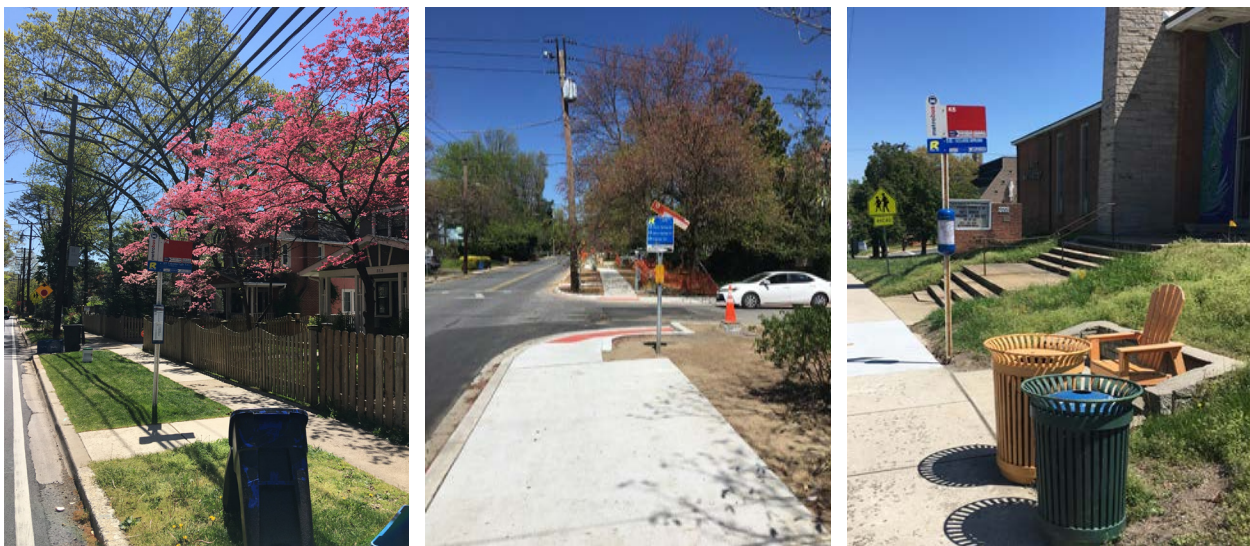
The three landing pads in Figure 3-14 demonstrate different ways that construction is influenced by existing sidewalks and adjacent land conditions. The left image shows a landing pad developed by expanding the sidewalk through a grassy buffer and to the street curb. In areas without landscape buffers, the landing pad would extend opposite of the curb as shown in the middle image. The right image shows a landing pad with a knee wall which provides protection from erosion accumulation or as a backstop for landing pads backing up to a steep ditch.

**Figure 3-14: Landing Pad & Sidewalk Design Examples**

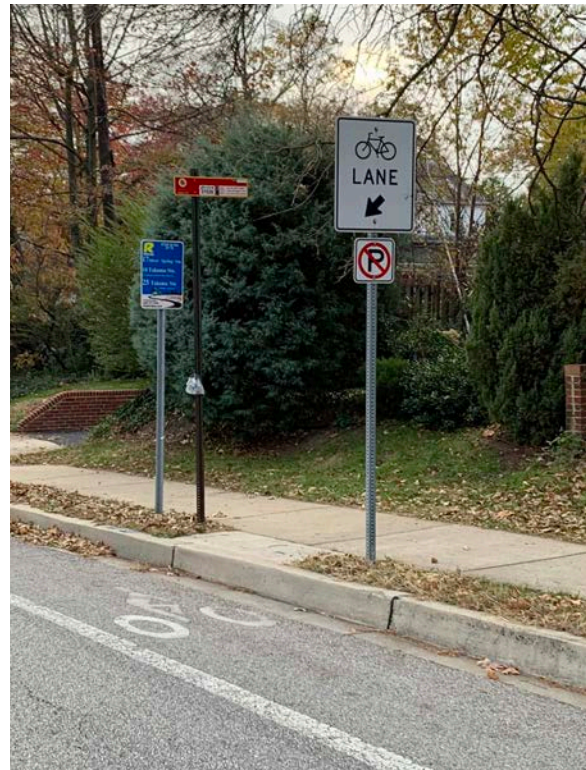
At locations where there are two or more service providers, bus stop signs should be consolidated onto one bus stop pole. This eliminates any doubts about a stop's location when two bus stop signs/poles are in close proximity. Consolidating onto one bus stop pole also reduces duplicative efforts, improves safety and promotes an image of a well-coordinated and collaborative transit system. In Takoma Park, Ride On and Shuttle-UM have a number of shared stops along Carroll Ave. and Flower Ave. where there are two bus stop poles and signs (see Figure 3-17). The City should coordinate with both operators to relocate bus stop signs onto a shared pole. In some instances, signage at these shared stops is a pathway protrusion. Care should be taken to ensure signage does not protrude into the walk path or is installed at a height of 80 inches or greater.

**Figure 3-17: Two Bus Stop Poles at a Stop on Carroll Ave.**

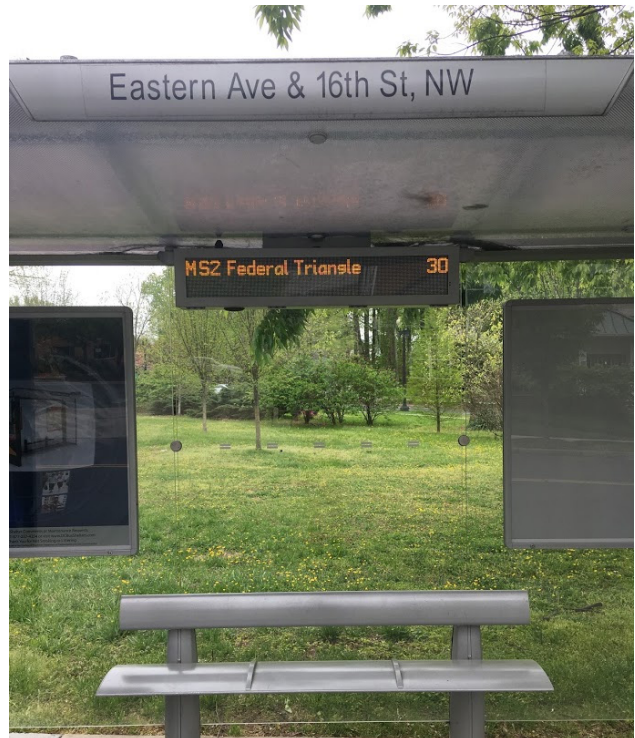
Figure 3-21: Example of a WMATA Digital Display on Eastern Ave.

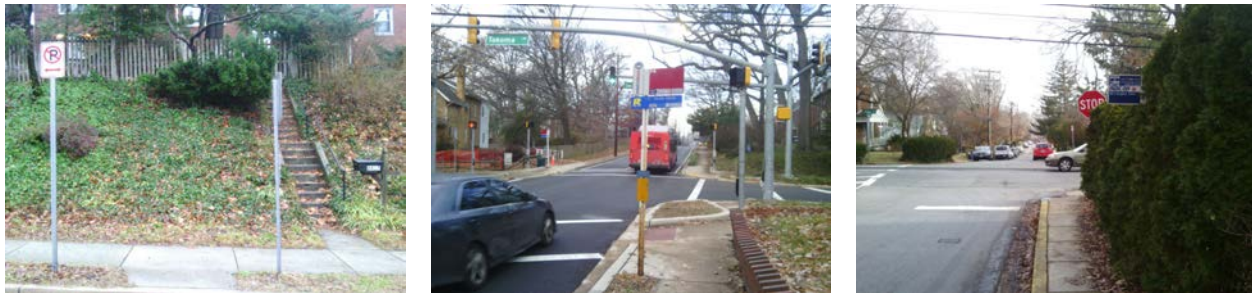
**Figure 4-21: Landing Pad Installation Conflicts in Takoma Park**
