Prepared for:  
**City of Takoma Park**  
**Department of Public Works**

## **Illicit Discharge Tracking Memo**

**April 2020**

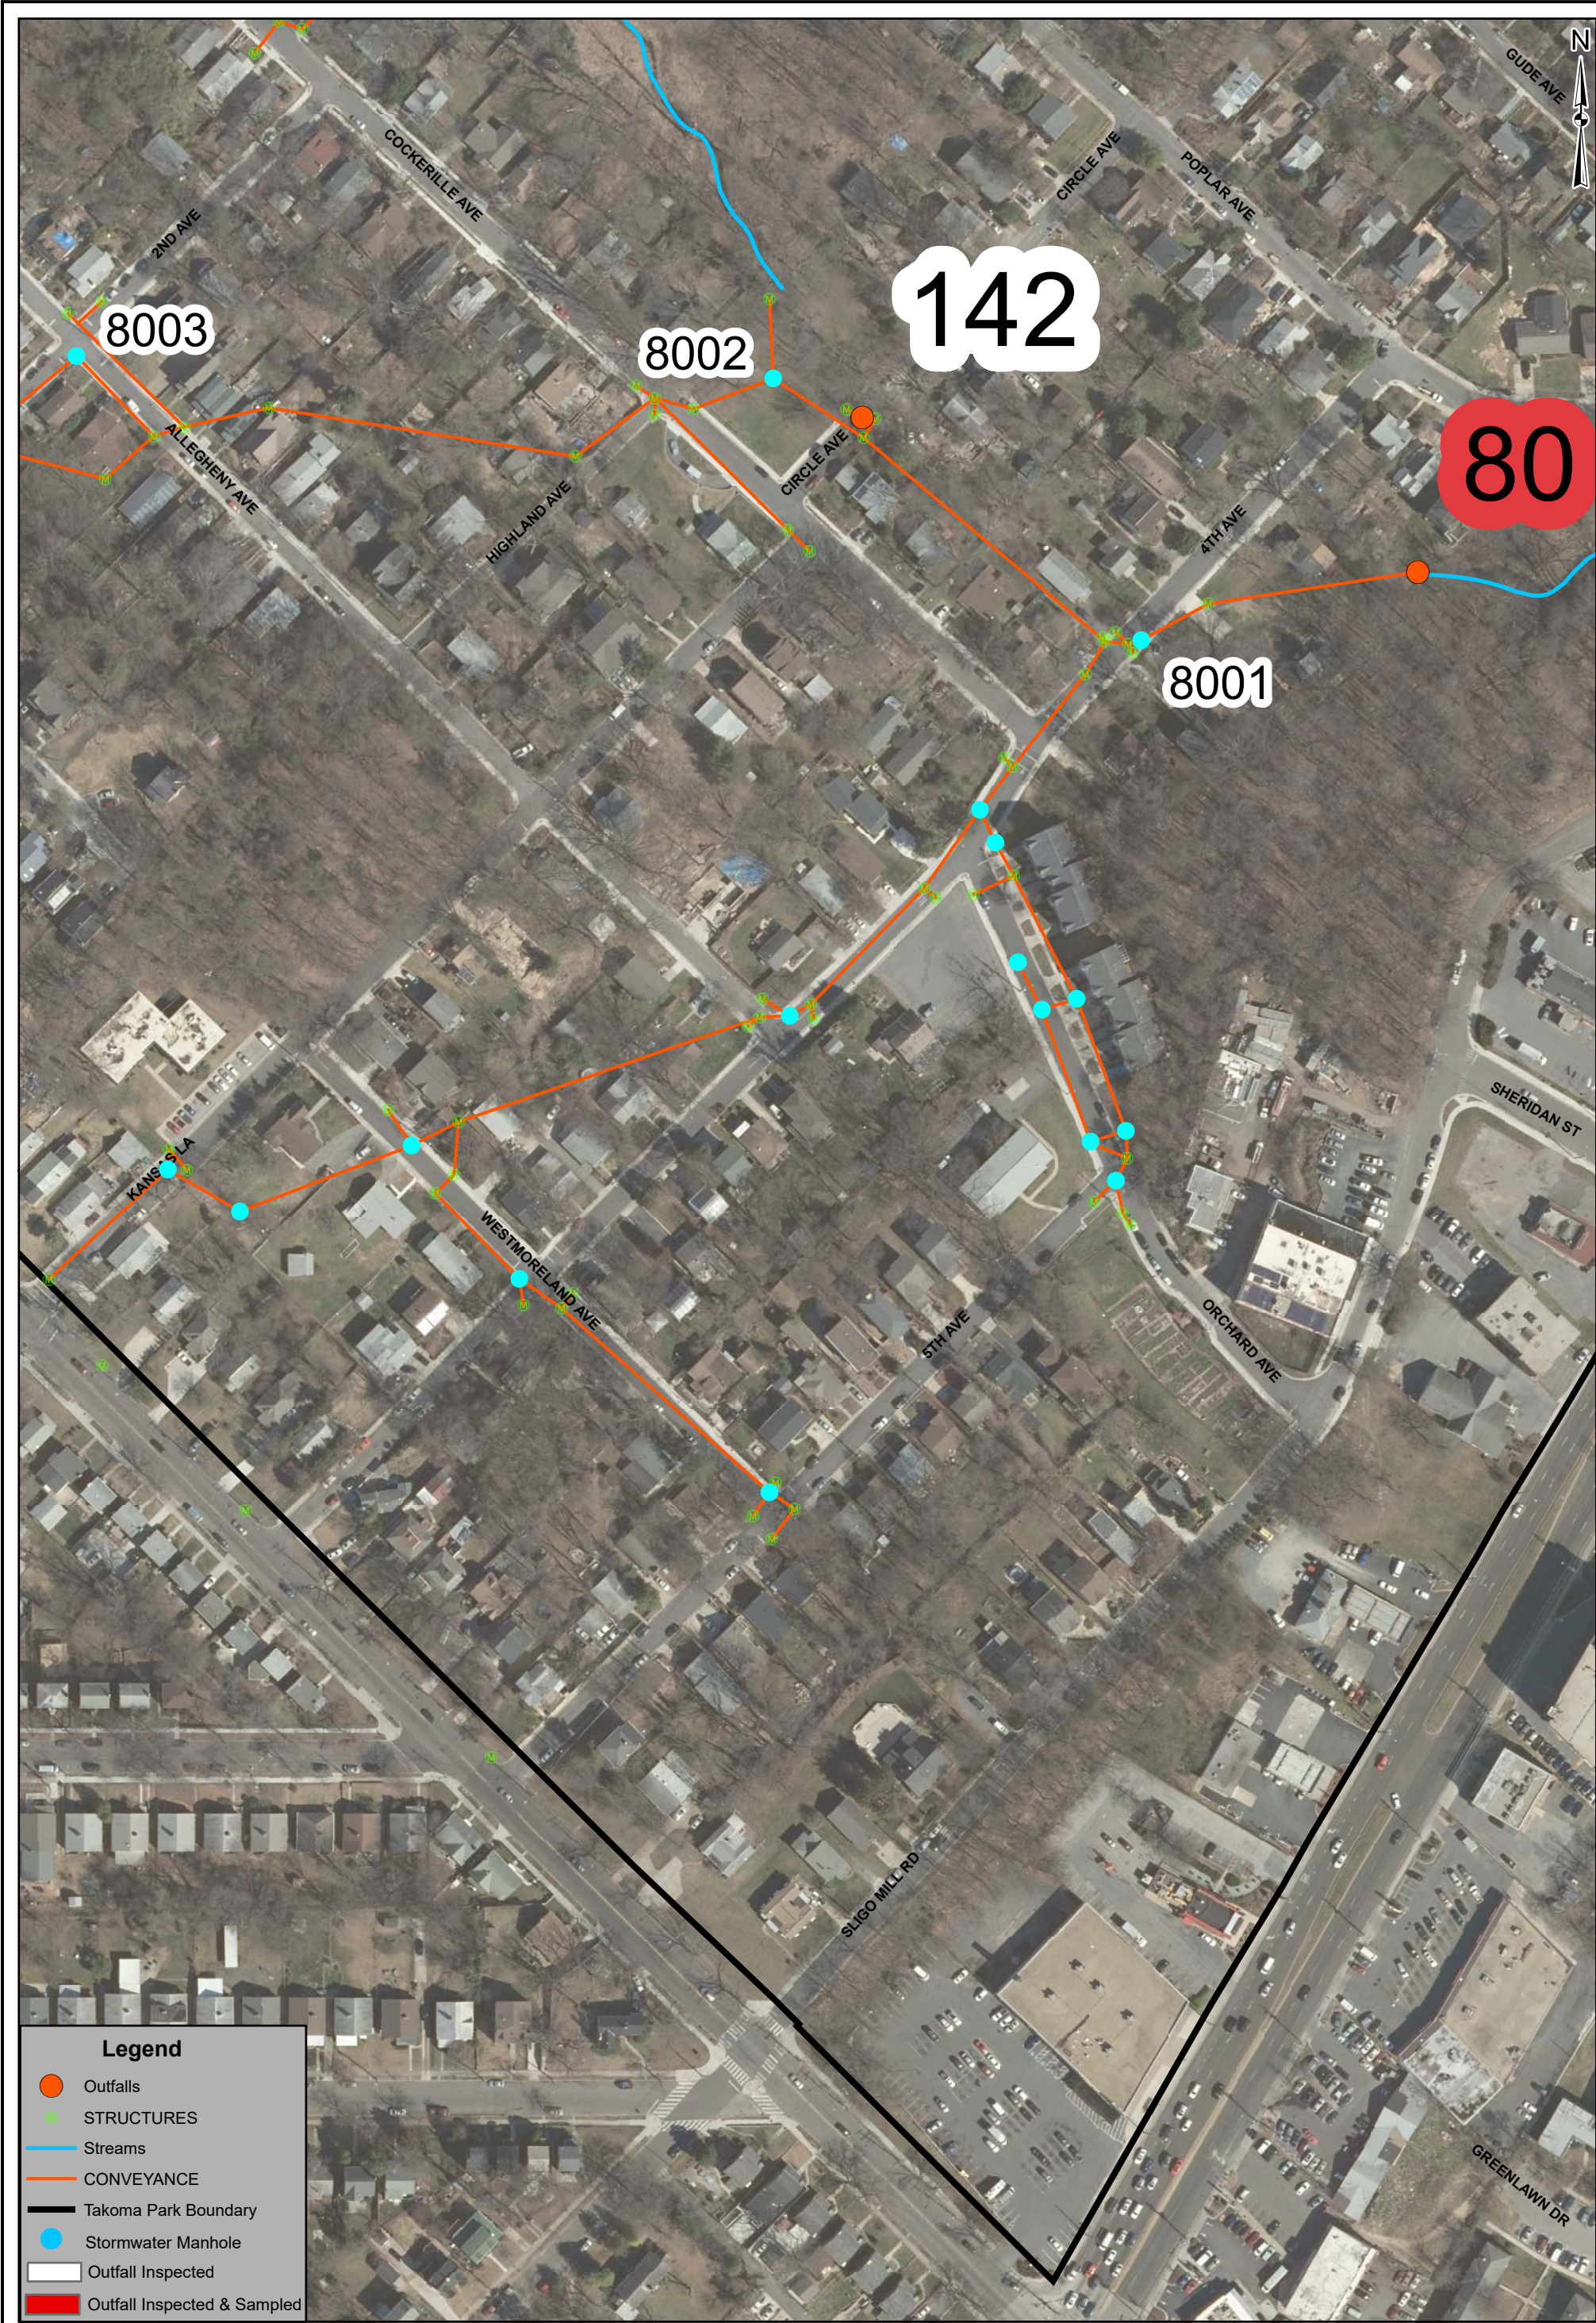
Visual inspections of three outfalls were conducted throughout the Sligo Creek watershed within the City of Takoma Park following 72 hours of dry weather (Figure 1). BayLand collected surface water samples at the three outfalls and the preceding manholes where active flow was observed.

The spatial distribution of the three outfalls where dry weather flow was observed. BayLand conducted more advanced methods of tracking illicit discharges to determine the upstream sources.

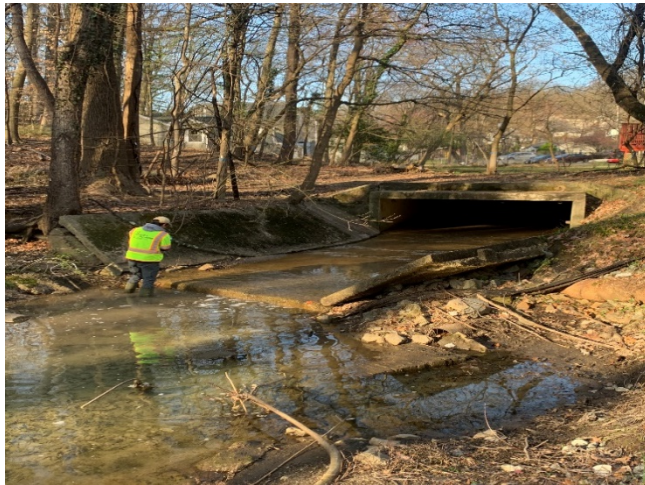
Photo 1 – Structure #80

Outfall #80 is located in the woods bordering Poplar Avenue and Fourth Avenue. This area is surrounded by residential properties. Outfall #80 flows into a small tributary that eventually leads into Sligo Creek. The structure is a ten-foot wide by four-foot tall concrete box culvert. The flow type was substantial. Outfall #212 is in the wooded area between Poplar Ave, Spring Ave, and Cockerille Ave. This two-foot square box culvert has a moderate flow which drains into a small tributary that flows into Sligo Creek. Outfall #1106 is located at the intersection of New Hampshire Road and Sligo Creek Parkway. New Hampshire road is a major four lane road. This outfall flows directly into Sligo Creek. Outfall #1106 is a concrete two-foot diameter pipe with substantial orange colored flow.

Outfall #80 and three manholes: 8001, 8002, and 8003 were sampled for E. coli, Enterococci, and chlorine. Directly at Outfall #80 E. coli exceeded EPA standards and enterococci exceeded both the Maryland and EPA standards. The first manhole up the stormwater system (8001) exceeded the EPA standards in enterococci. The second manhole (8002) exceeded both Maryland and EPA standards for E. coli. The third manhole (8003) exceeded both Maryland and EPA standards for enterococci and chlorine.

| <b>Outfall System/<br/>Flow Type</b> | <b>Exceedance<br/>Parameters</b> | <b>Conclusions</b> |
|---|--|--|
| #80 and<br>manholes<br>Substantial | E. coli<br>Enterococci<br>Chlorine | Manhole 8003 was high in chlorine which can be an indication of possible wastewater, potable water migration into the storm drain system, and/or illicit industrial discharges. Results also suggest possible sanitary wastewater contamination or septic migration into the storm drain system. |

- CCTV beginning at the outfall and upstream of manhole 8003.
  - This will help determine if exfiltration is occurring from the sewer system.

- If chlorine results at outfall #80 for the 2020 outfall screening are high in concentration a hot spot study may be needed at the shopping plaza on Laurel Avenue.

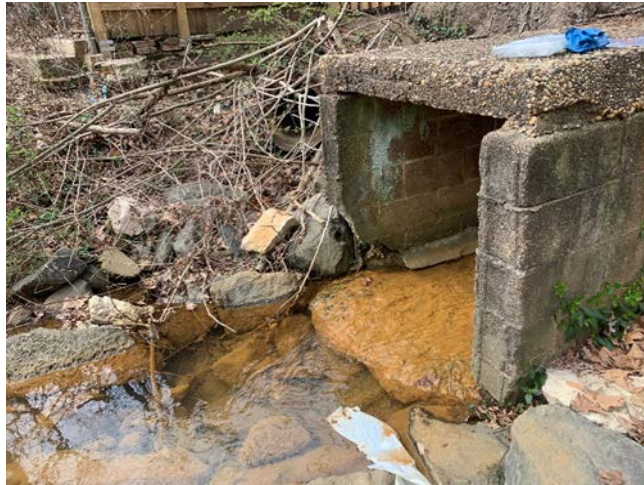
Photo 2 – Structure #212

Outfall #212 and five manholes: 21201, 21202, 21203, 21204, 21205 were sampled for E. coli and enterococci. 21205 was the last sample taken and it was cancelled by the lab. The outfall and most of the manholes showed low levels of E. coli and enterococci, apart from 21202 which exceeded both Maryland and EPA standards for enterococci.

| <b>Outfall System/<br/>Flow Type</b> | <b>Exceedance<br/>Parameters</b> | <b>Conclusions</b> |
|---|--|--|
| #212 and<br>manholes<br>Moderate | E. coli<br>Enterococci | Results suggest possible sanitary wastewater contamination or septic migration into storm drain system from manhole 21202. |

- CCTV beginning at the outfall and upstream to manhole 21203.
  - This will help determine if there has been septic migration into the storm drain system around manhole 21202

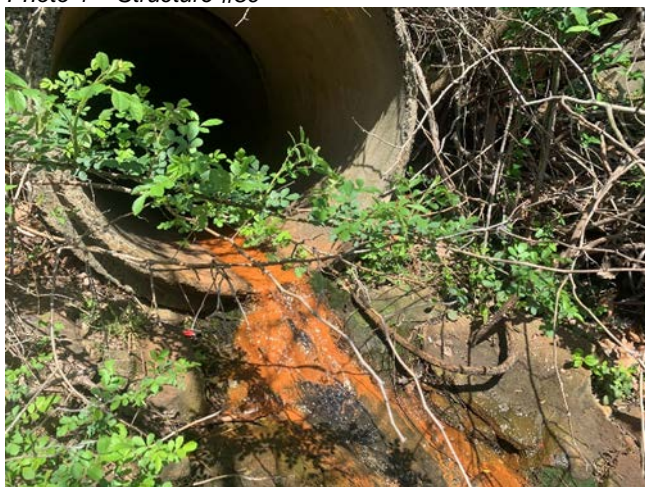
Photo 3 – Structure #1106

Outfall #80 had substantial flow and was tested for E. coli, Enterococci, and chlorine because they exceeded EPA standards during the 2019 outfall screening. Outfall #212 was tested for E. coli and enterococci as they both exceeded EPA standards during the 2019 outfall screening. Outfall #1106 was tested for enterococci, color, chloride, and chlorine as the levels were above EPA standards. Outfall #1106 displayed orange staining in both the pipe and outfall channel.

Outfall #1106 and one manhole 110601 were sampled for enterococci, chloride, chlorine, and color. EPA standards for chloride were exceeded at both 1106 and 110601. Chlorine was not detected for either sample. Manhole 110601 had a distinct odor and exceeded both EPA and Maryland standards for color. Manhole 110601 was not able to be tested for enterococci due to the water having a very distinct orange stain and contained too many solids in the sample.

| <b>Outfall System/<br/>Flow Type</b> | <b>Exceedance<br/>Parameters</b> | <b>Conclusions</b> |
|---|--|--|
| #1106 and<br>manhole<br>Substantial | Enterococci<br>Chloride<br>Chlorine<br>Color | Results suggest the elevated chloride could be a result of sewage contamination and water softener discharges. At manhole 110601 the exceeded color could be an indication of sewage, grey water and industrial discharges. |

- CCTV beginning at the outfall and upstream of manhole 110601.
  - Manhole 110601 had a strong sewage odor and the water was heavily stained with orange and contained some solids.
  - This will help determine if exfiltration is coming from the sewer system into manhole 110601.
  - Manhole 110601 could not be tested for enterococci as the lab considered the results unreadable due to the color and solids in the sample.

We consider the recommendations for outfall #1106 to be of highest priority and outfall #212 to be the lowest priority.
