Takoma Park Study Area 1

Site Visit Notes

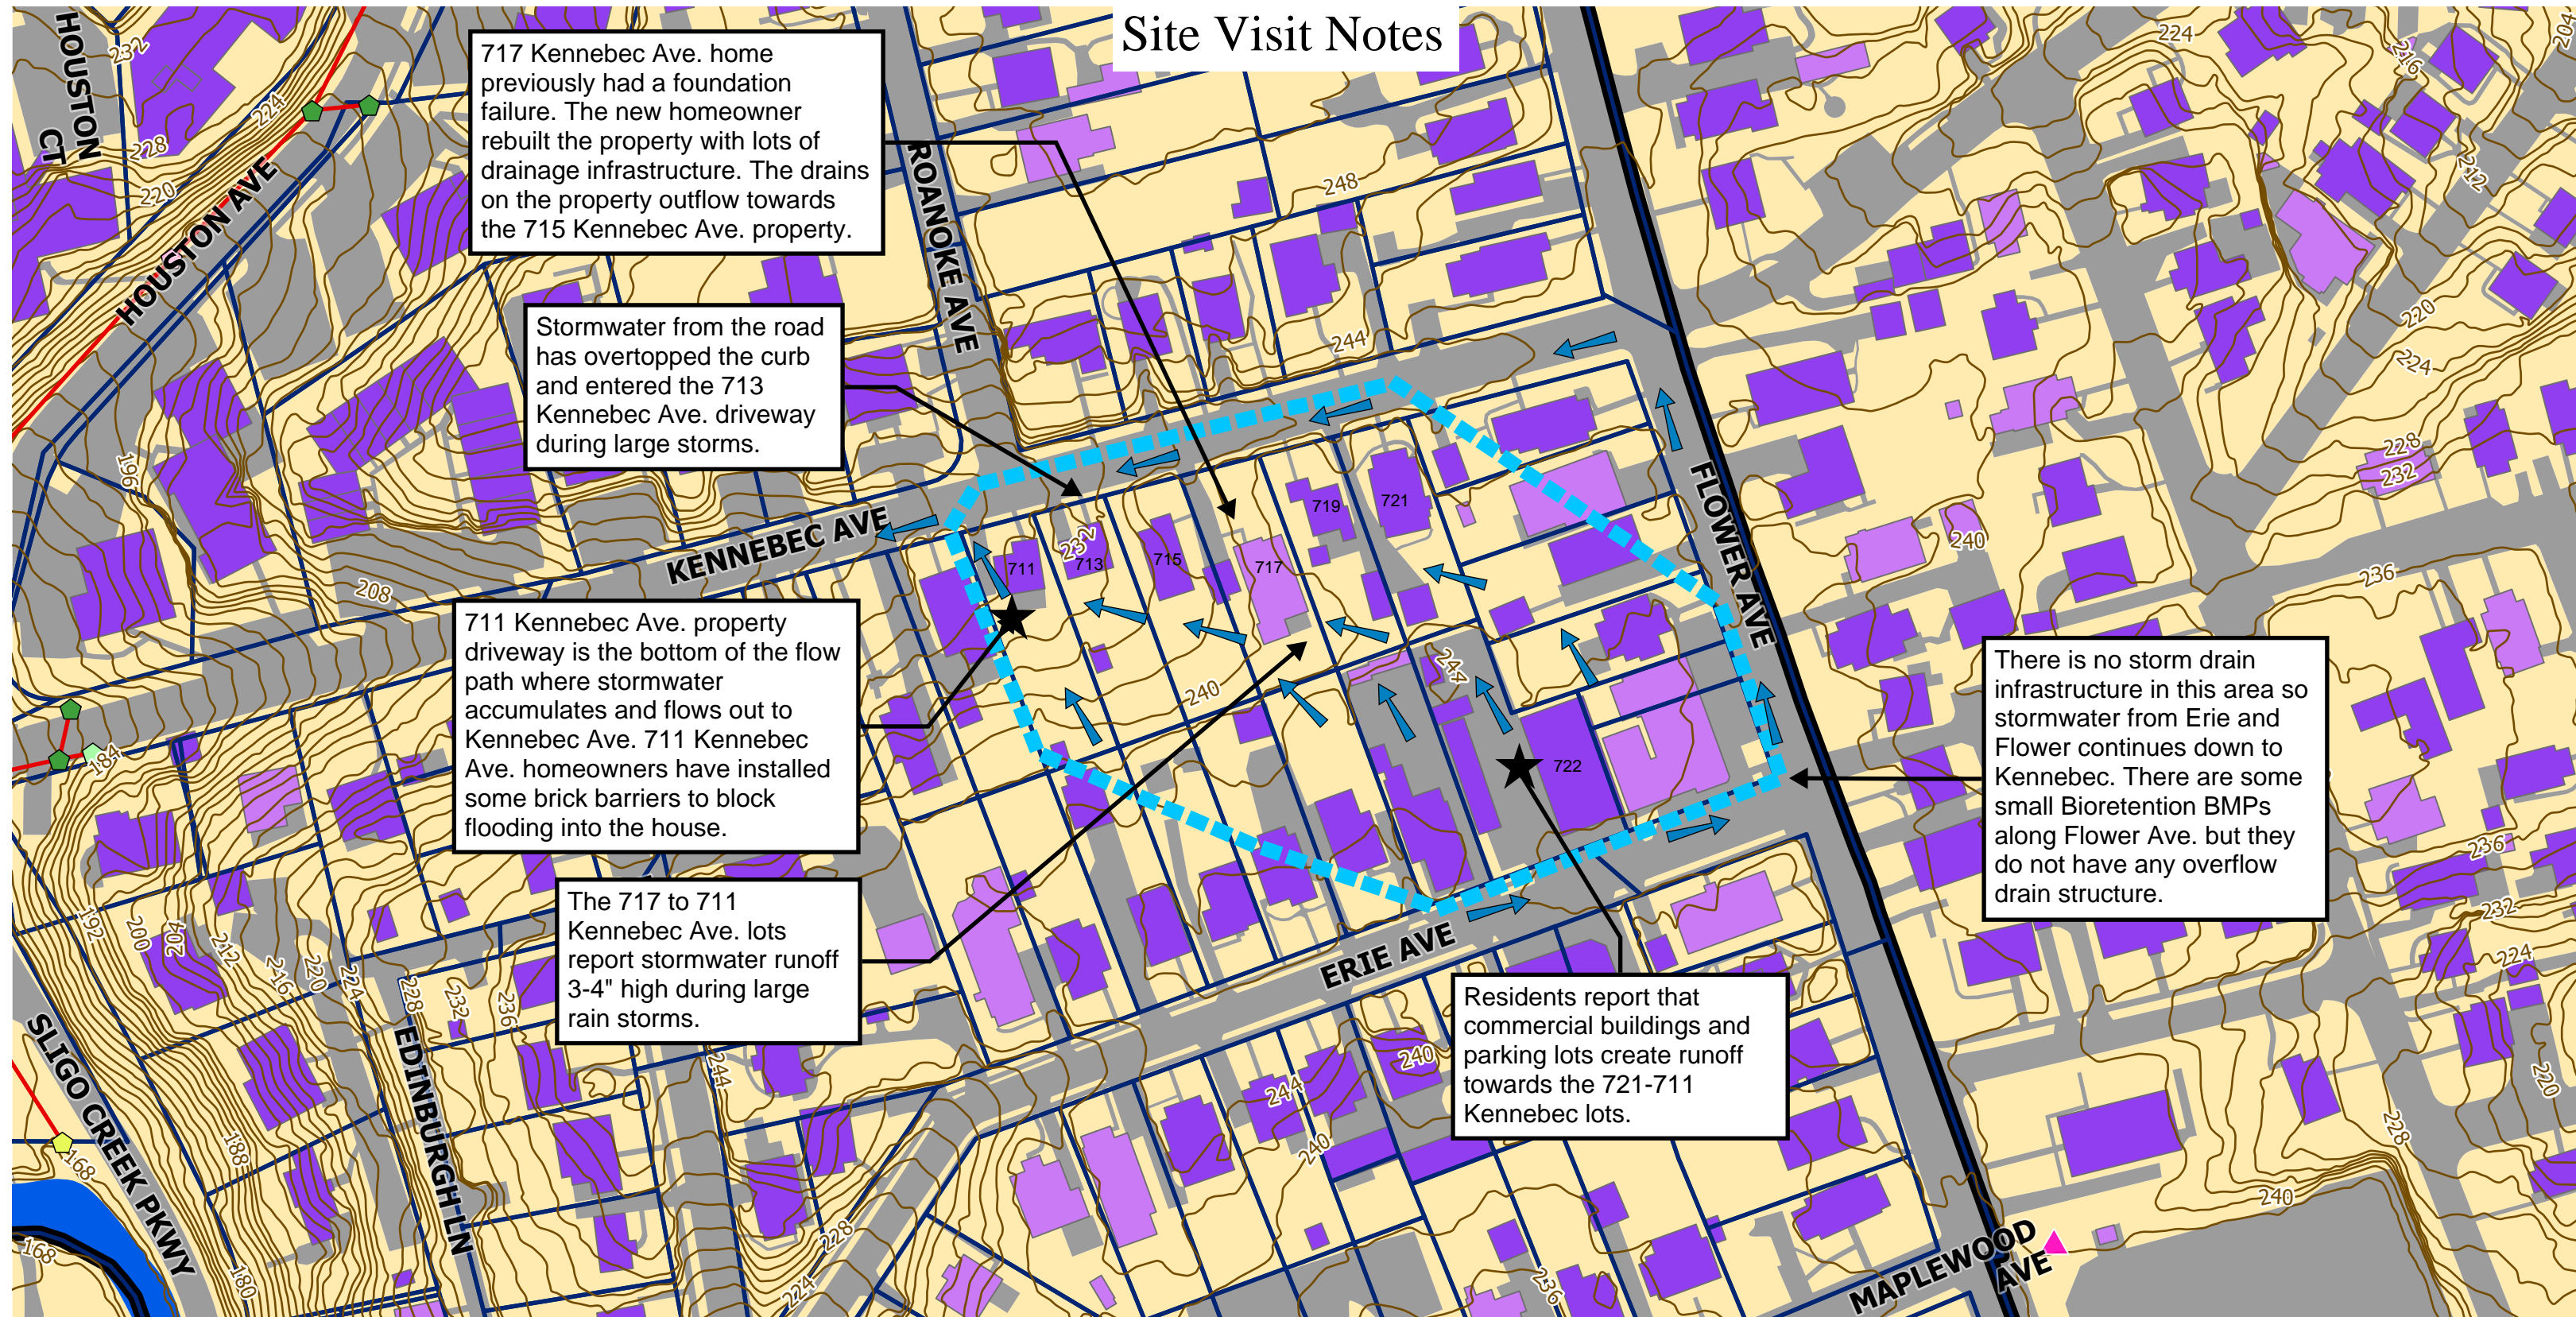
Takoma Park Study Area 6

It was determined from field investigation that the drainage issues along the Kennebec Ave. lots are not caused by water coming from the public right of way, except at the 713 Kennebec Ave. driveway.

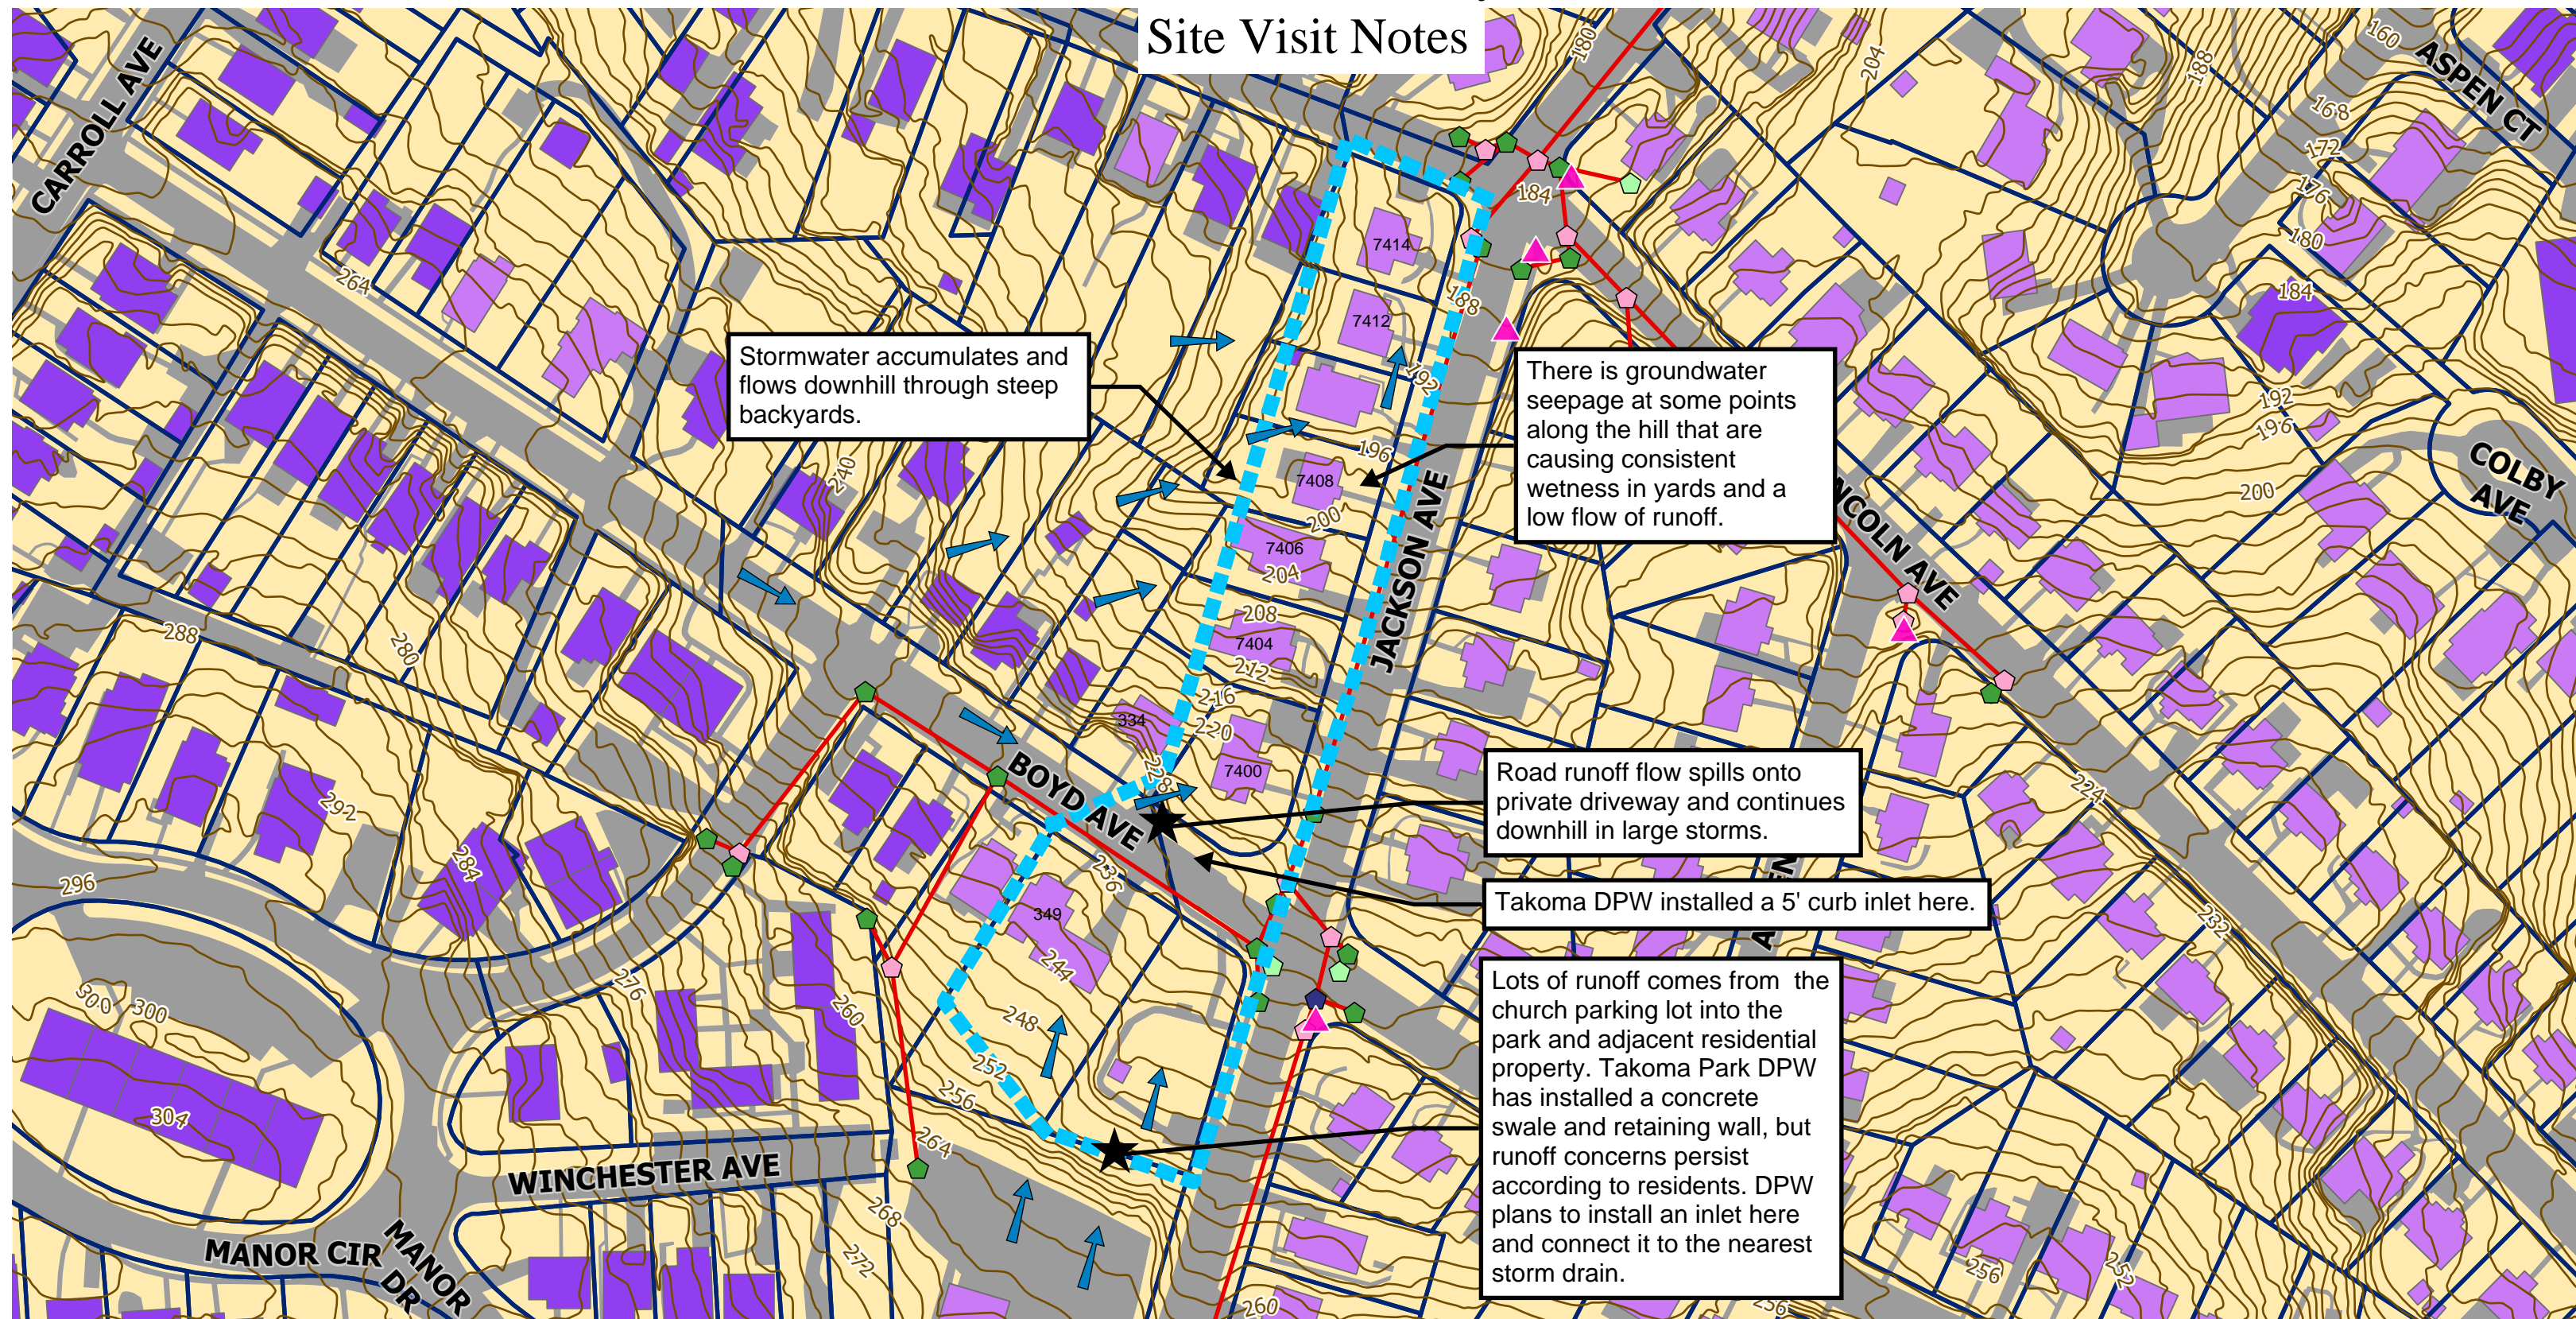
Takoma Park Study Area 7

It was determined from field investigation that the drainage issues along the Jackson Ave. lots are not caused by water coming from the public right of way except at 334 Boyd Ave. driveway.
