Stormwater Climate Adaptation Plan Report for the City of Takoma Park, Maryland

Prepared by:
The Low Impact Development Center for The City of Takoma Park

June 2024

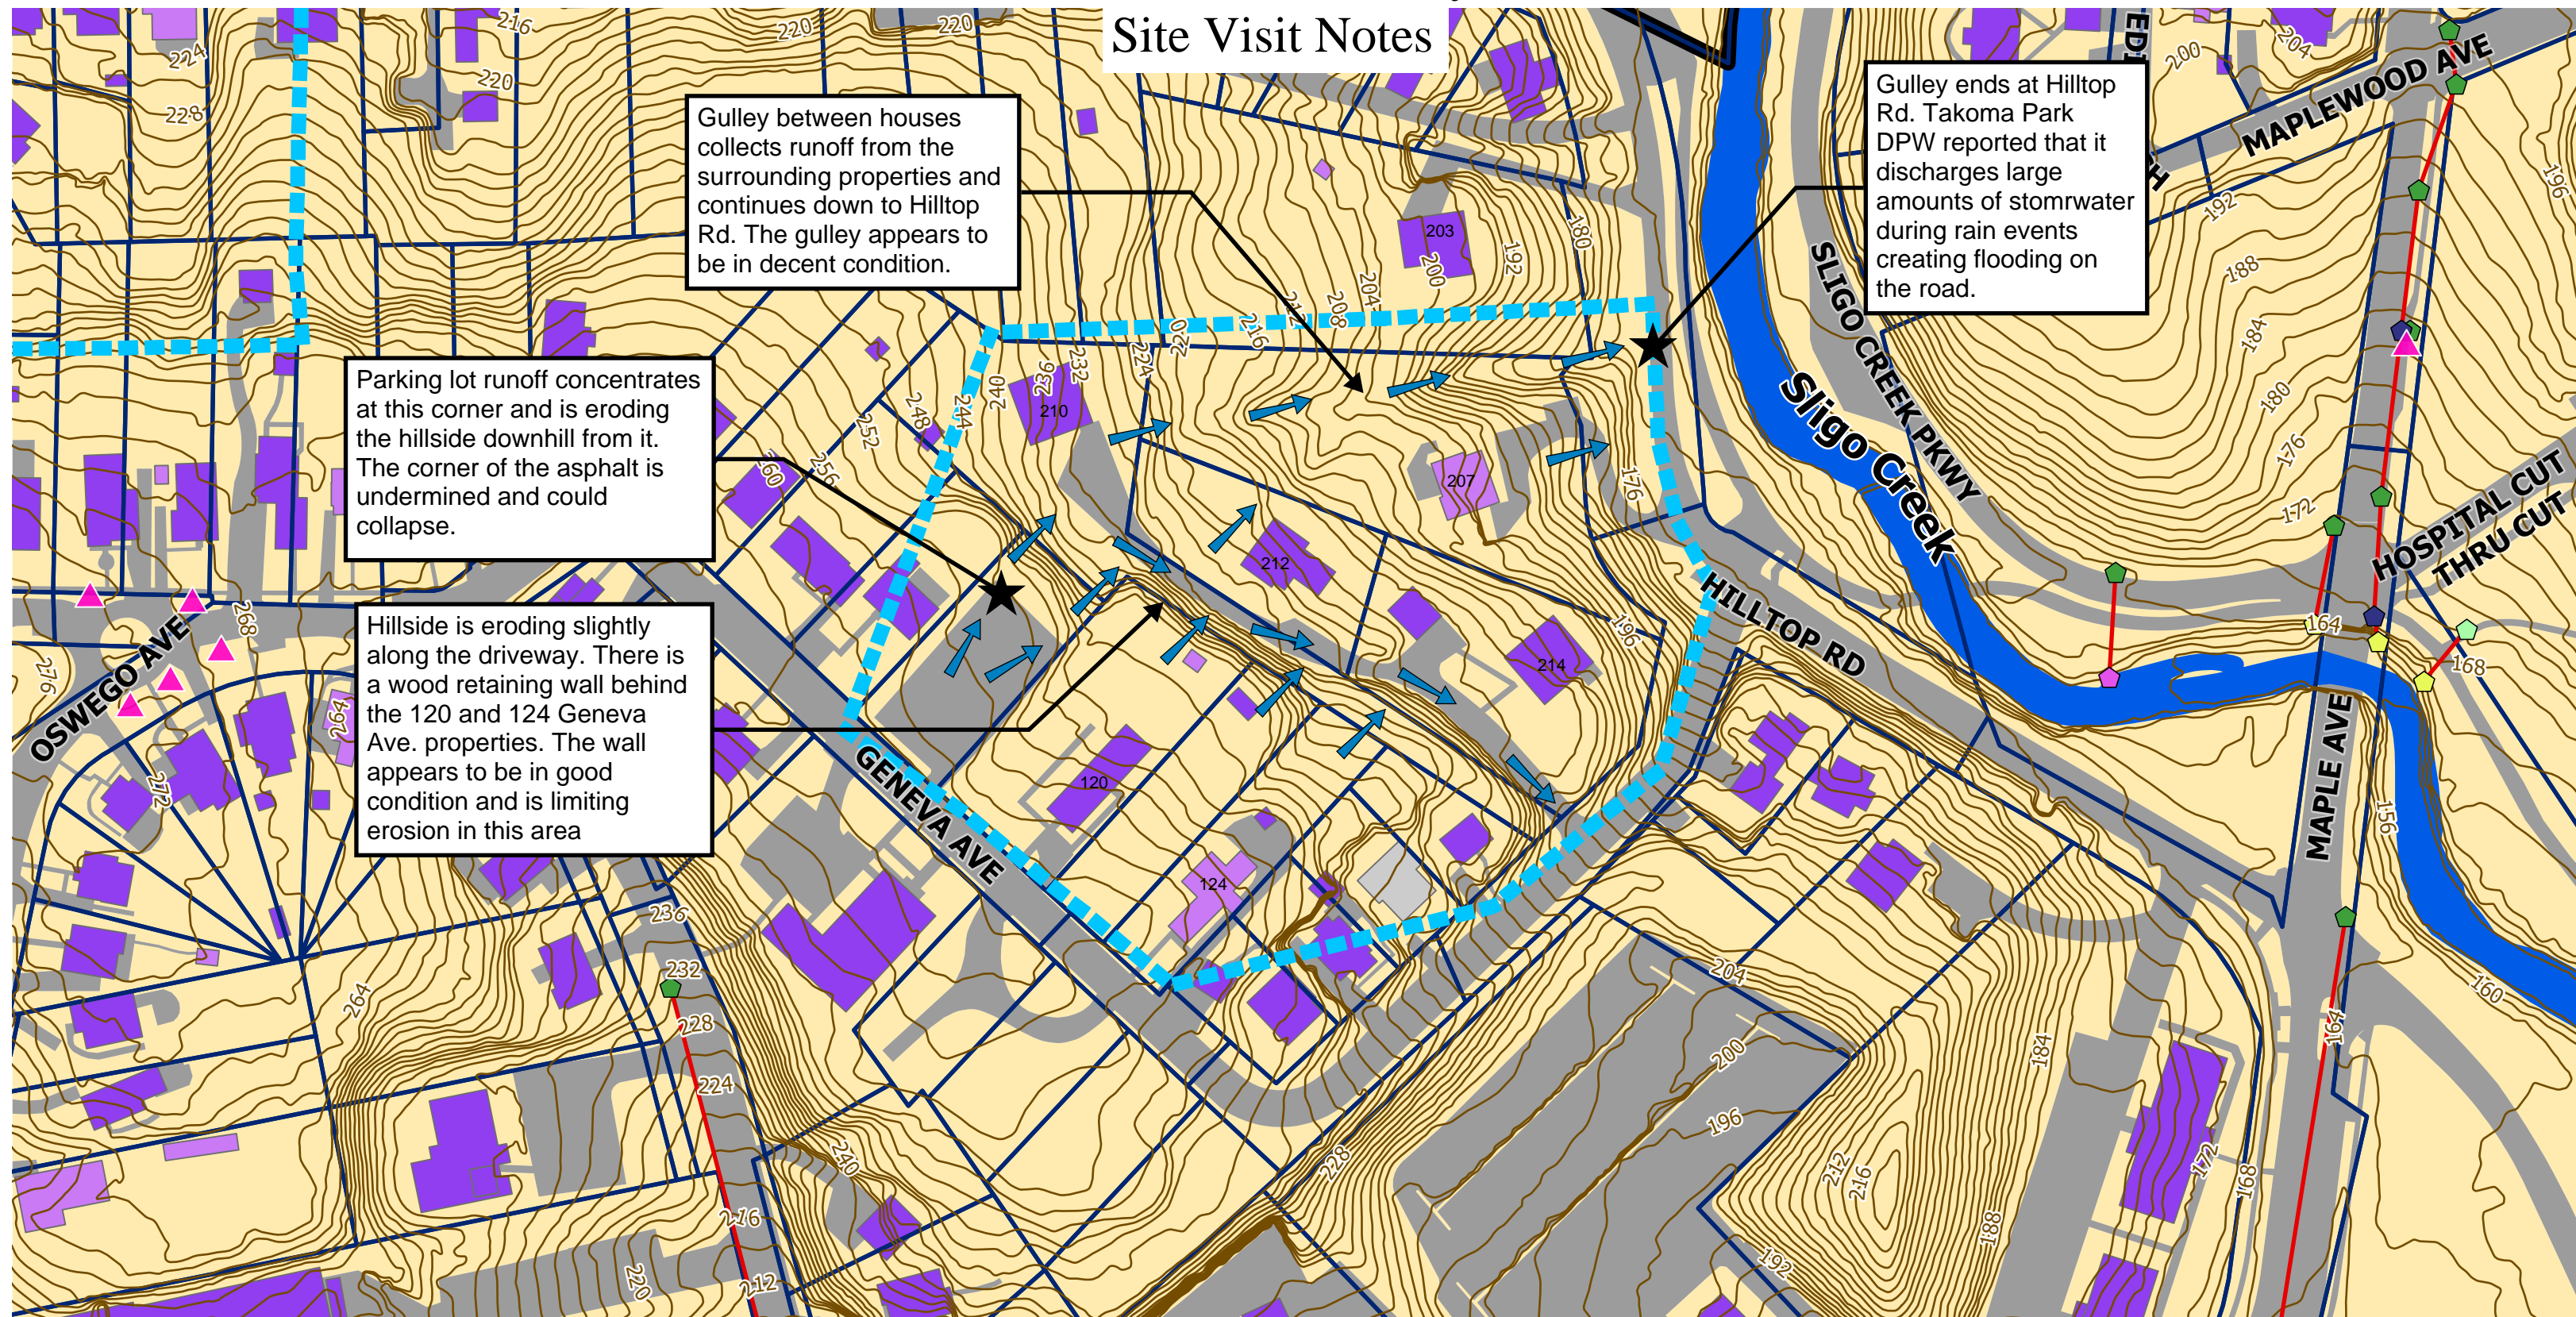
Takoma Park Study Area 5

Gully between houses collects runoff from the surrounding properties and continues down to Hilltop Rd. The gully appears to be in decent condition.

Hillside is eroding slightly along the driveway. There is a wood retaining wall behind the 120 and 124 Geneva Ave. properties. The wall appears to be in good condition and is limiting erosion in this area

Gully ends at Hilltop Rd. Takoma Park DPW reported that it discharges large amounts of stormwater during rain events creating flooding on the road.

It was determined from field investigation that the drainage issues around the Geneva Ave. lots and private driveway are not caused by water coming from the public right of way.

Some tools residents may be able to utilize to address drainage concerns include overland flow paths and private storm drains. Neighbor collaboration may be necessary. Refer to the resident guidance pamphlet and the Study Area 5 Report for details.

Takoma Park DPW may consider installing an inlet on Hilltop Rd. near the gully outflow point to facilitate drainage of the roadway. The storm drain inlet would need to be piped under the road and outfall into Sligo Creek. This work would need to be coordinated with M-NCPPC.

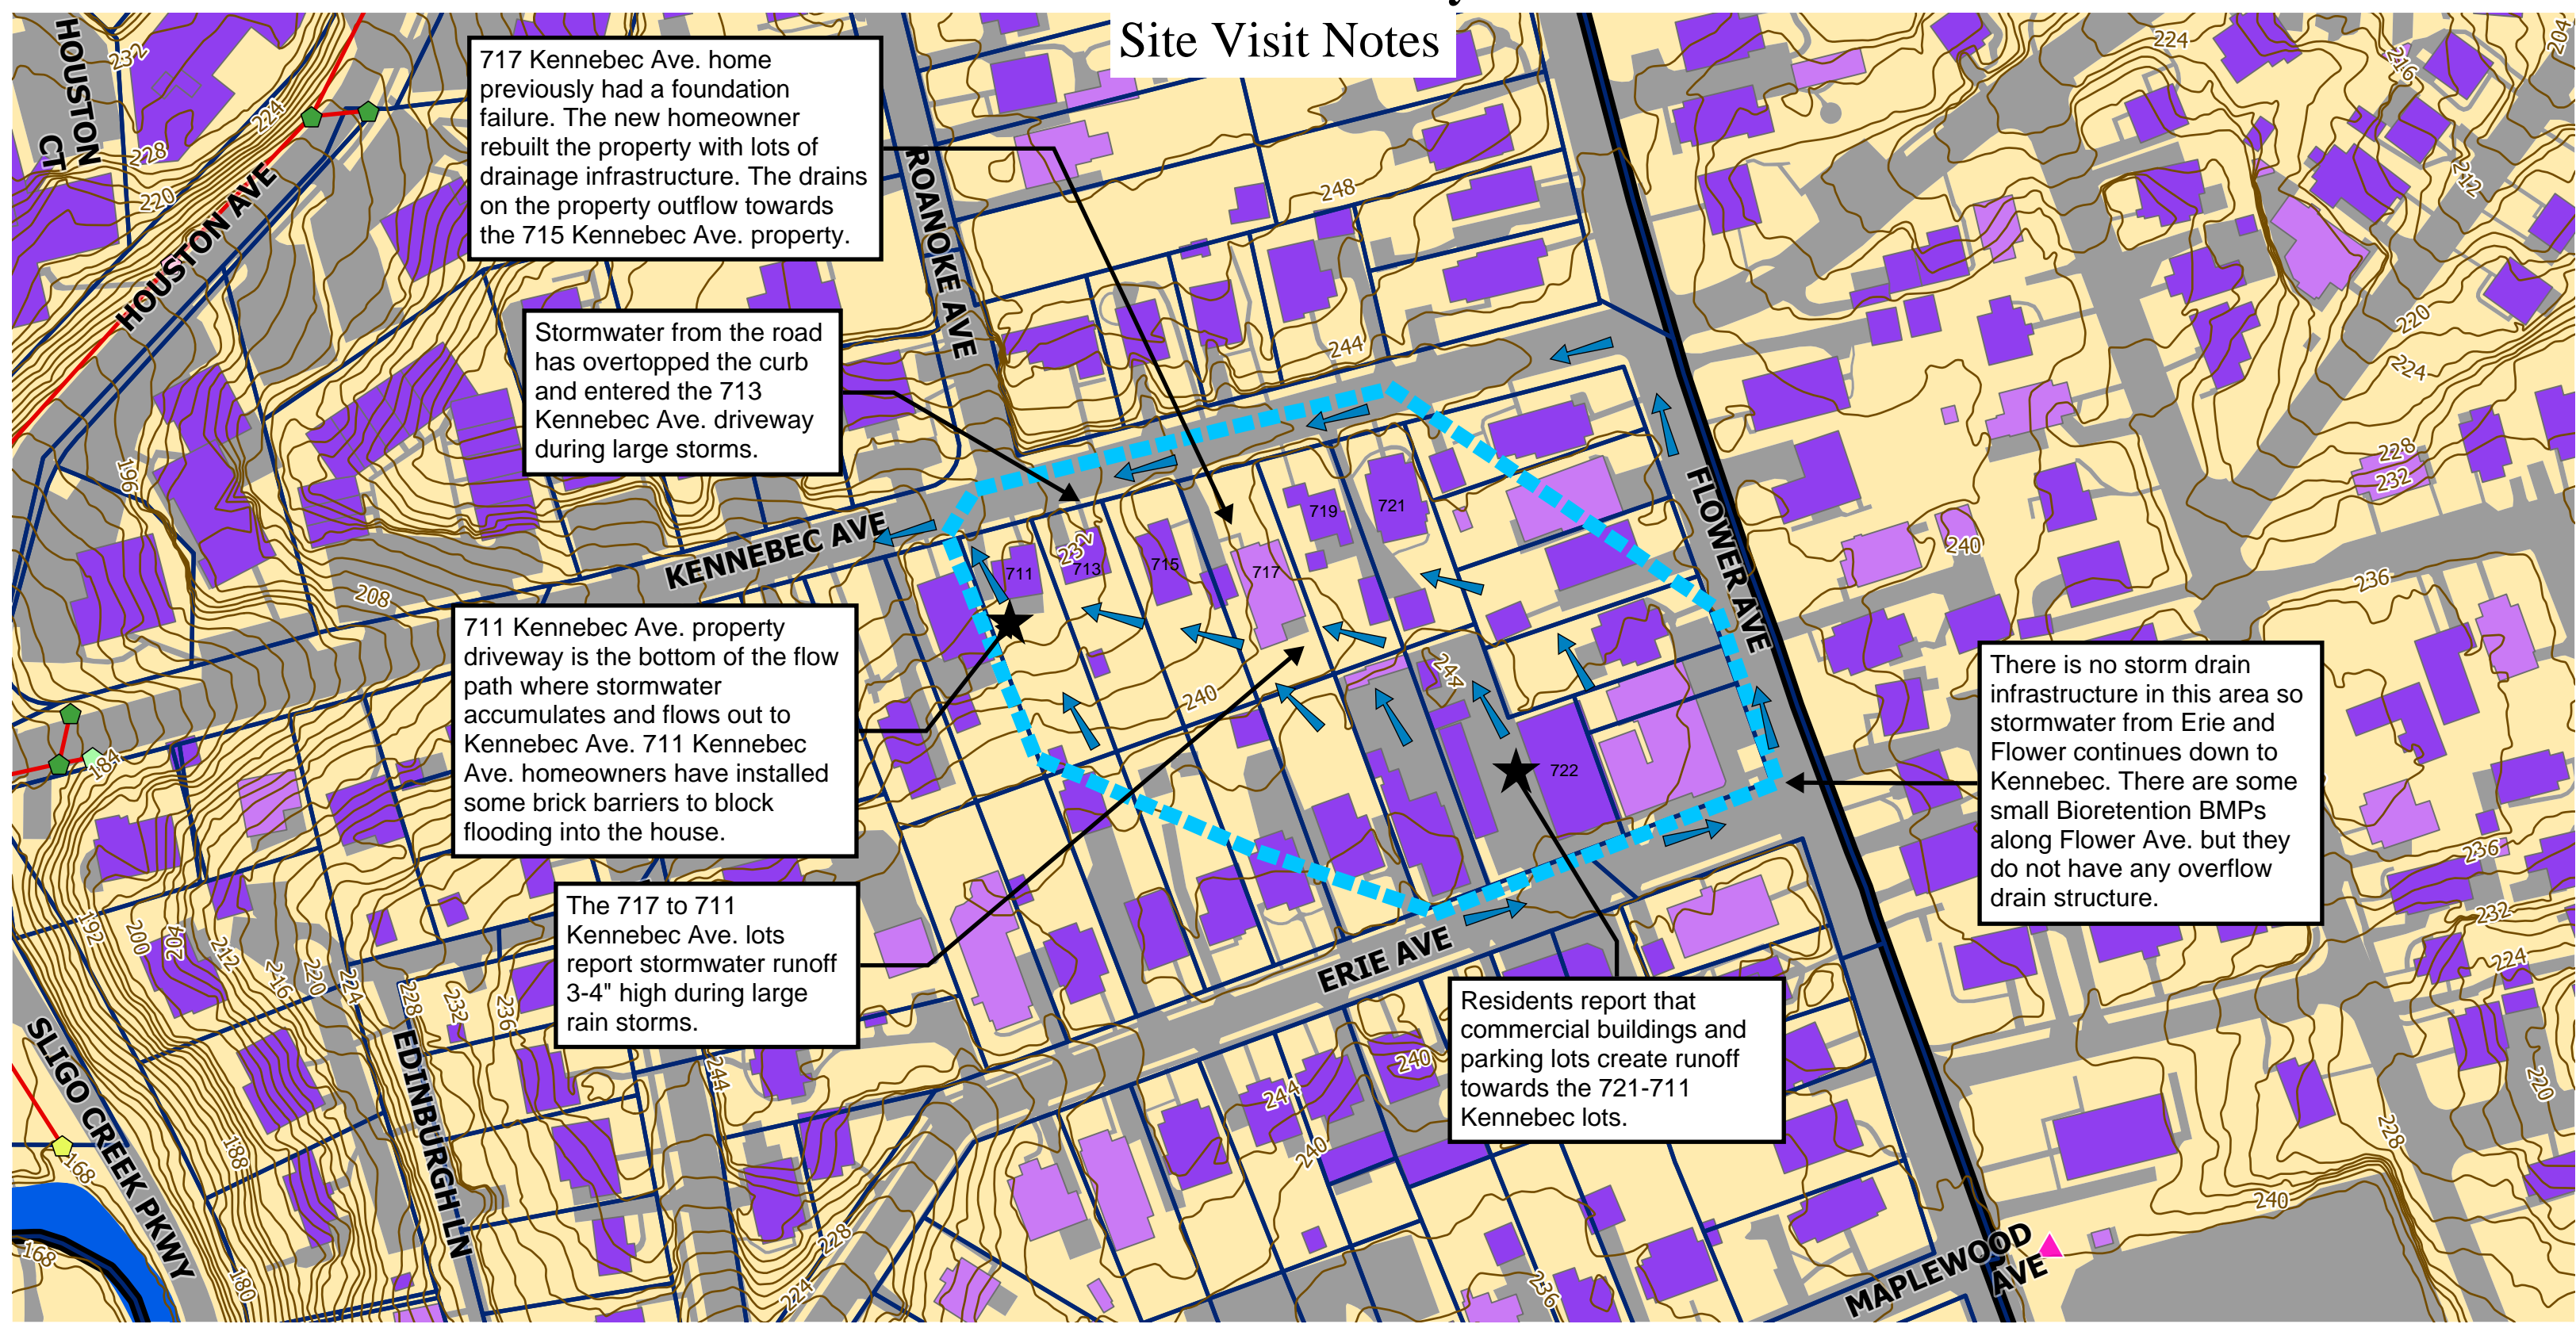
717 Kennebec Ave. home previously had a foundation failure. The new homeowner rebuilt the property with lots of drainage infrastructure. The drains on the property outflow towards the 715 Kennebec Ave. property.

Residents report that commercial buildings and parking lots create runoff towards the 721-711 Kennebec lots.

There is no storm drain infrastructure in this area so stormwater from Erie and Flower continues down to Kennebec. There are some small Bioretention BMPs along Flower Ave. but they do not have any overflow drain structure.

It was determined from field investigation that the drainage issues along the Kennebec Ave. lots are not caused by water coming from the public right of way, except at the 713 Kennebec Ave. driveway.

Some tools residents may be able to utilize to address drainage concerns include overland flow paths and private storm drains. Neighbor collaboration may be necessary to limit cross property runoff. Refer to the resident guidance pamphlet and the Study Area 6 Report for details.

Takoma Park DPW may consider facilitating a discussion with commercial property owners regarding runoff from their properties.

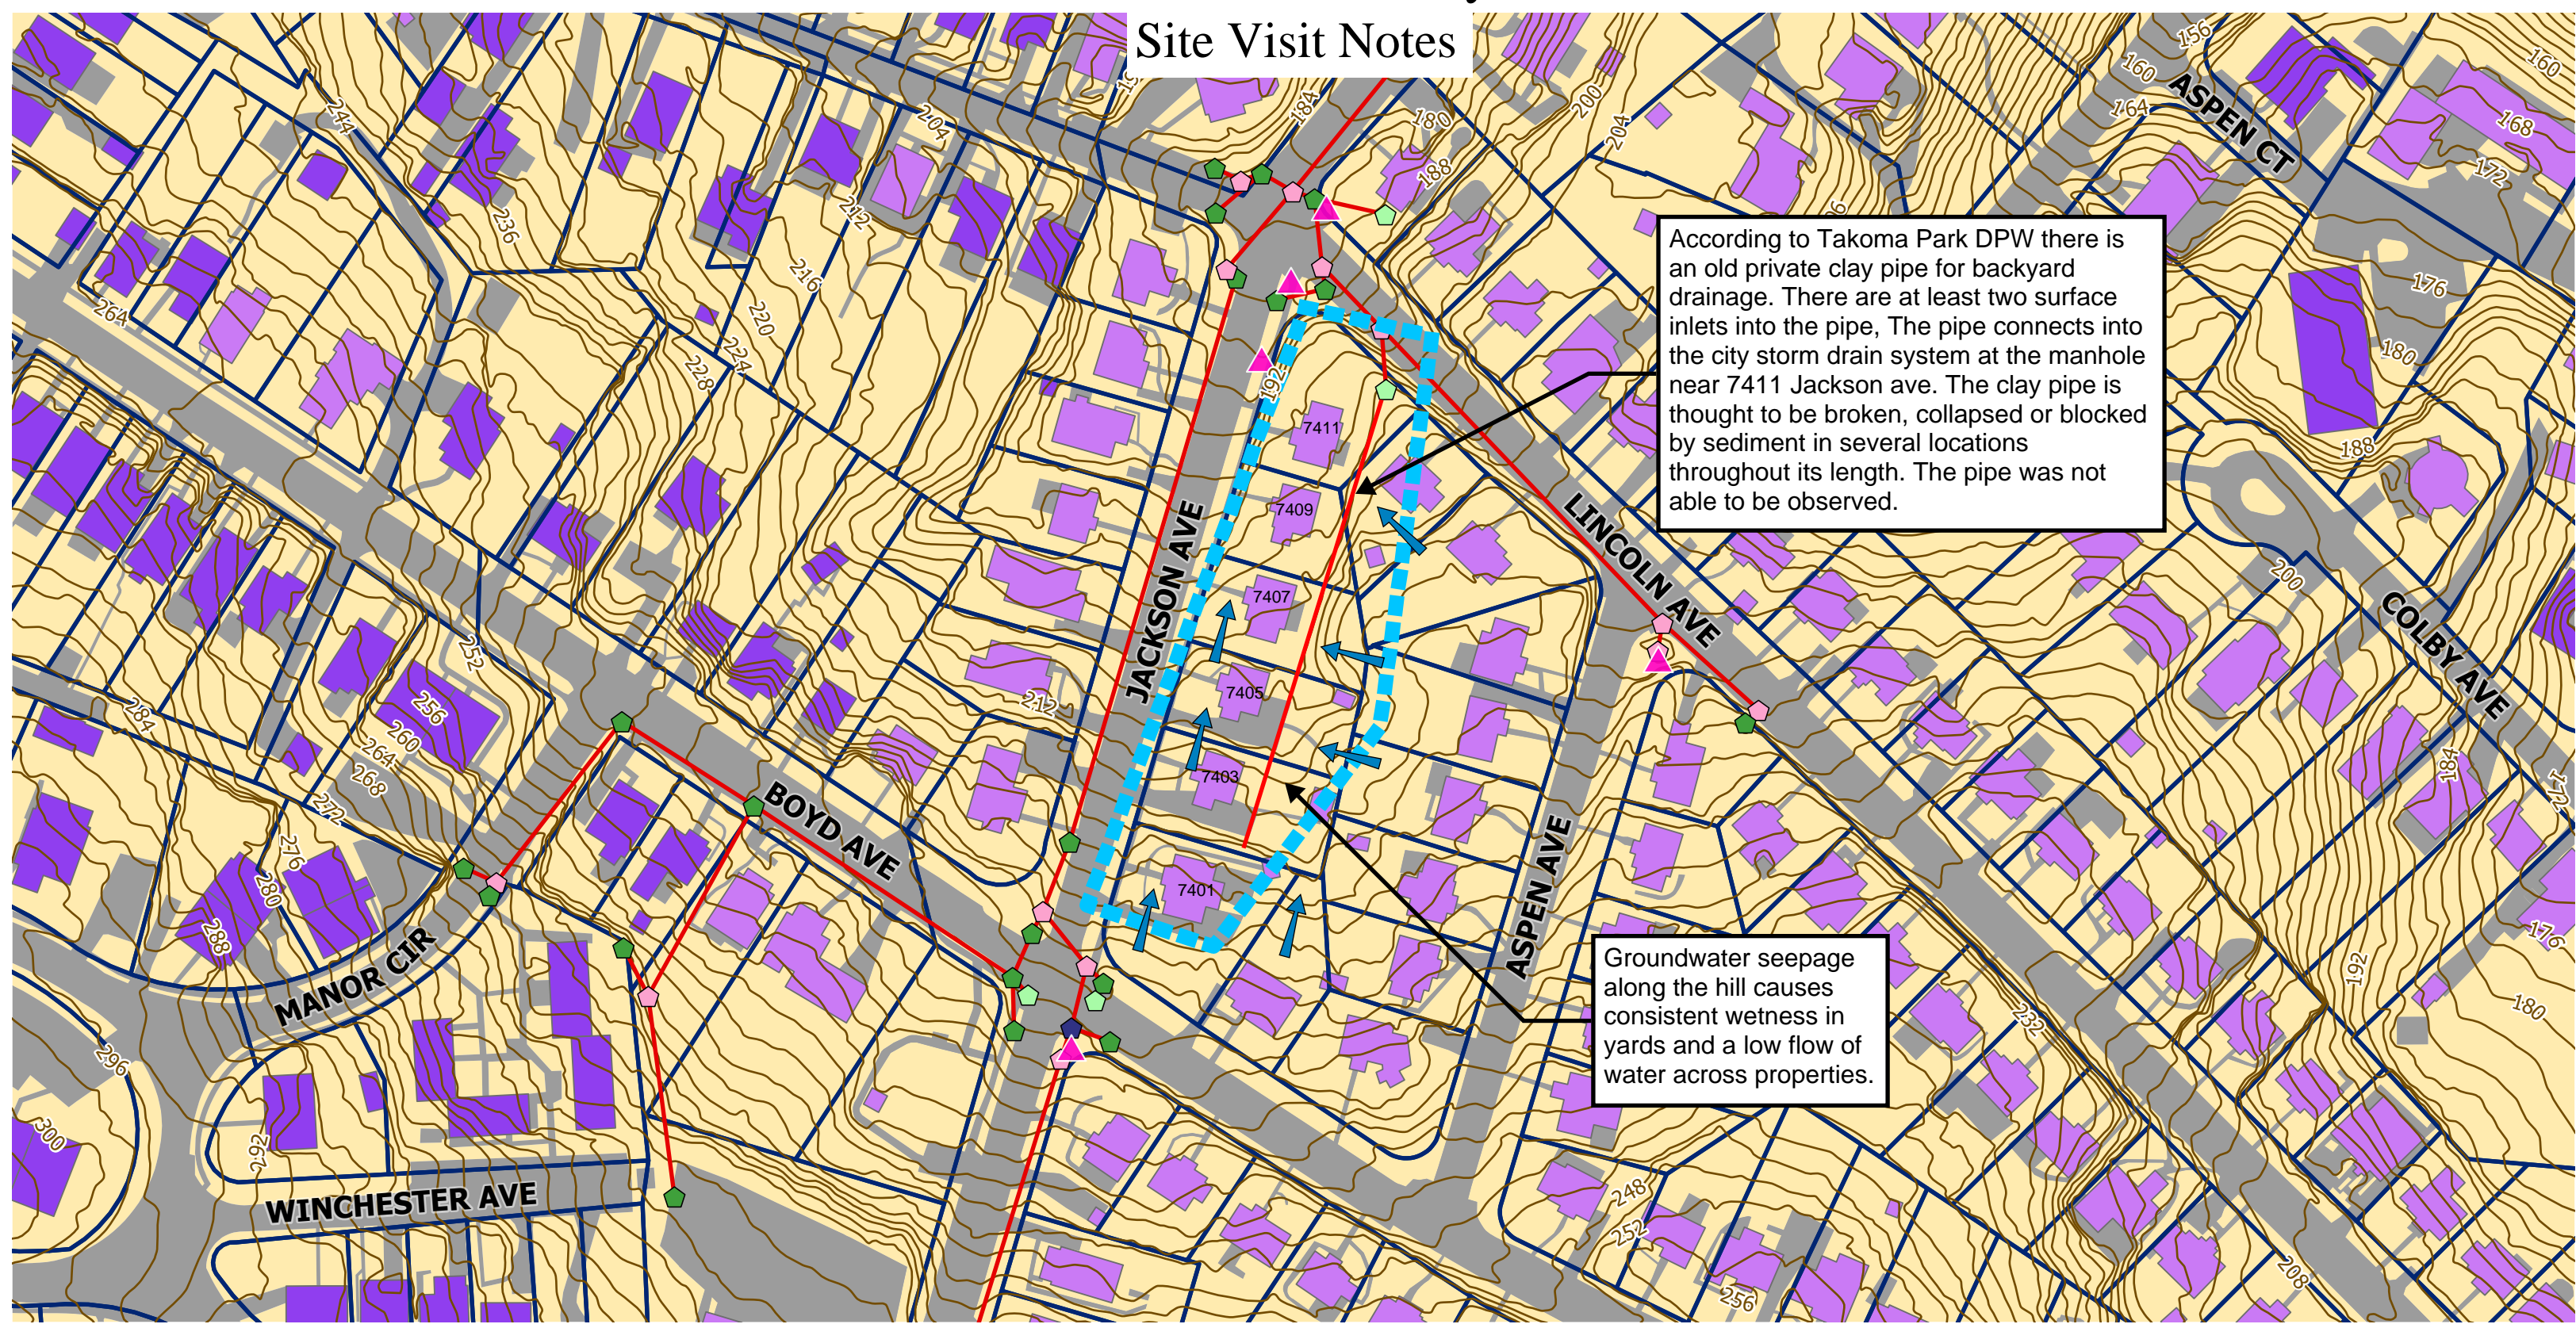
According to Takoma Park DPW there is an old private clay pipe for backyard drainage. There are at least two surface inlets into the pipe, The pipe connects into the city storm drain system at the manhole near 7411 Jackson ave. The clay pipe is thought to be broken, collapsed or blocked by sediment in several locations throughout its length. The pipe was not able to be observed.

Groundwater seepage along the hill causes consistent wetness in yards and a low flow of water across properties.

It was determined from field investigation that the drainage issues along the Jackson Ave. lots are not caused by water coming from the public right of way.

Some tools residents may be able to utilize to address drainage concerns include french drains and private storm drain maintenance. Takoma Park DPW may want to encourage residents to replace the private storm drain pipe with a new drainage system. Neighbor collaboration may be necessary to limit cross property runoff. Refer to the resident guidance pamphlet and the Study Area 8 Report for details.

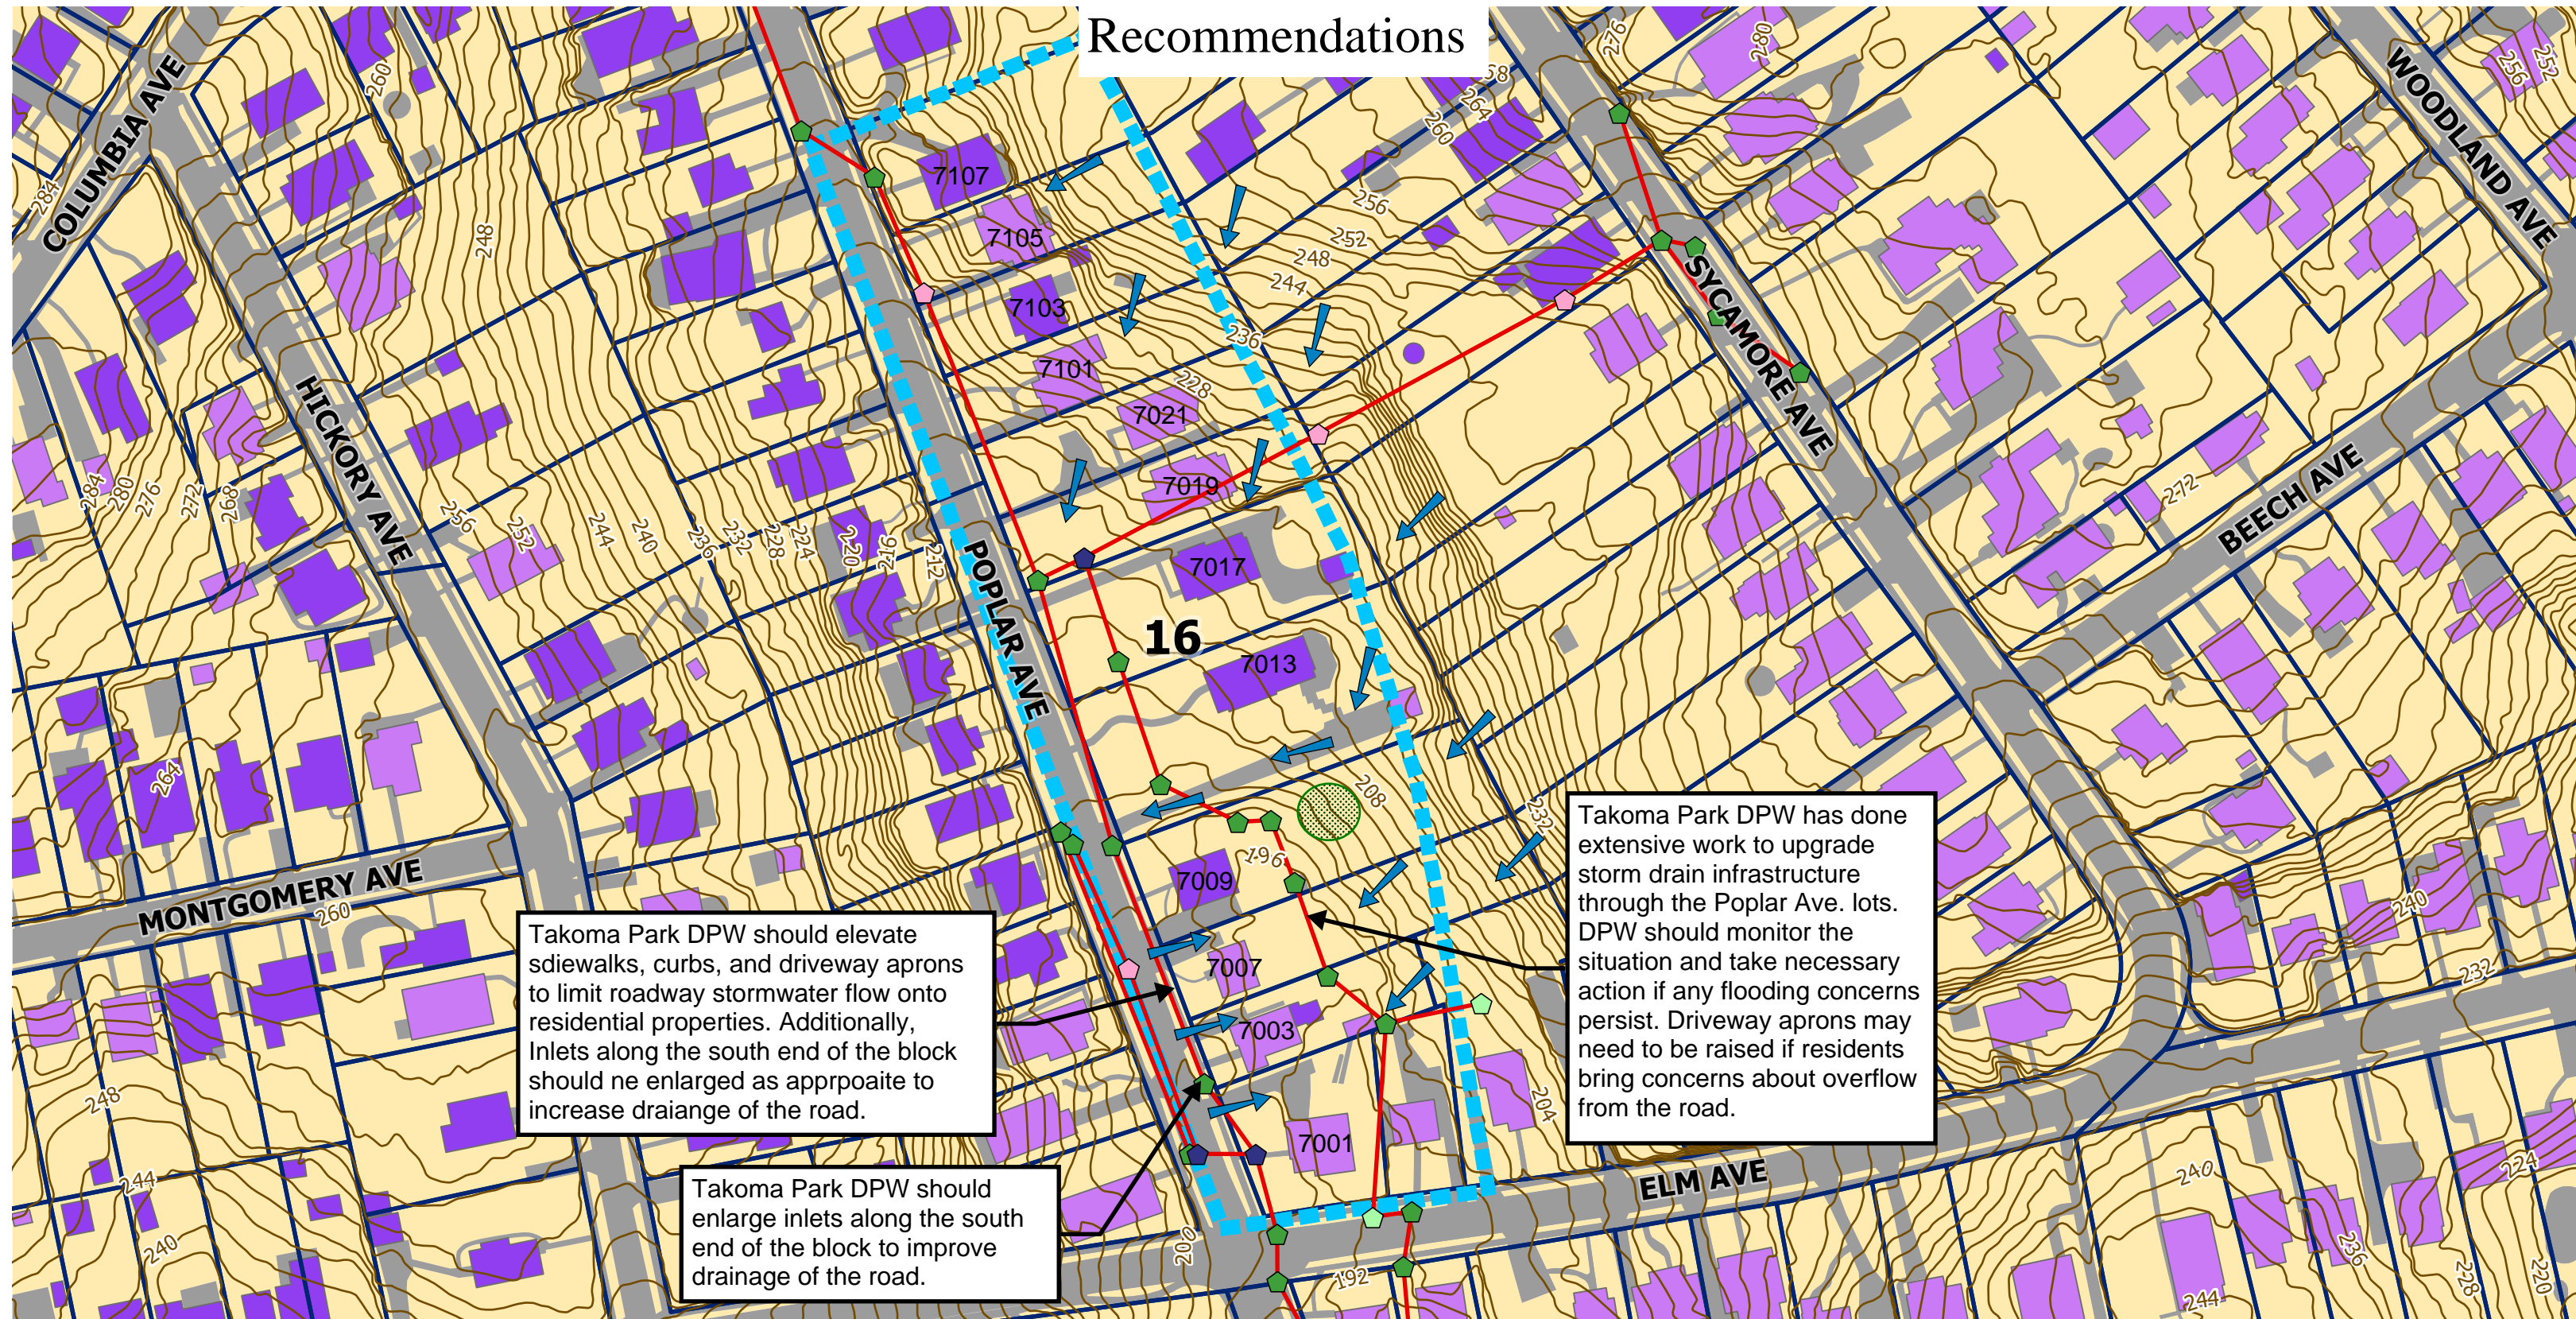
Takoma Park Study Area 16

The backyards of 7001-7009 Poplar Ave. are a low lying area that does not drain to the public right of way. Takoma Park DPW recently replaced a storm drain pipe with 4 inlets and enlarged an inlet on Elm Ave. to help drain the backyards.

Takoma Park DPW should elevate sidewalks, curbs, and driveway aprons to limit roadway stormwater flow onto residential properties. Additionally, inlets along the south end of the block should be enlarged as appropriate to increase drainage of the road.

Takoma Park DPW should enlarge inlets along the south end of the block to improve drainage of the road.

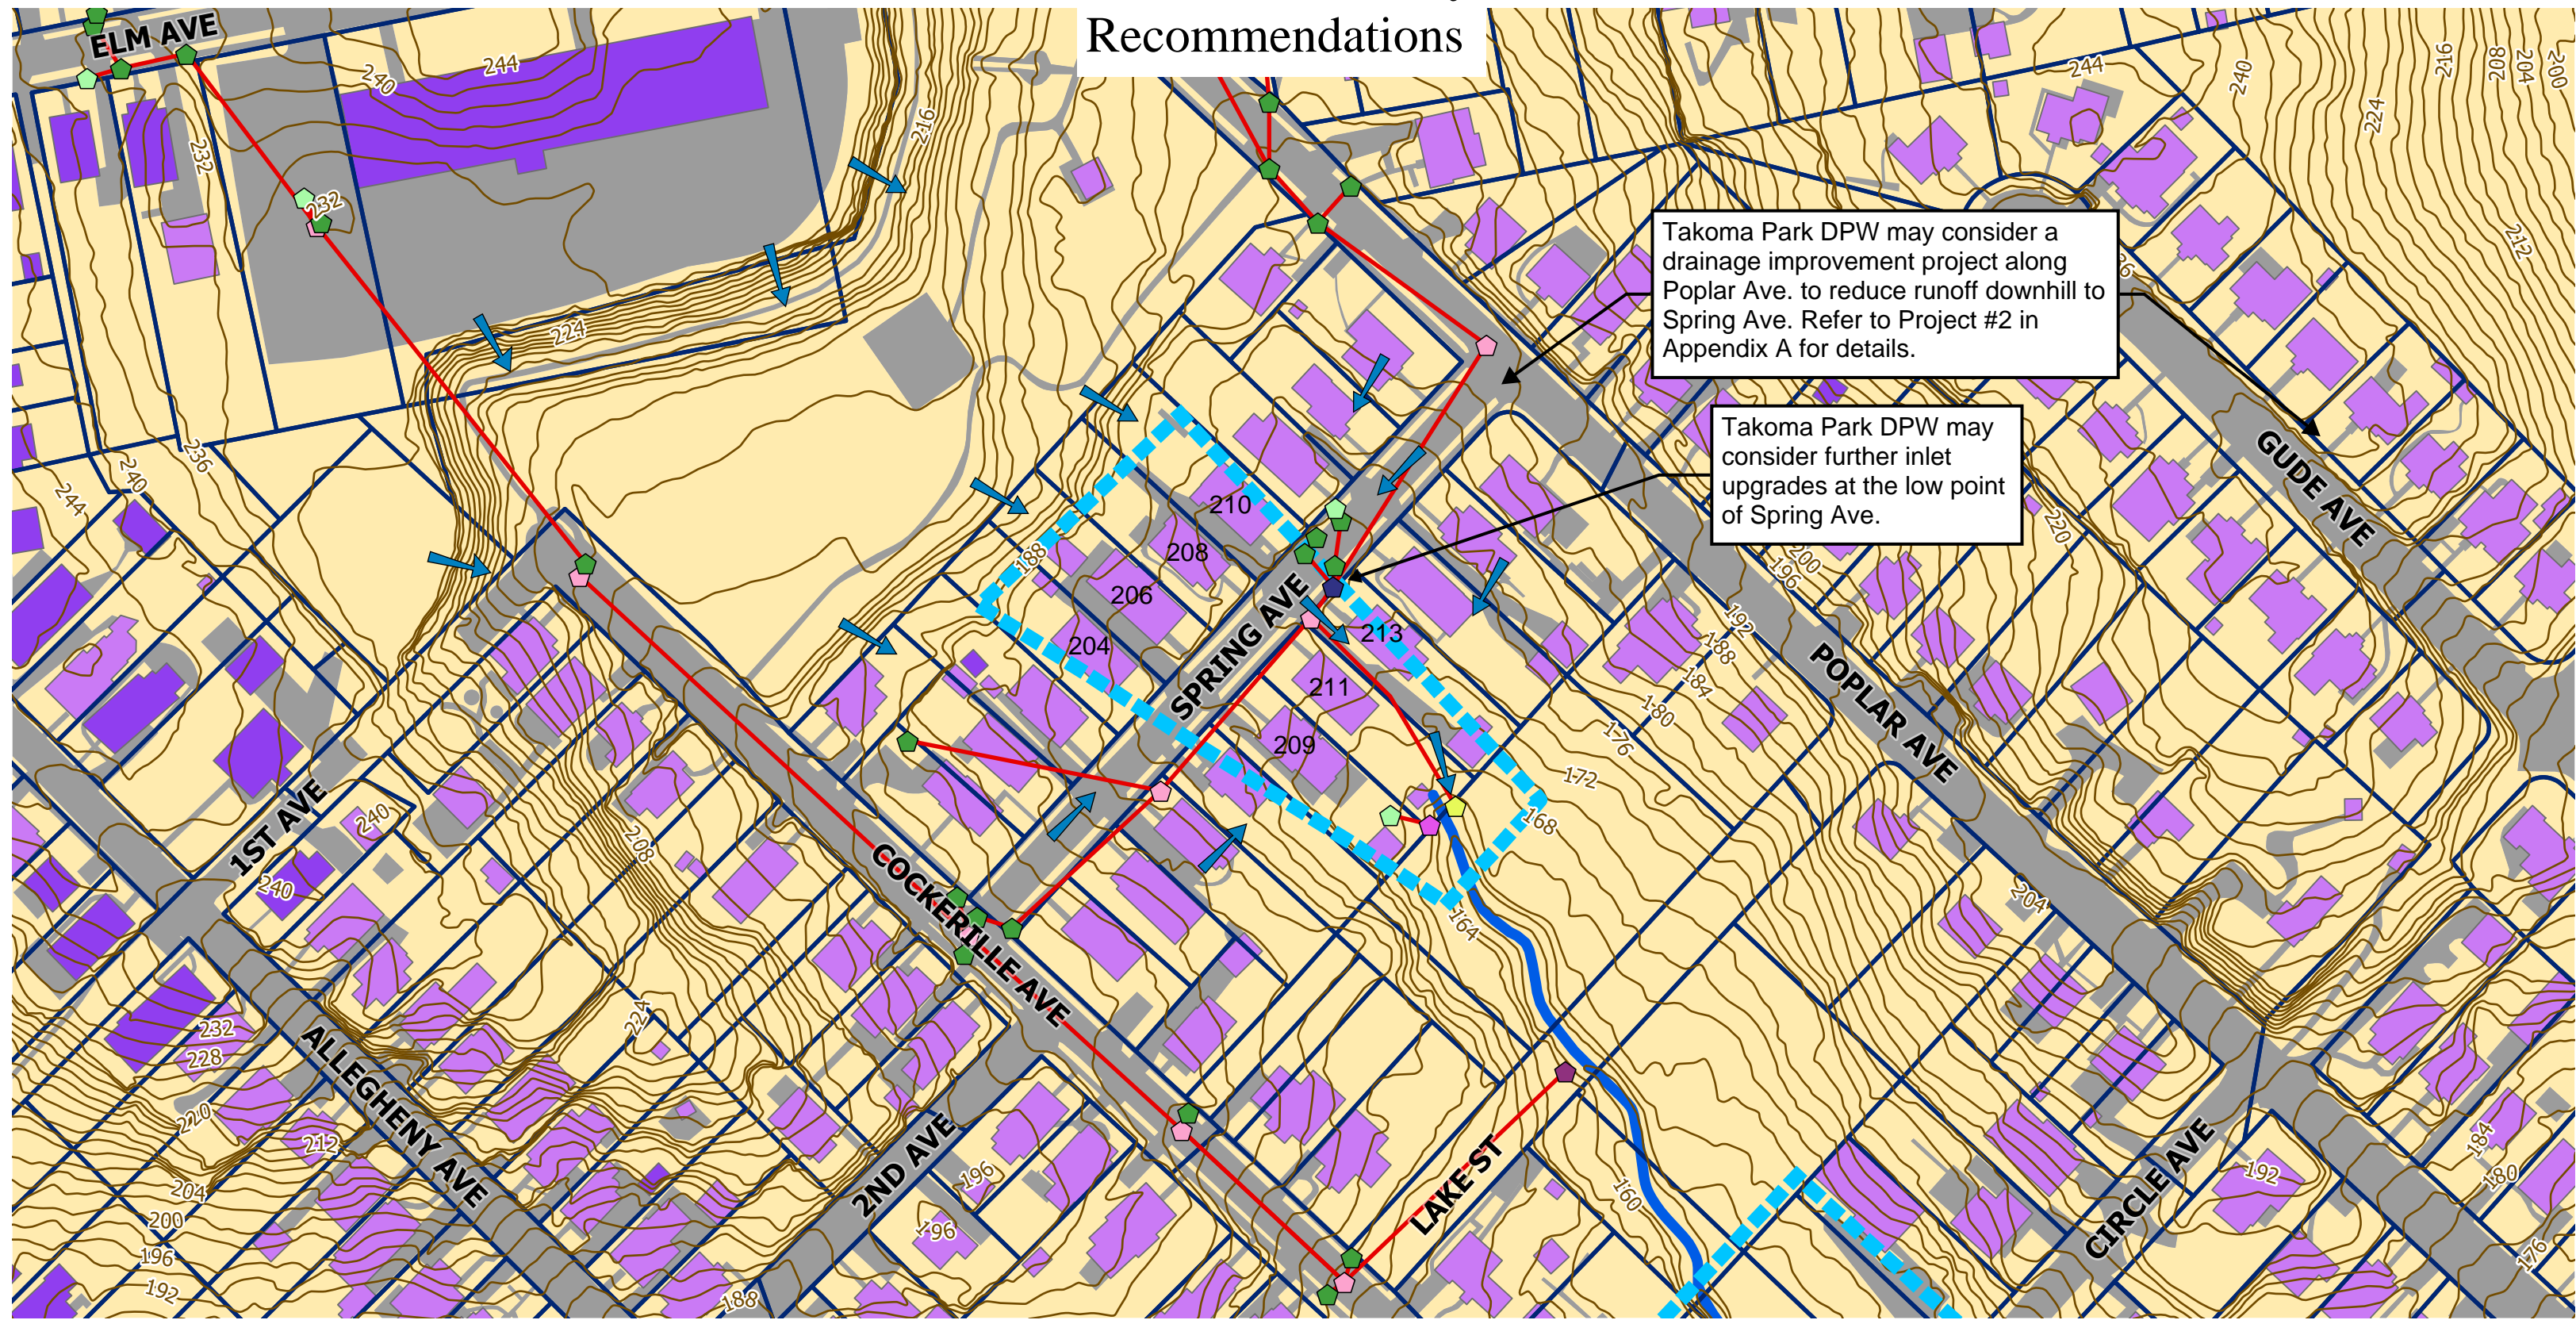
Takoma Park Study Area 17

Inlets at the sump of Spring Ave. can overflow and cause runoff onto the private properties. This has caused serious flooding concerns for the 211 and 213 property. Takoma Park DPW has upgraded the inlets in this area, but there are still concerns about overflows.

Takoma Park DPW may consider a drainage improvement project along Poplar Ave. to reduce runoff downhill to Spring Ave. Refer to Project #2 in Appendix A for details.

Takoma Park DPW may consider further inlet upgrades at the low point of Spring Ave.
